Presentation from WP1 Input in managing strategies

Anatoly O. Sinitsyn (SINTEF), Yared Bekele (SINTEF), Anni Vehola (LUT University and UNIS), Lena Rubensdotter (NGU and UNIS), Sebastian Westermann (UiO) and Juditha Aga (UiO)

Input in managing strategies – Report Nr. 6 – Draft version

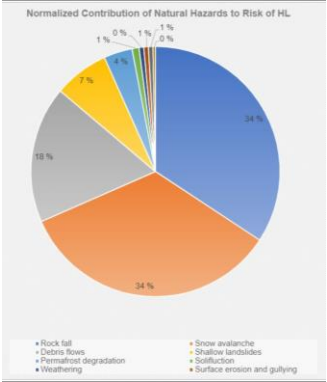
Figure 3. Aggregated risk of Heritage Loss (referred as HL in the figure) from natural hazards to the post nr. 6 on Cable car line 1b.

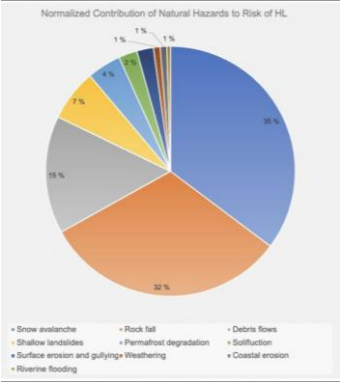
Aggregated average risk of Heritage Loss (referred as HL in the figure) for Cable car line 1b. Figure: [6].

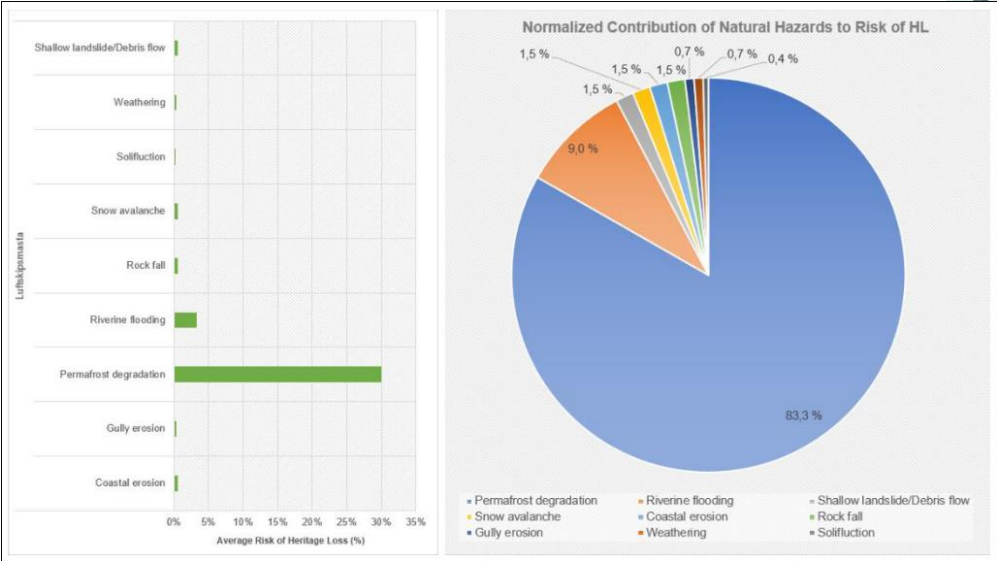
Contribution of different natural hazards to the risk of Heritage Loss for the Air ship mast.

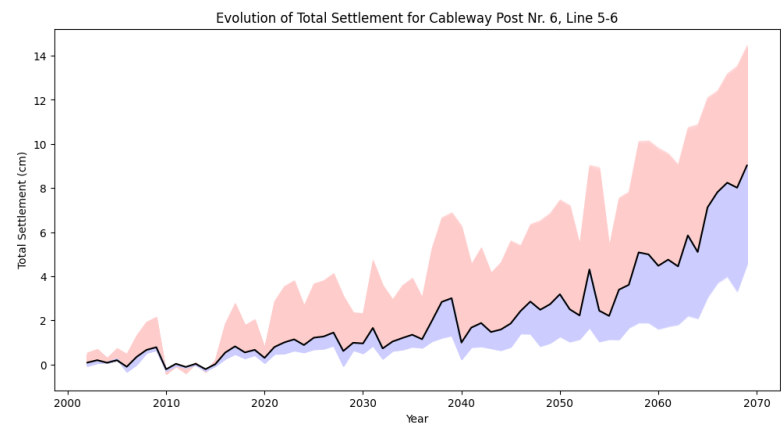
Cableway Post Nr. 6 (Line 5–6),

Figure 1. Evolution of total settlement (creep and thaw) for Cableway Post Nr. 6, Line 5-6 from 2000 to 2070. Figure: [13].

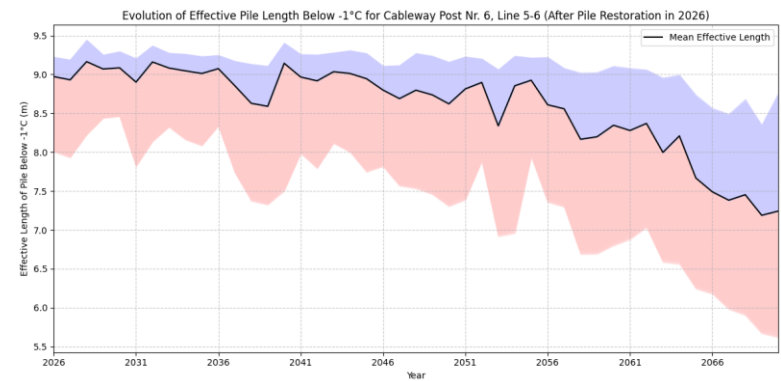
Figure 2. Evolution of effective pile length for Cableway Post Nr. 6, Line 5-6 after assumed pile restoration in 2026. Figure: [13].

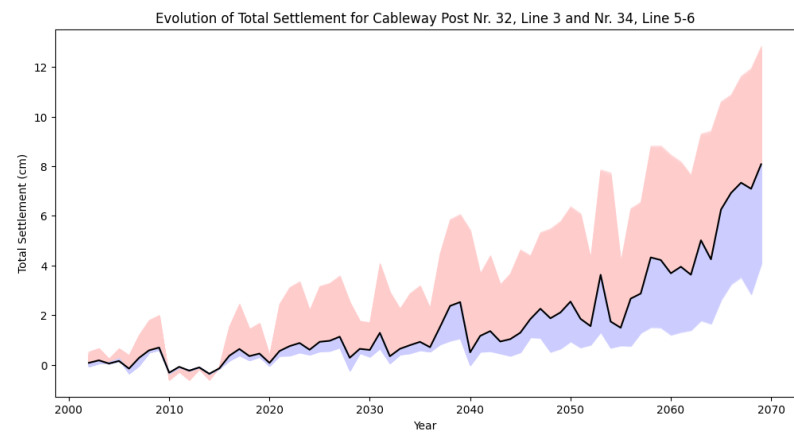
Cableway Posts Nr. 32 (Line 3) and Nr. 34 (Line 5–6)

Figure 1. Evolution of total settlement (creep and thaw) for Cableway Post Nr. 32, Line 3 and Nr. 34, Line 5-6. Figure: [13].

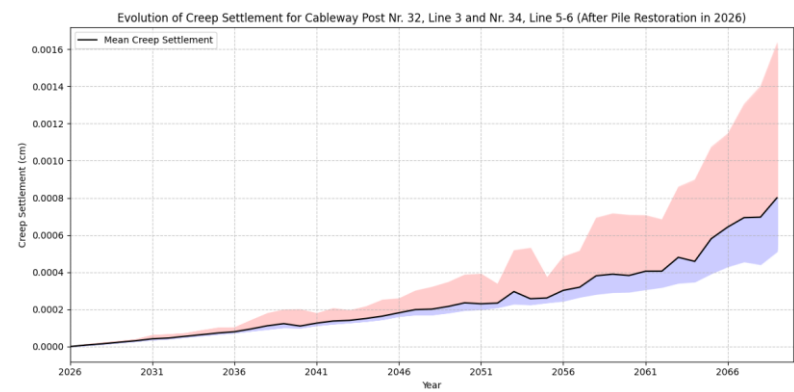
Figure 2. Evolution of creep settlements for Cableway Post Nr. 32, Line 3 and Nr. 34, Line 5-6 after assumed pile restoration in 2026. Figure: [13].

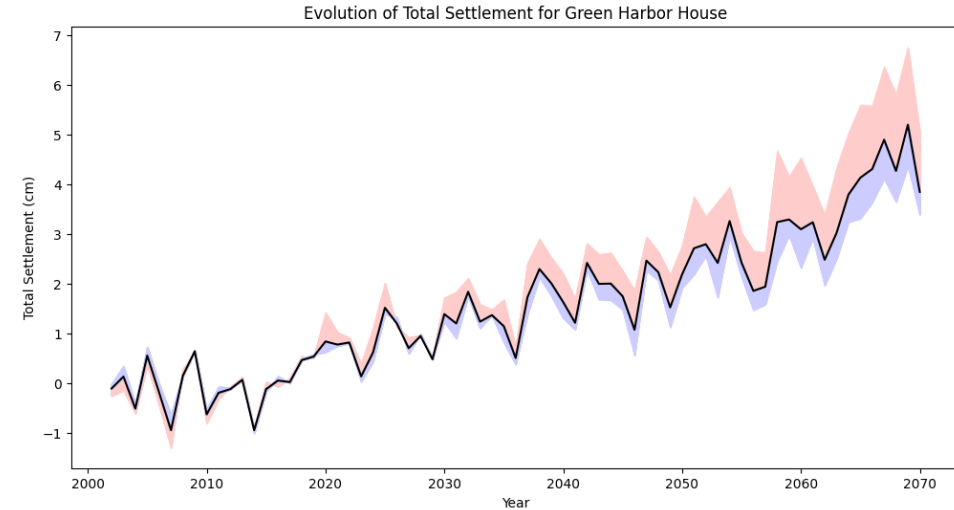
Figure 1: Evolution of total settlement for Green Harbour House. Figure: [13].

Green Harbour House rests on a series of surface foundations (logs supporting a simple frame). By 2070, total settlement (Figure 26) begins to approach levels that, especially if uneven, might compromise the structure's alignment or functionality. Although these absolute values remain moderate, heritage structures in permafrost often have little tolerance for differential movement. Therefore, even a few centimeters of settlement can become problematic over time.

Shallow rock lying at approximately 3 m depth was discovered at Green Harbour House during PCCH-Arctic field work in Ny-Ålesund in spring 2024 ([18]). This suggests considering using pile foundations when restoring Green Harbour House. At the same time, as the load from the house is small and the object itself is quite compact it may be advised to keep the authentic foundation solution with introduction of minor modifications such as slightly deeper planks of the foundation "grill" (see Figure 15). The grill plate may also be made sufficiently rigid to allow its levelling by inserting new timber elements underneath when deemed.

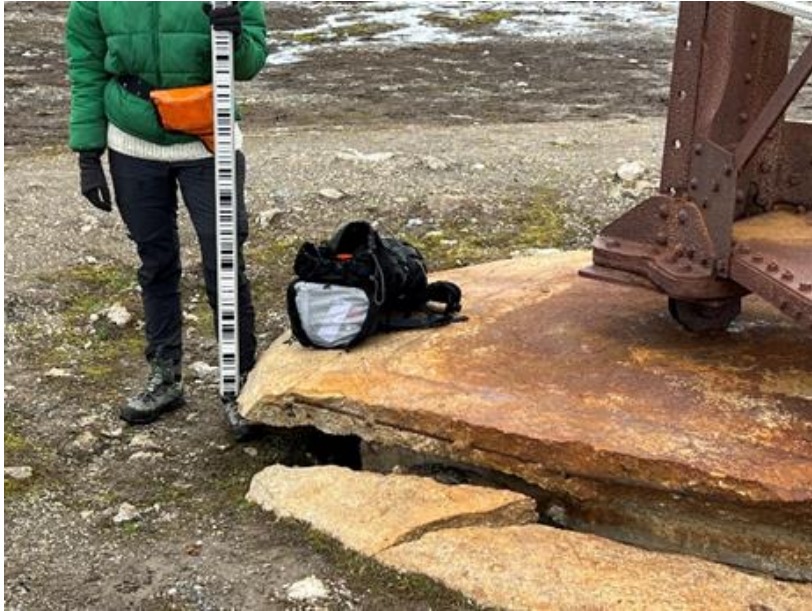
Figure 1. Terrain settlements (about 30-40 cm) around Luftskipsmasta (picture: 2022).

***Luftskipsmasta** is supported by shallow foundations and bears an estimated total weight of approximately 14 tons. Although specific creep settlement calculations are not shown here, the thaw settlement projections in Figure 25 apply similarly to this structure, and the added creep component could further elevate total long-term deformation. These predictions correlate with settlements of terrain at Luftskipsmasta that were observed in 2022 (Figure 27). Given the historical and symbolic significance of Luftskipsmasta, installing temperature/settlement monitoring instrumentation – such as ground-embedded thermistors and surveying markers – could provide early warnings of foundation distress. In 2024 it became known that pile foundations installed in bedrock will be utilized when restoring Luftskipsmasta in 2025.*

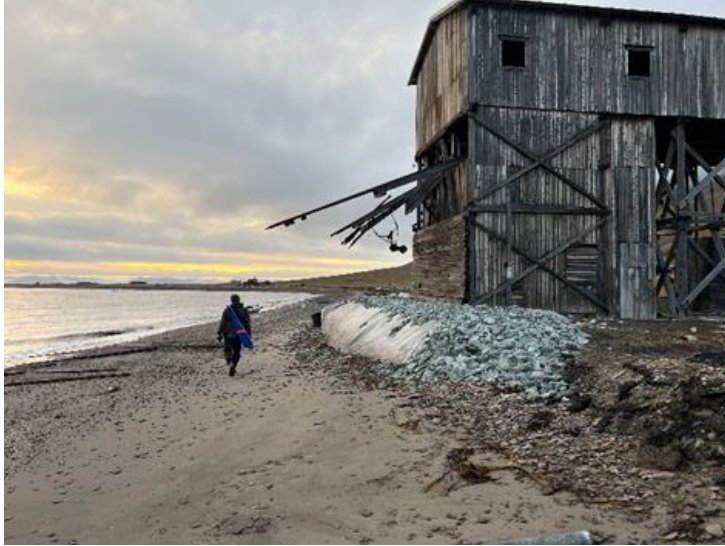
Figure 1. The Old cableway station (Taubanestasjonen) in Hiorthhamn protected by temporal solution against coastal erosion (picture: 2024).

A potential solution shall comply with cultural and historical contexts; it also may comply with the principles of sustainability. In this regard several solutions may be suggested; the solutions are:

1. Temporal protection with geotextile bags that are filled with local soil
2. Temporal protection (geotextile bags) combined with permanent solution, i.e. submerged breakwater

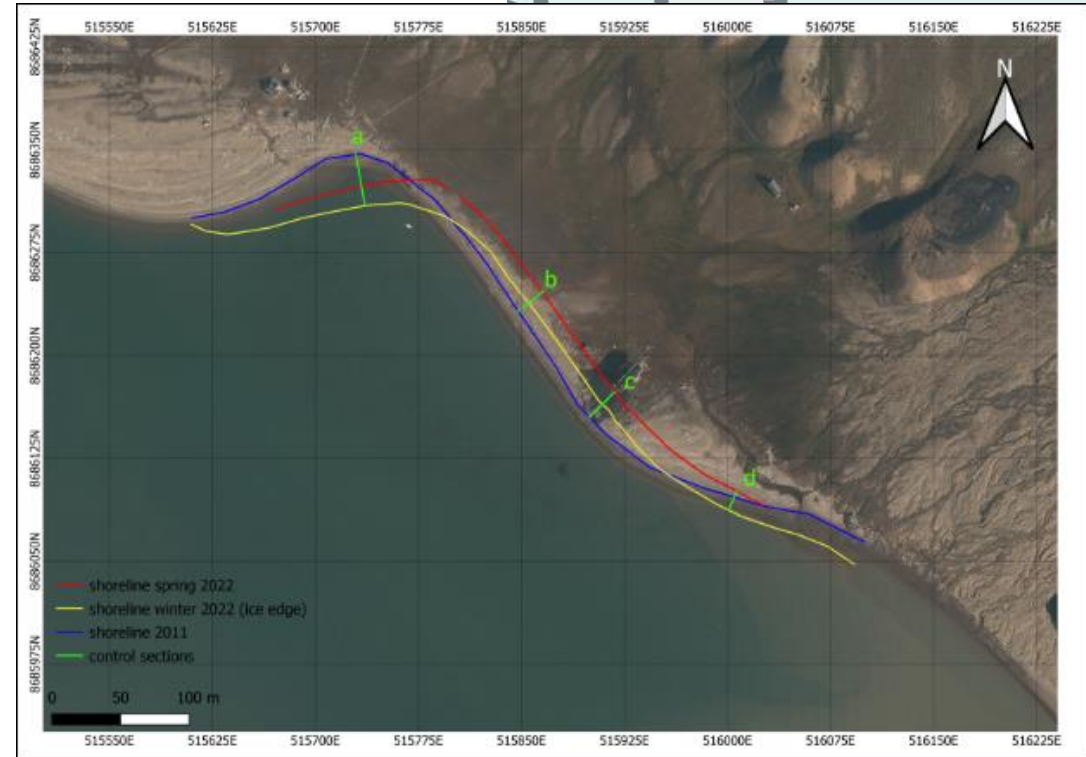
Figure 1. Shoreline evolution from 2011 to 2022. Aerial picture: © TopoSvalbard, Figure: [22].

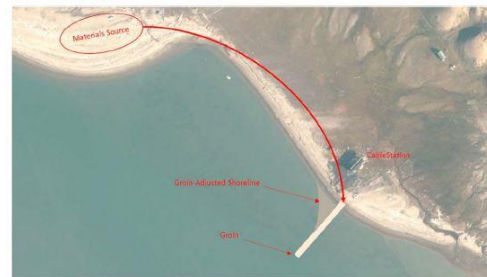
Figure 1. Groin for Hiorthhamn, Photo: © TopoSvalbard, figure: from [22].

4. Groin. Goin may help capturing sediments (if there is enough of sediments) coming from the area above the station, hence some accumulation of the material in front of the station may be achieved.

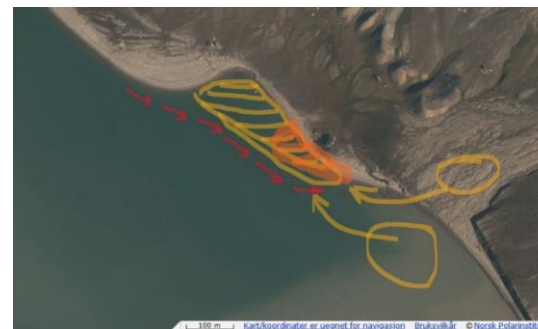
Figure 1. Principal scheme for artificial beach. Photo: © TopoSvalbard.

5. Artificial beach, fed by soil from alluvial fan of the Telegrafdalen . This might even enable longshore transport to the station. This solution is based on the already mentioned observations of Antonello [22] that a spit (accumulative landform locate in few hundred meters to the west) is drifting towards the station with estimated speed of approximately 5 m per year. By creating artificial beach, one will introduce the landform that may appear in this location in some 50 years in the future. Such approach can be then classified as truly nature-based. It will also restore the original outline of the coastline, that will comply with antiquarian value. Groin may be a part of such solution.

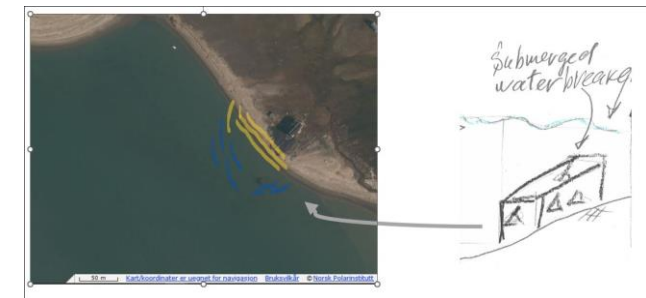
Figure 1. Temporal protection (geotextile bags) combined with submerged breakwater.

3. As system of submerged breakwaters. Such structures would be aimed at mitigation of wave action and creation of sheltered location. Submerged breakwaters would be preferable from the historical perspective as they will not be visible

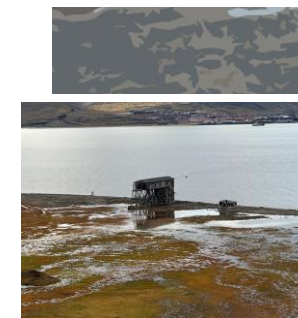
Figure 1. Terrestrial flooding after severe rain event, early September 2023.
