# Report 6

## Input in managing strategies

Recommendations for the objects managed by the user partners in PCCH-Arctic

This report presents input for managing strategies of selected objects of technical-industrial cultural heritage in Longyearbyen and Ny-Ålesund. In particular, the report provides results of condition survey of cableway trestles in Longyearbyen, assessment of natural hazard impacts on case study objects, recommendations for special case study objects, in addition to recommendations for monitoring and sources of data on climate projections.

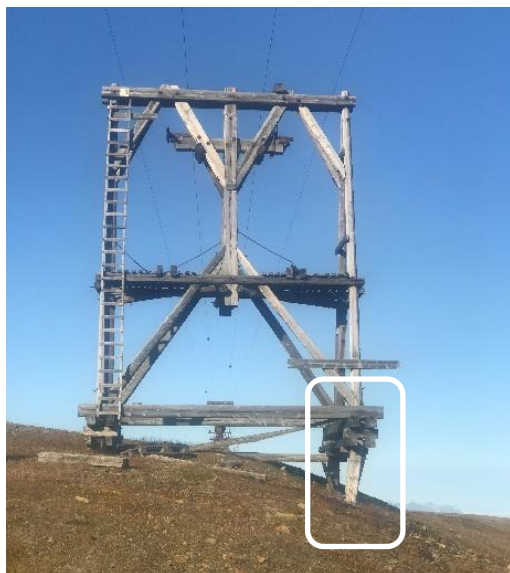
Such symptoms include slight tilt of foundations; tilted foundations, maximum two tilted foundations per object (examples are presented on Figure 1–Figure 2); rupture of cross-bracings (examples are presented on Figure 3–Figure 5).

**Figure 1. Cableway post Nr. 15 on the Line 5-6, tilt of foundations due to solifluction (general view from the front).**

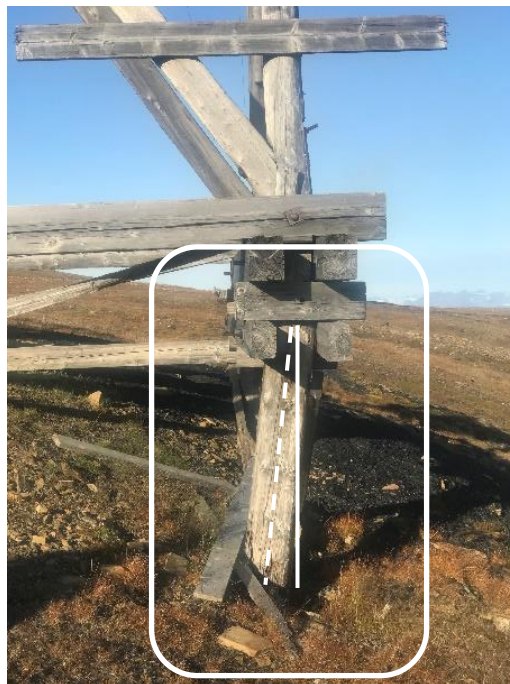
**Figure 2. Cableway post Nr. 15 on the Line 5-6, tilt of foundations due to solifluction (close look-up).**

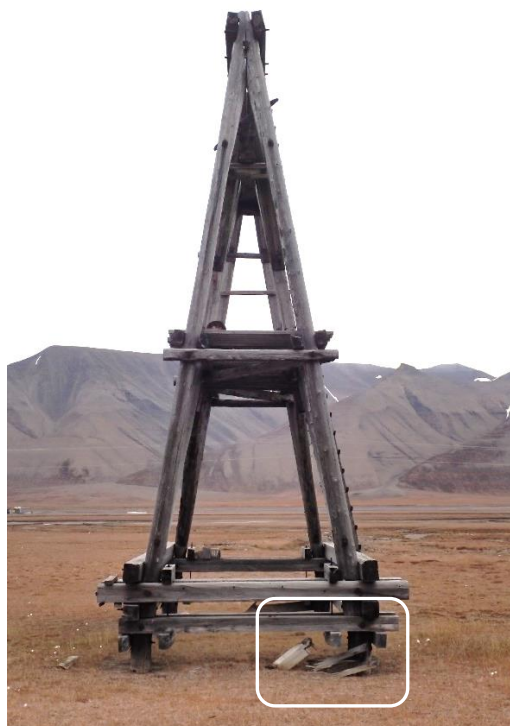
**Figure 3. Broken cross-bracing element at cableway trestle Nr. 36 at the Line 6 (general view).**

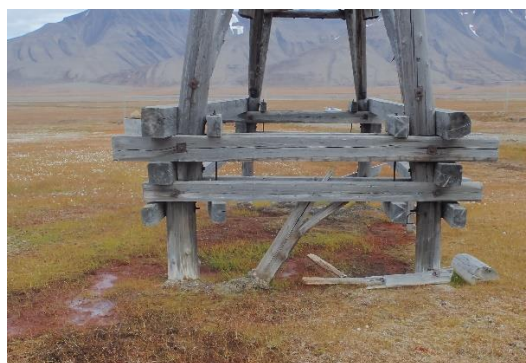
**Figure 4. Rupture of cross-bracing element at cableway trestle Nr. 25, Line 6.**

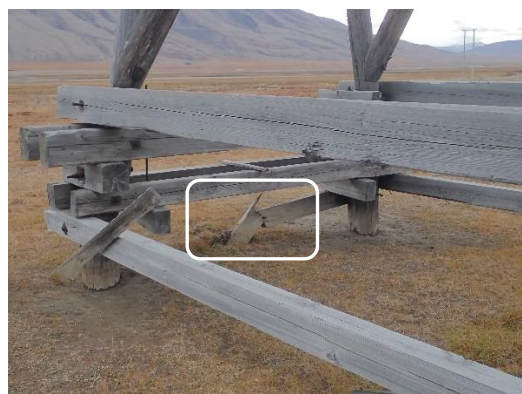
**Figure 5. Broken cross-bracing element at cableway trestle Nr. 36 at the Line 6 (close look-up).**

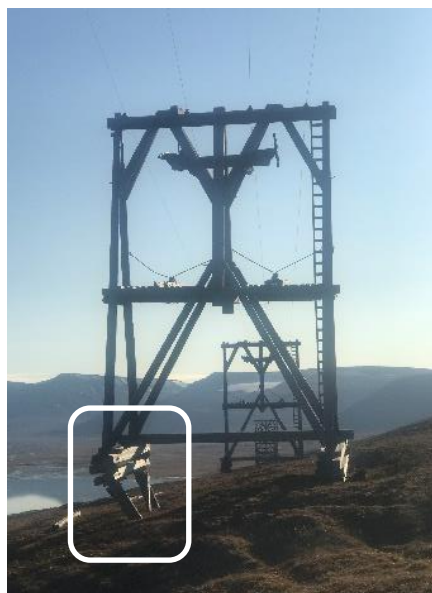
**Figure 6. Heavy tilt of two foundations of the cableway post Nr. 17 on the Line 5-6.**

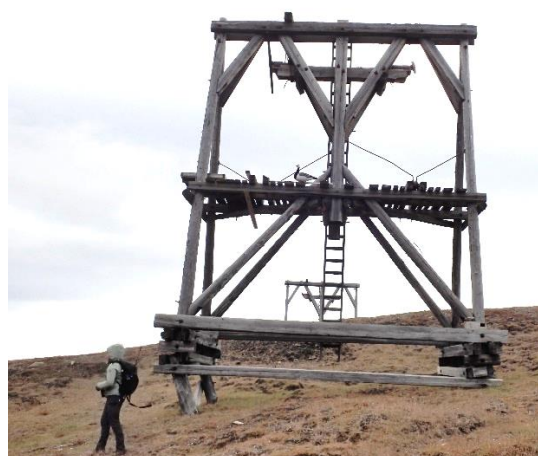
**Figure 7. Heavy tilt of two foundations of the cableway post Nr.22 on the Line 5-6.**

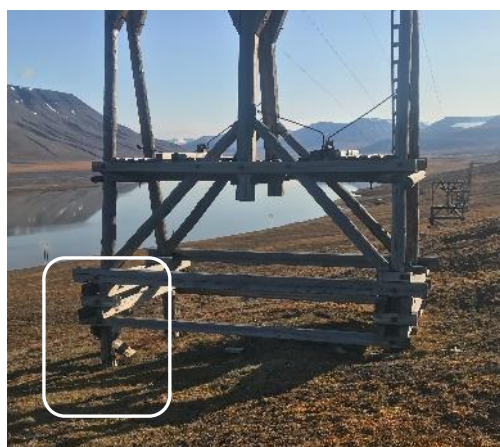
**Figure 8. Cableway post nr 22 on the Line 5-6, rupture of foundation element above the ground, presumably due to rot (general view from the front).**

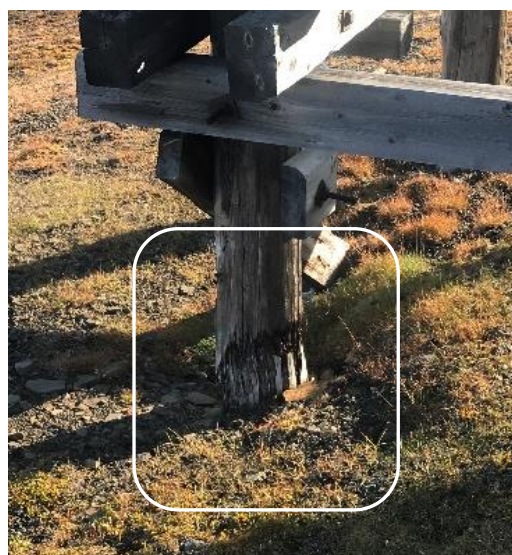
**Figure 9. Cableway post nr 22 on the Line 5-6, rupture of foundation element above the ground, presumably due to rot (close lookup).**

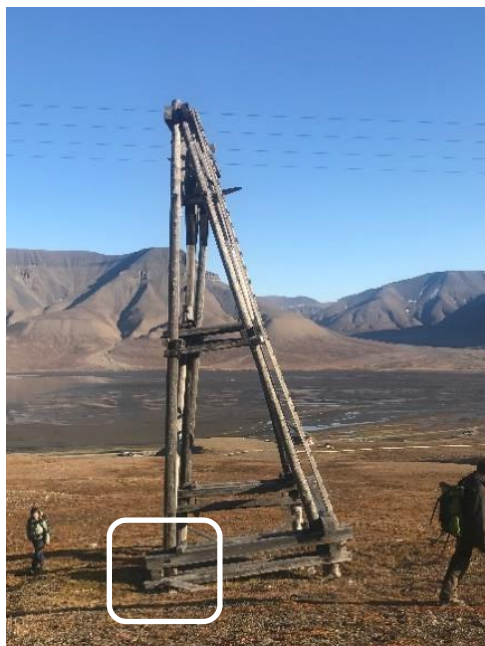
**Figure 10. Tilt of the Cableway post nr. 16 on the Line 5-6 due to rapture rupture of foundation element (general view).**

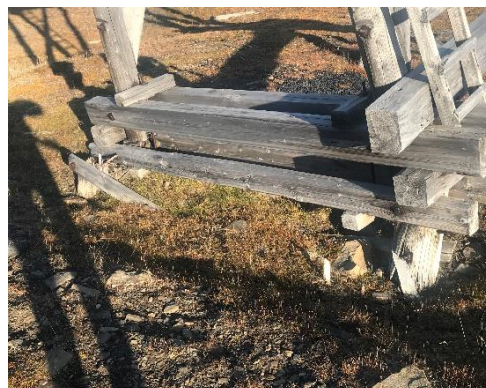
**Figure 11. Tilt of the Cableway post nr. 16 on the Line 5-6 due to rapture of foundation element (close look-up).**

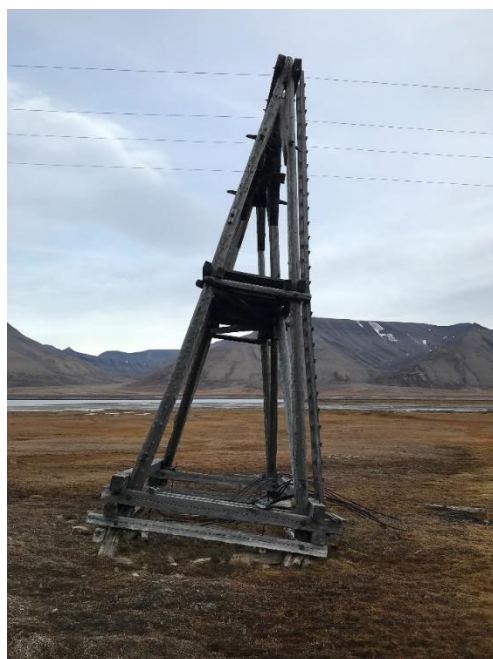
**Figure 12. Cableway post nr. 41 at the Line 5-6 – large vertical settlements and tilt due to degradation of permafrost (general view).**

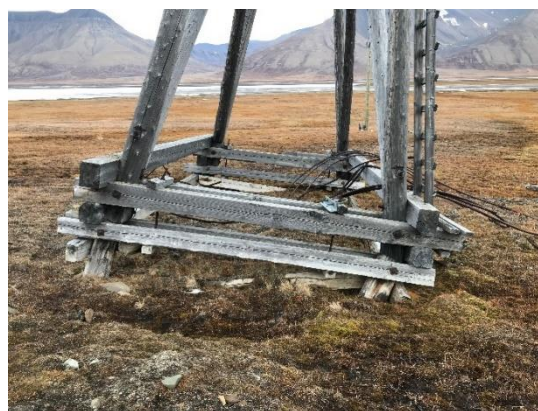
**Figure 13. Cableway post nr. 41 at the Line 5-6 – large vertical settlements and uneven tilt (close look-up).**

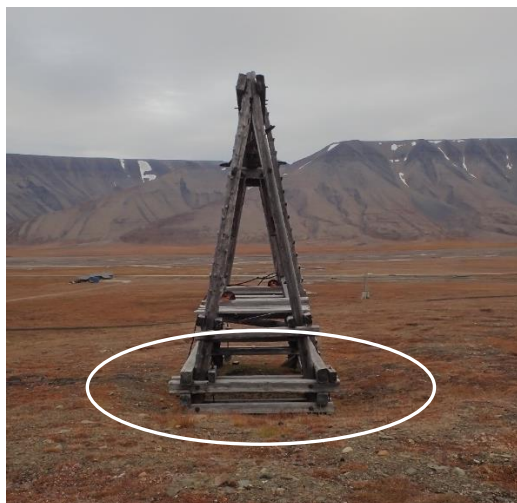
- Large settlements of structure into terrain (Figure 14), even if the structure looked intact (examples are presented on Figure 14–Figure 15, and interpretation of observations is presented on Figure 16) one may expect that cross-bracing elements would be broken in the result of settlement (examples are presented on Figure 17–Figure 18).

**Figure 14. Settlement of terrain due to permafrost degradation and large uniform settlement of Cableway post Nr. 21 at the Line 6 into the permafrost. White line outlines settled area.**

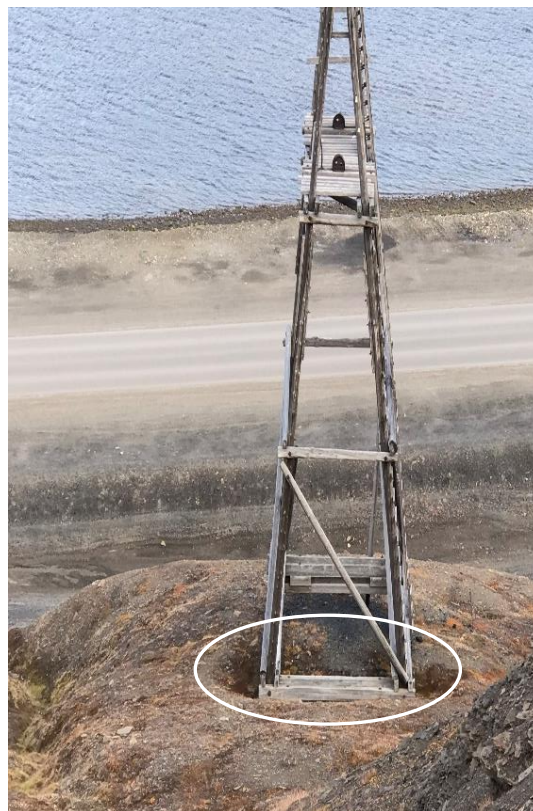
**Figure 15. Cableway Nr. 18, Line 3 – terrain settlements under and around the structure. White line outlines settled area.**

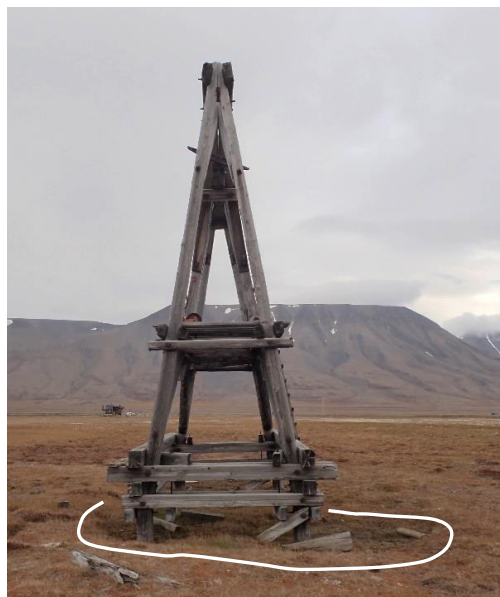
**Figure 17. Cableway trestle Nr. 9, Line 6: massive terrain settlements under and around the structure and rupture of cross-bracing element. White line outlines settled area.**

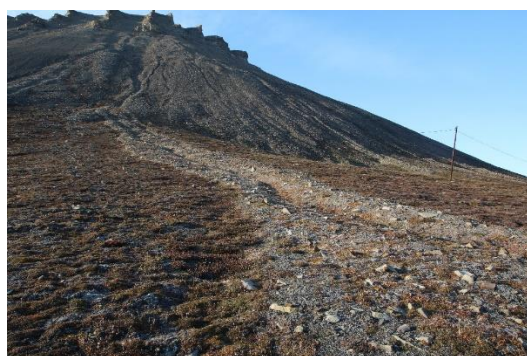
**Figure 19. Remains of old debris flow above Cableway post Nr. 9, Line 5.**

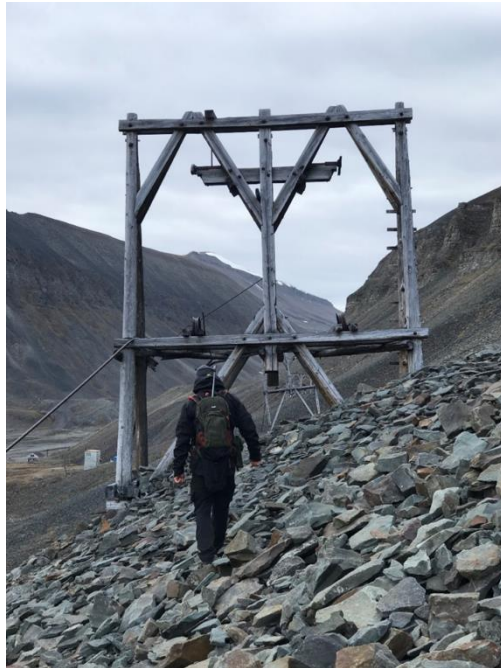
**Figure 21.** Accumulation of rock debris at cableway trestle Nr. 5, Line 1b as an indicator of previous snow avalanche activity in the area. Despite impacts from snow avalanches and structural damages (one broken foundation) Cableway trestle Nr. 5 is still standing.

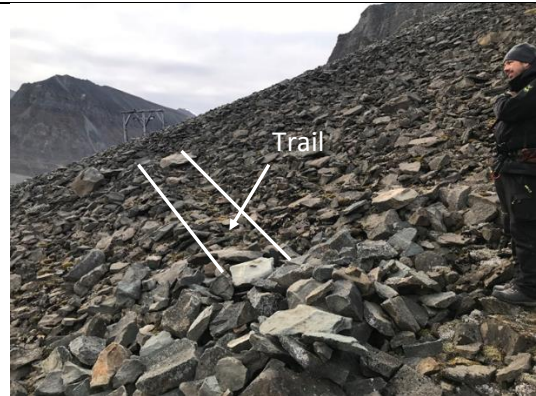
**Figure 22.** Ground surface between cableway trestles Nr. 5 and Nr. 4 (view towards Nr. 4) – former trail is partly covered with loose rock debris.

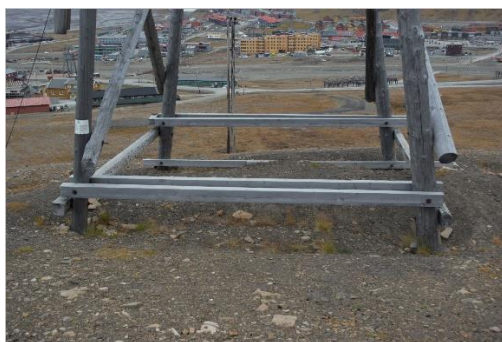
**Figure 23. Ground depressions under cableway trestle Nr. 23 on the Line 1b (2021). This trestle was restored in 2007. Picture: © Snaprud Christensen, C.**

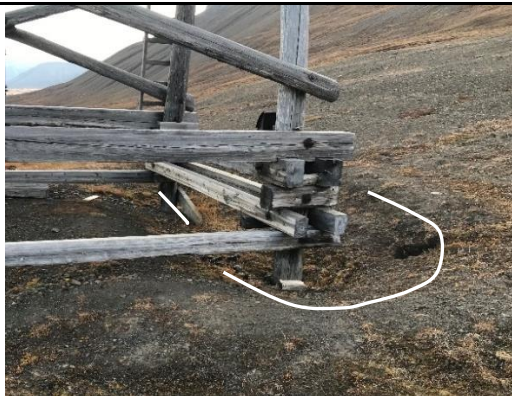
**Figure 27. Depressions around vertical foundation elements at cableway trestle Nr. 19 at the Line 5-6.**

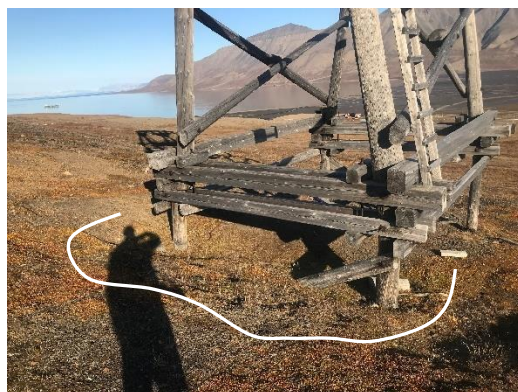
**Figure 28. Depressions around vertical foundation elements at cableway trestle Nr. 20 at the Line 5-6.**

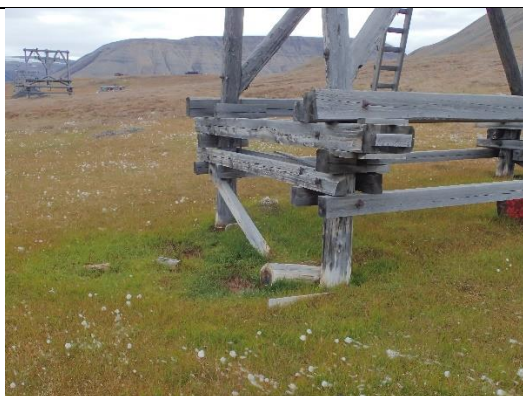
**Figure 29. More lush vegetation under cableway trestle Nr. 27 at the Line 6.**

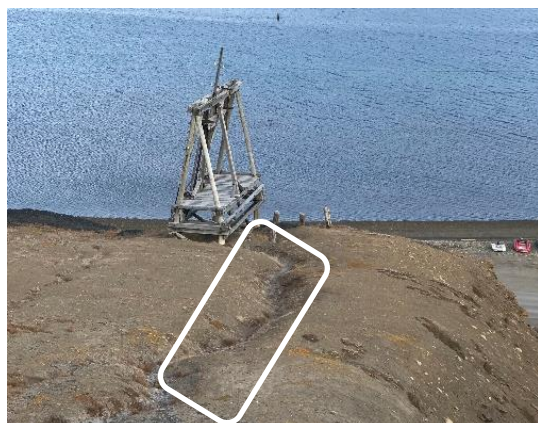
Figure 36. Cableway post Nr. 15 on the Line 3, seasonal creek running under the structure. Creek may cause both, surface erosion under the structure and increased degradation of permafrost. White rectangle depicts the creek.

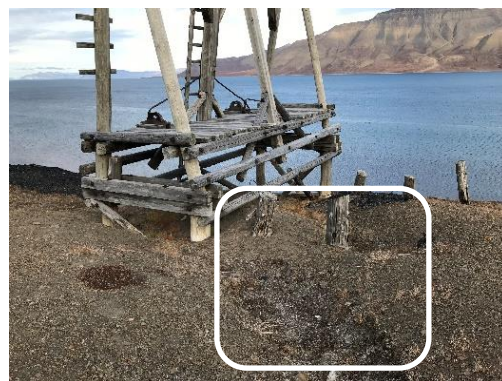
Figure 37. Cableway post Nr. 15 on the Line 3, seasonal creek running under the structure (close look-up). White rectangle depicts the creek.

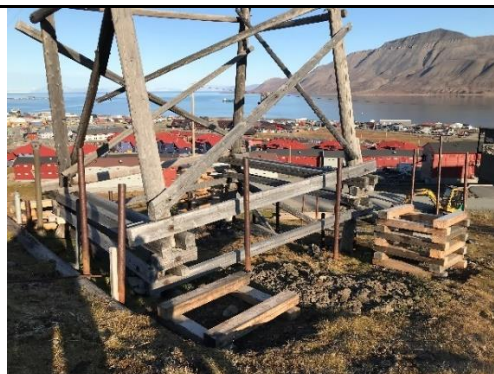
**Figure 42. Cableway trestle Nr. 8 at the Line 5-6. This structure was affected by solifluction, and an attempt to stop this process was undertaken some years, see rusty metal poles.**

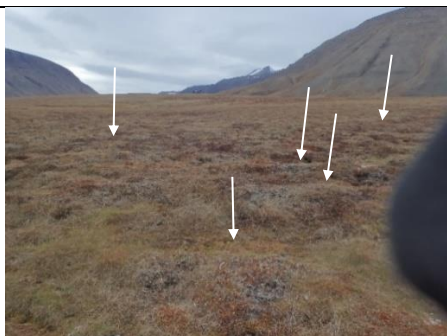
**Figure 43. Solifluction above the Cableway trestle Nr. 17 at the Line 6. White arrows point of “dumps” on terrain surface that are typical for solifluction.**

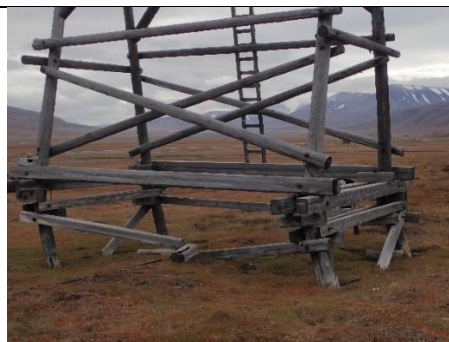
**Figure 44. Heavy tilt of vertical foundation elements of the cableway trestle Nr. 17 at the Line 6. Tilt of foundation elements occurs due to action of solifluction.**

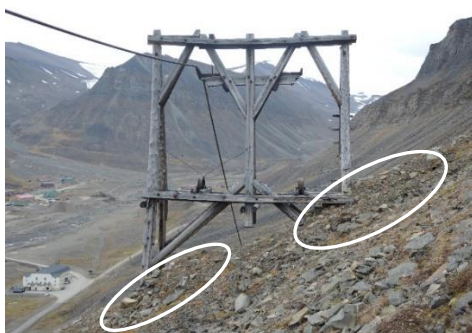
- Additional loads due to snow avalanche activity: accumulation of blocky material (normally delivered by slab avalanches) on the object (example is presented on Figure 45–Figure 46). Accumulation of blocky material may impose additional loads in the objects.

**Figure 45. Accumulation of rock debris at cableway trestle 10, Line 1b. Accumulated material around the structure is marked with ovals.**

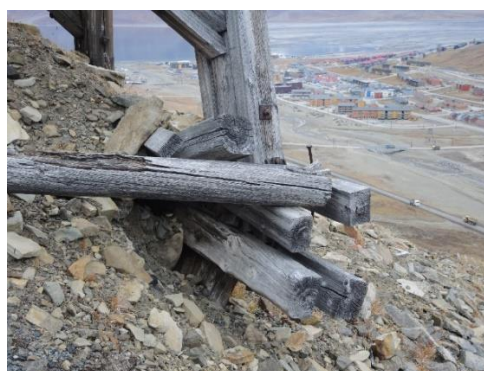
**Figure 46. Close-up at accumulated material at cableway trestle Nr. 10, Line 1b.**

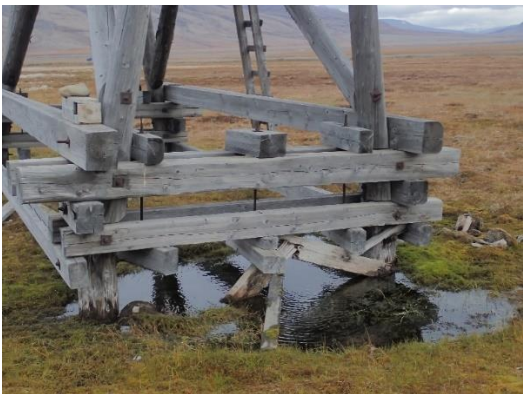
</div> <p><b>Figure 47. Close-up to ponding of water in ground depressions around a cableway post. Depressions are probably caused by degraded permafrost below the structure (cableway trestle Nr 8, Line 6). Ponding of water, in turn, leads to intensified degradation of permafrost.</b></p> <div data-bbox="906 781 1423 1523">

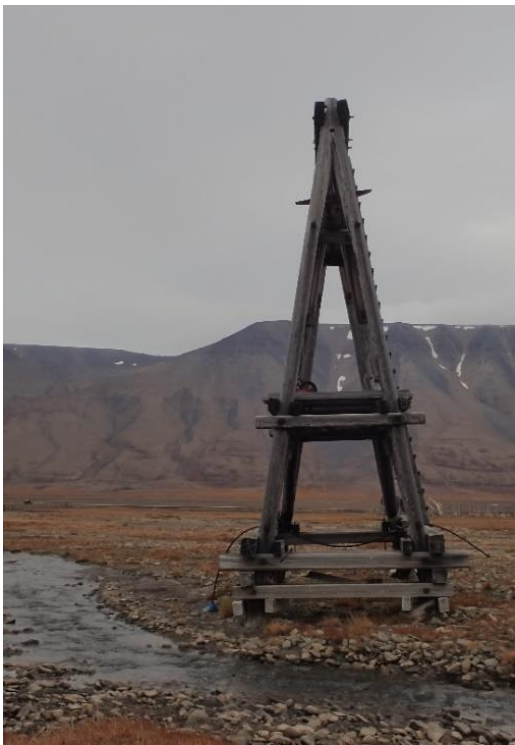
</div> <p><b>Figure 48. Tilted cableway trestle in the situation when permafrost is affected by running surface water (cableway trestle Nr 10, Line 6). Running surface water intensifies degradation of permafrost. This case also presents an example of small creak meandering towards the object; this may cause partial undermining of foundation by the running water.</b></p>

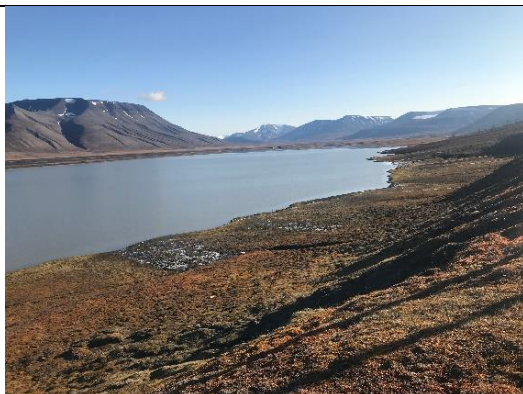
**Figure 49. Terrain with pronounced solifluction by the cableway trestle Nr. 26.**

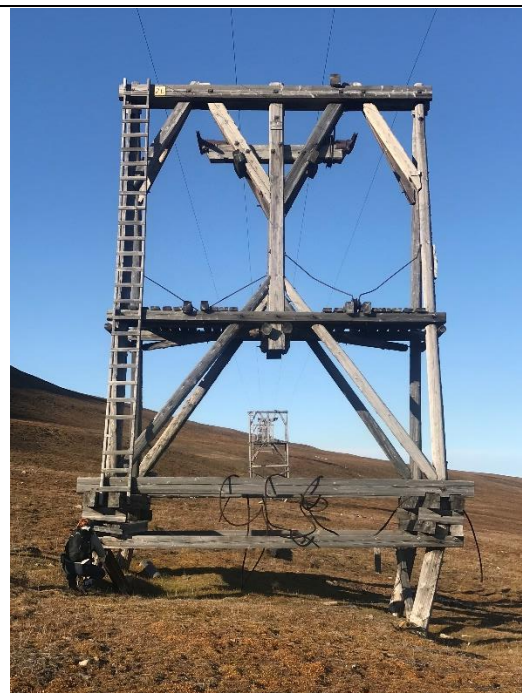
**Figure 50. Effects of solifluction on foundation of cableway trestle Nr. 26 at the Line 5-6: heavily tilted foundations.**

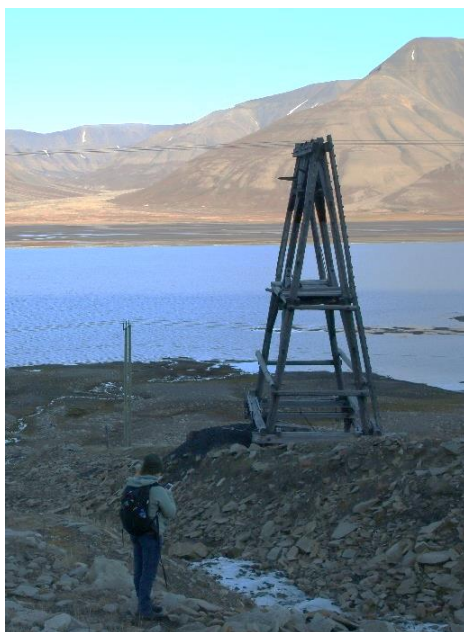
**Figure 51. Development of a ravine next to cableway trestle Nr. 36, Line 5-6. This development of ravine may lead to local slide of the slope supporting the trestle and subsequent collapse of it.**

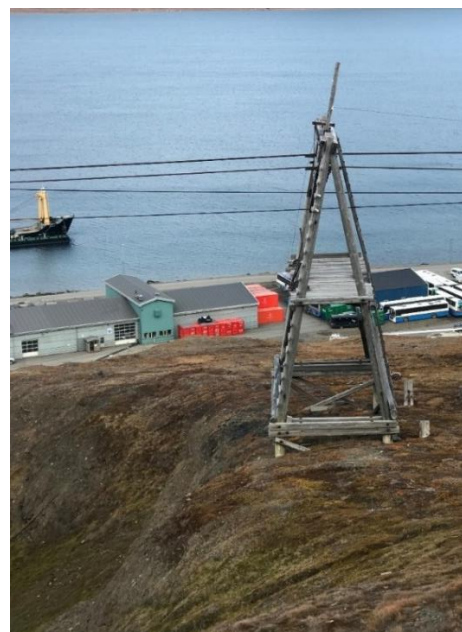
**Figure 52. Cableway post Nr. 3 on the Line 3. Instability of adjacent slope and surface wash on it may affect stability of this post.**

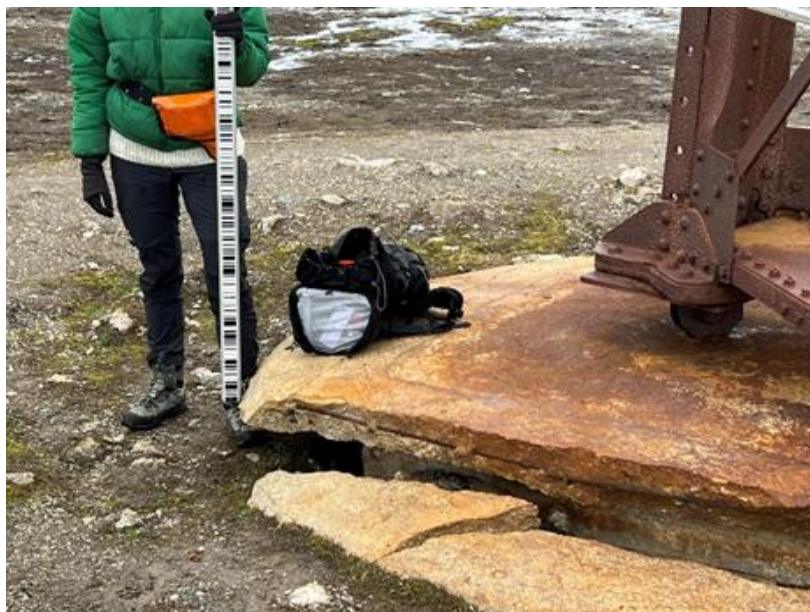
Figure 79. Terrain settlements (about 30-40 cm) around Luftskipsmasta (picture: 2022).

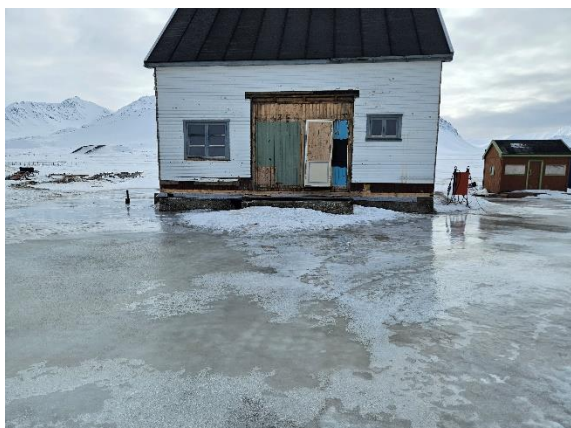
**Figure 80. Flooding by the White House in Ny-Ålesund (April 2024), picture: ©Aga, J.**

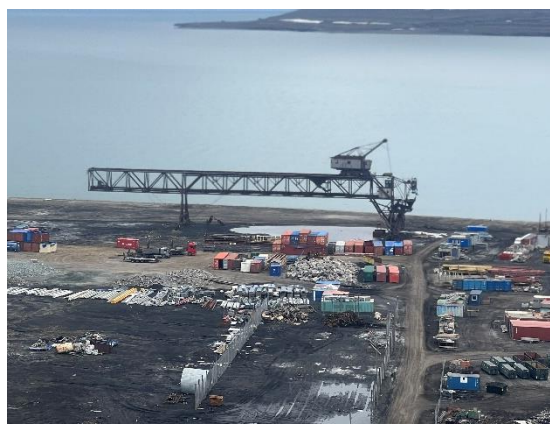
**Figure 83. Flooding by the Titan crane (June 2023), picture: © SINTEF/Sinitsyn, A.O.**

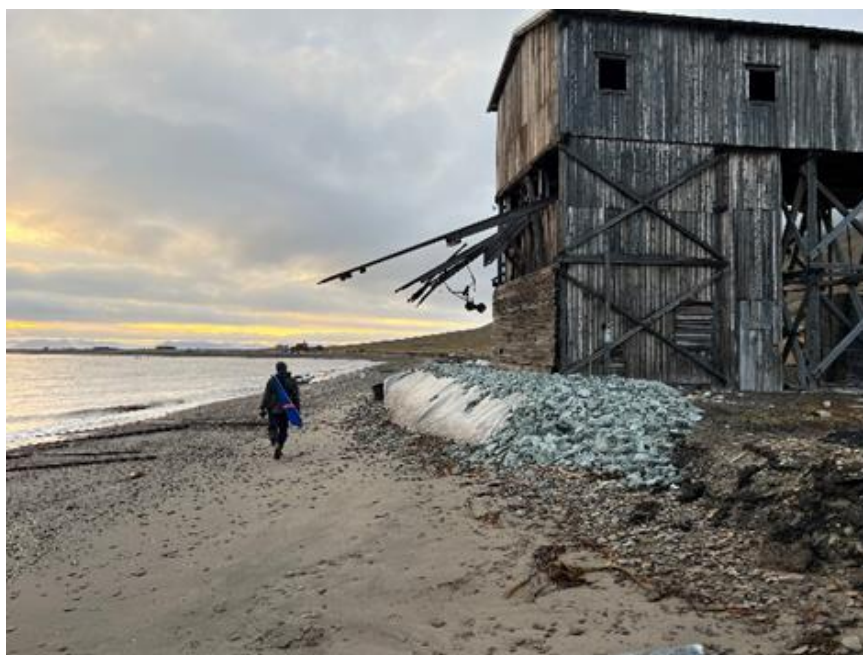
**Figure 90. The Old cableway station (Taubanestasjonen) in Hiorthhamn protected by temporal solution against coastal erosion (picture: 2024).**
