# Data Insights from an Offshore Wind Turbine Gearbox Replacement

Alexios Koltsidopoulos Papatzimos<sup>1,2</sup>  
Tariq Dawood<sup>2</sup>  
Philipp R. Thies<sup>3</sup>

<sup>2</sup>*EDF Energy R&D UK Centre, London, CR0 2AJ*

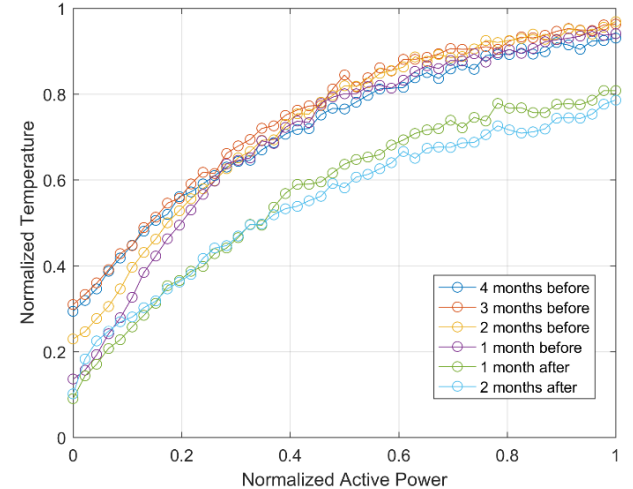
High Speed Temperature vs Active Power

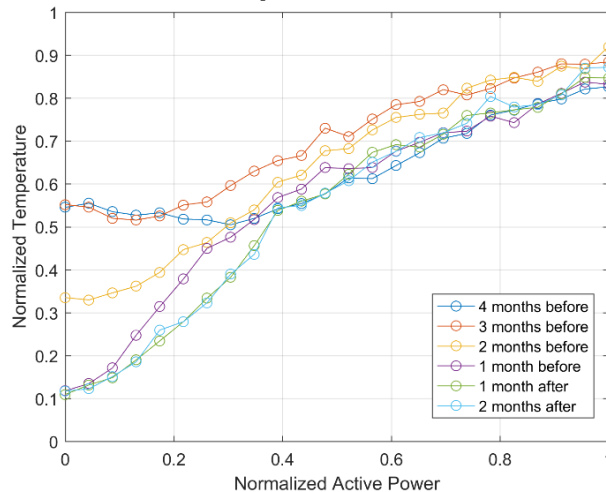
Gearbox Oil Temperature vs Active Power

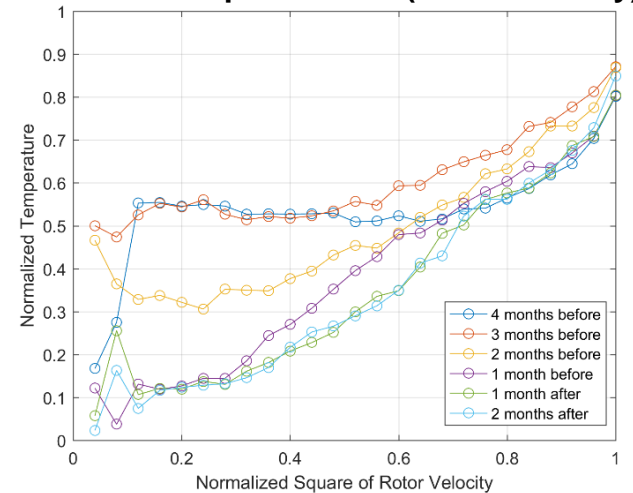
Gearbox Oil Temperature vs (Rotor Velocity)<sup>2</sup>

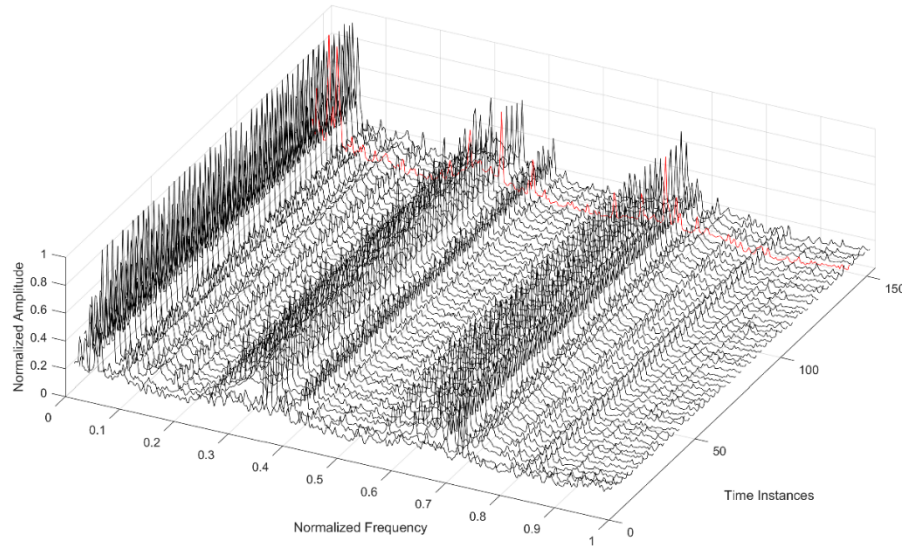
Planet Bearing Envelope

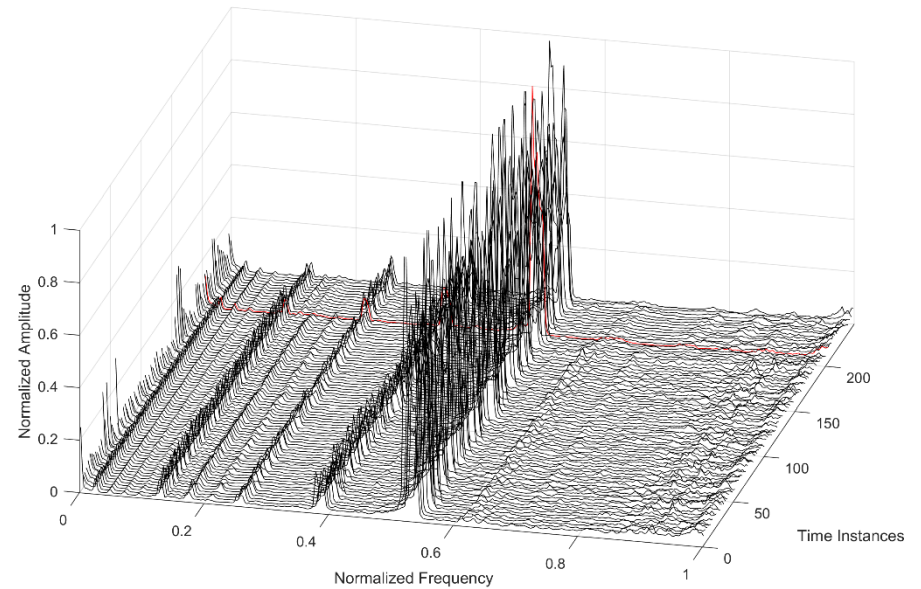
Planet Bearing FFT

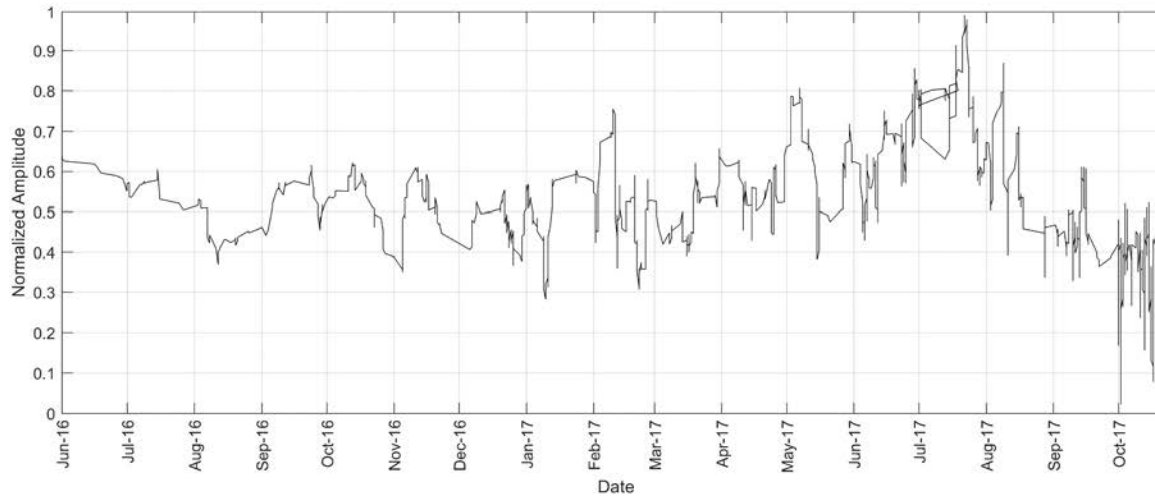
Planet Bearing Cepstrum RMS

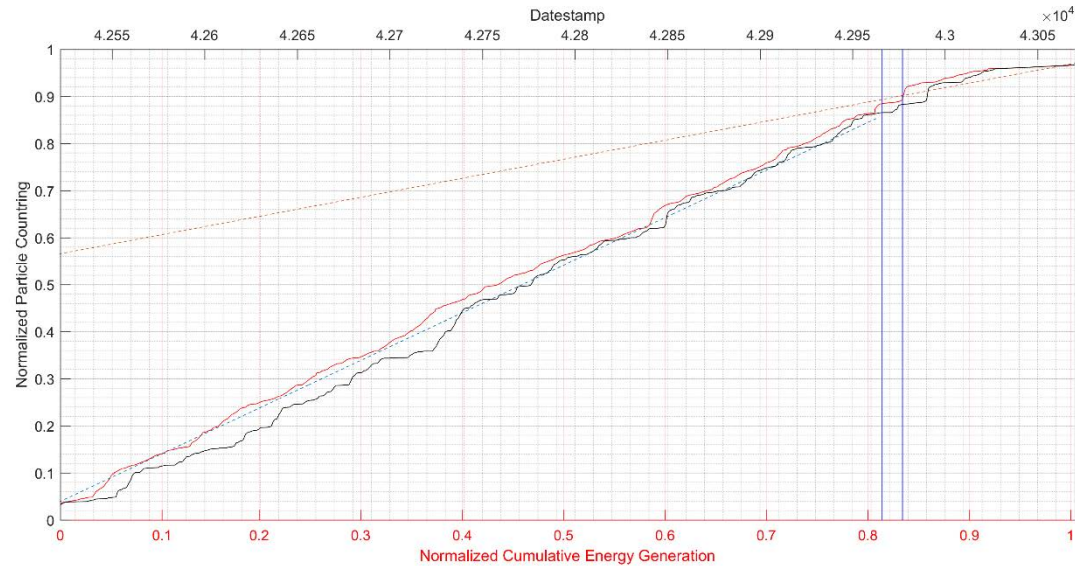
Particle Counter
