Husby terrasse

Renovated terrace houses in Norway

SINTEF Building and Infrastructure

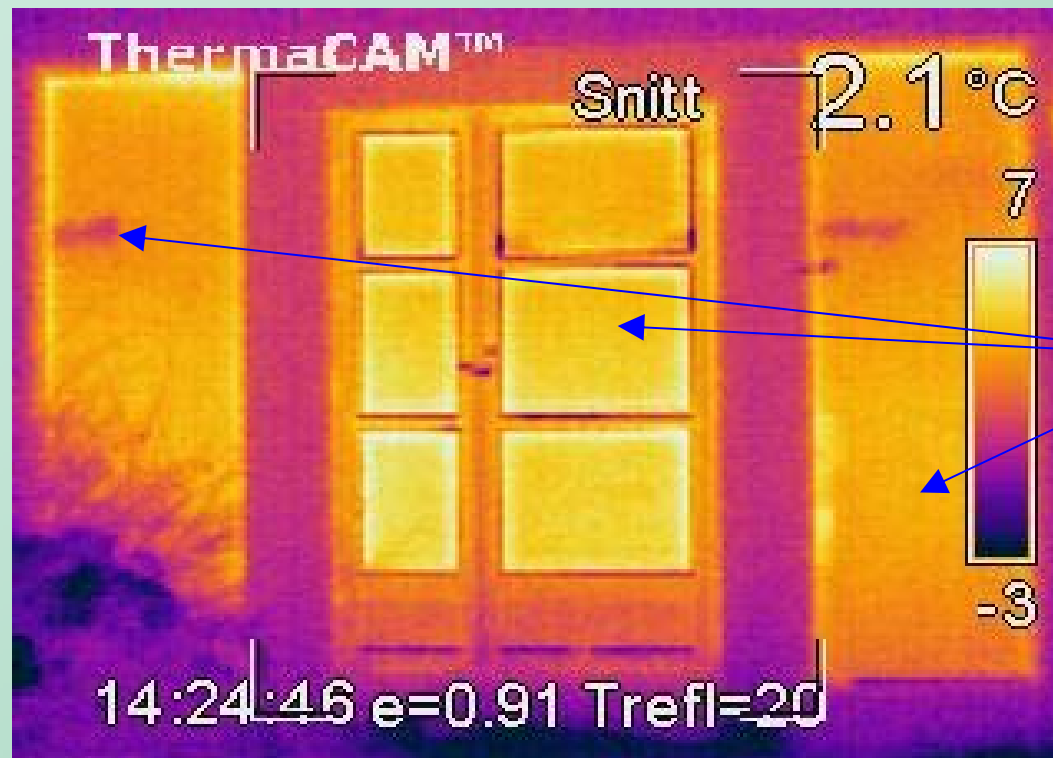
High U-value in windows and balcony door, result in heat leakages from the inside.

(photo is taken from outside)

New windows and balcony doors

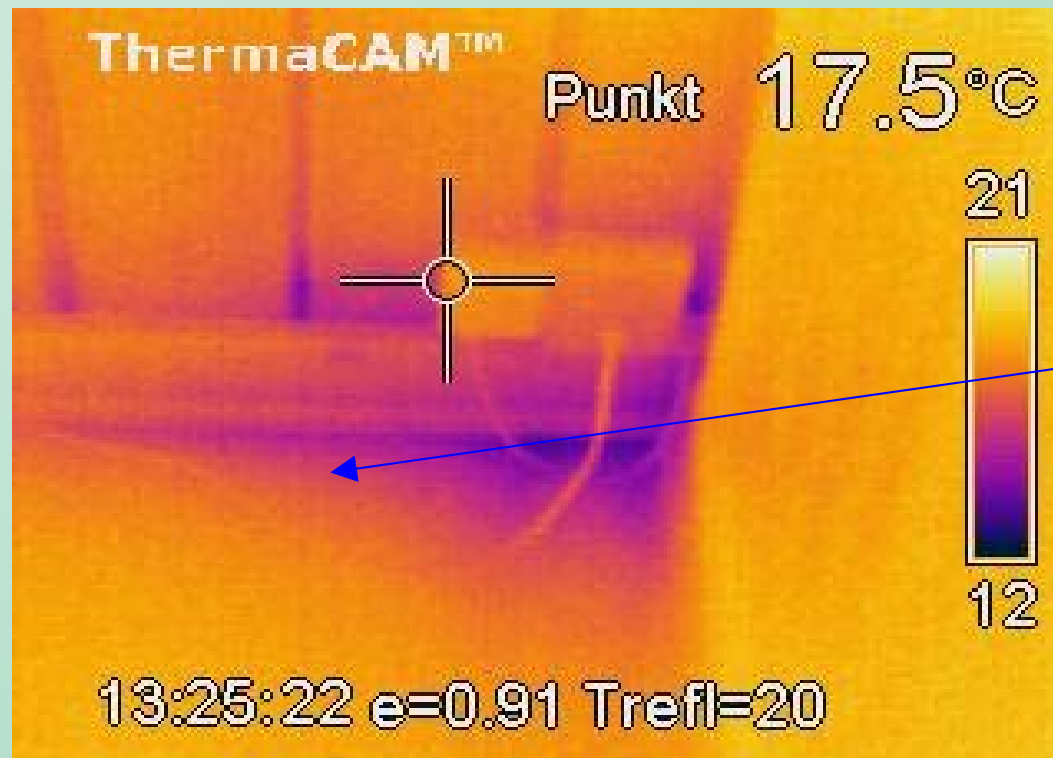
Thermal bridge in the joint between external walls and the floor (concrete slab)

(photo is taken from inside)

Reduces thermal bridges in front of the front wall

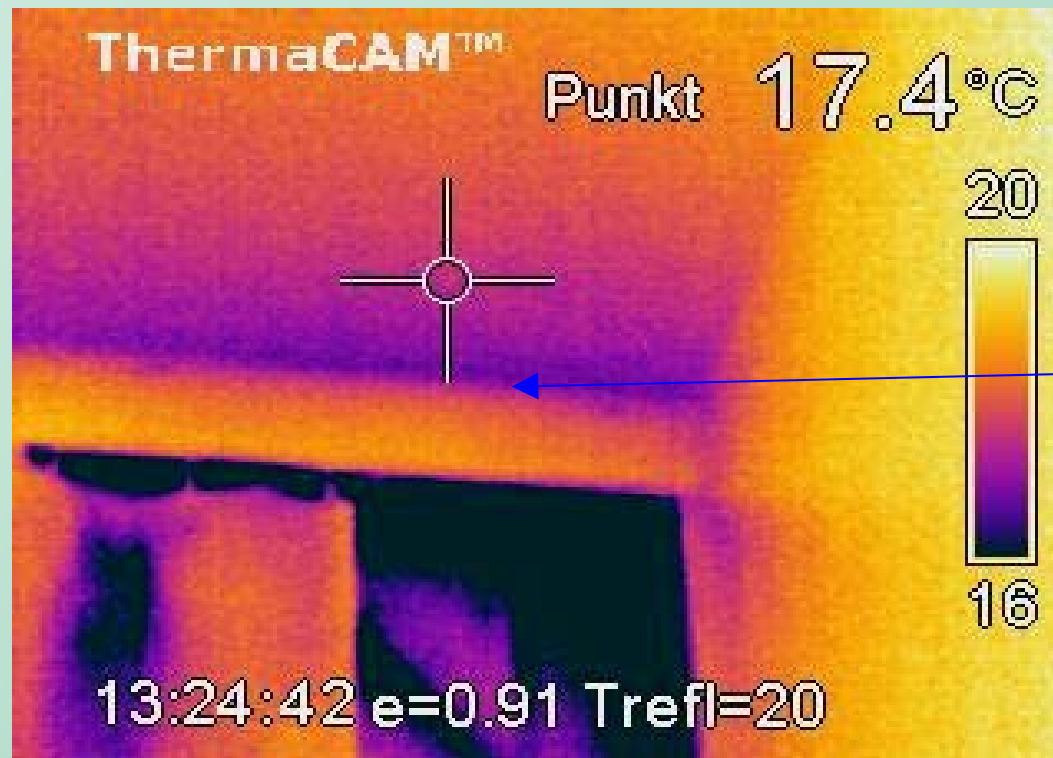
Thermal bridge in the joint between external walls and the roof (concrete slab)

(photo is taken from inside)

No measures carried through, but silicon filling where obvious air leakages

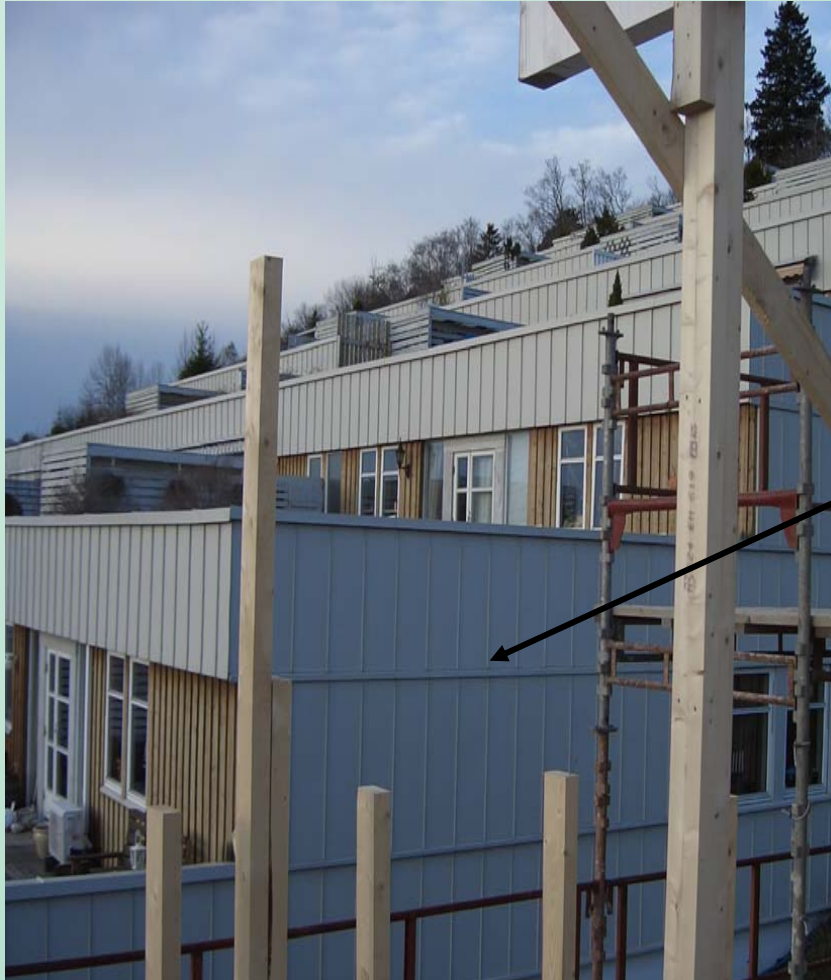
Outside wall before adding insulation.

Old steel panels. The panels are removed
