Accident  
Investigation Board  
Norway

SL 2018/04

## REPORT ON THE AIR ACCIDENT NEAR TURØY, ØYGARDEN MUNICIPALITY, HORDALAND COUNTY, NORWAY 29 APRIL 2016 WITH AIRBUS HELICOPTERS EC 225 LP, LN-OJF, OPERATED BY CHC HELIKOPTER SERVICE AS

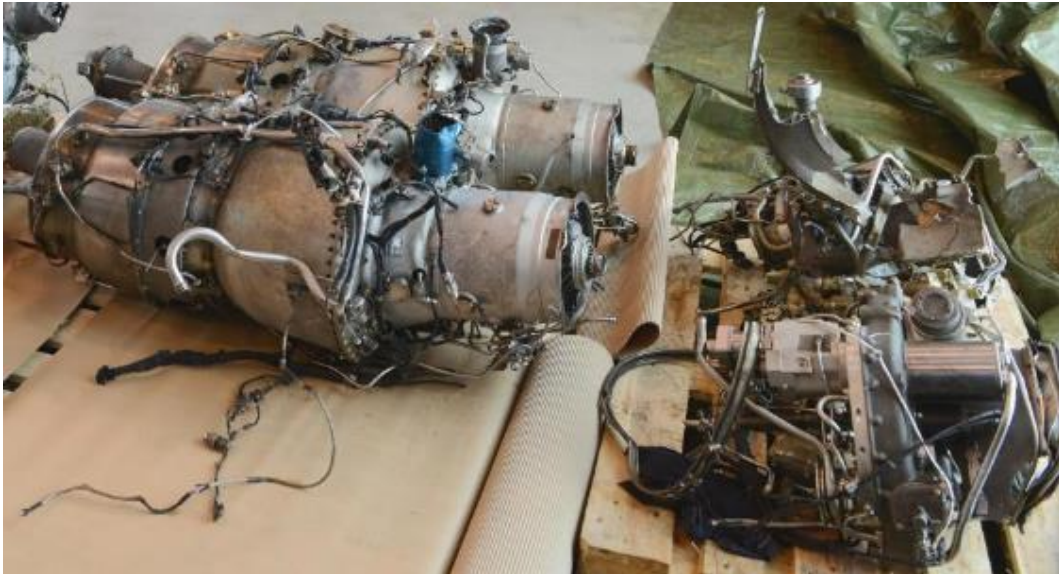
*Figure 23: The engines at the AIBN hangar. They had similar damage to a large extent. Both intake sections (Module M01) which had separated from the front part of the engines can be seen to the right of the photo. Photo: AIBN*

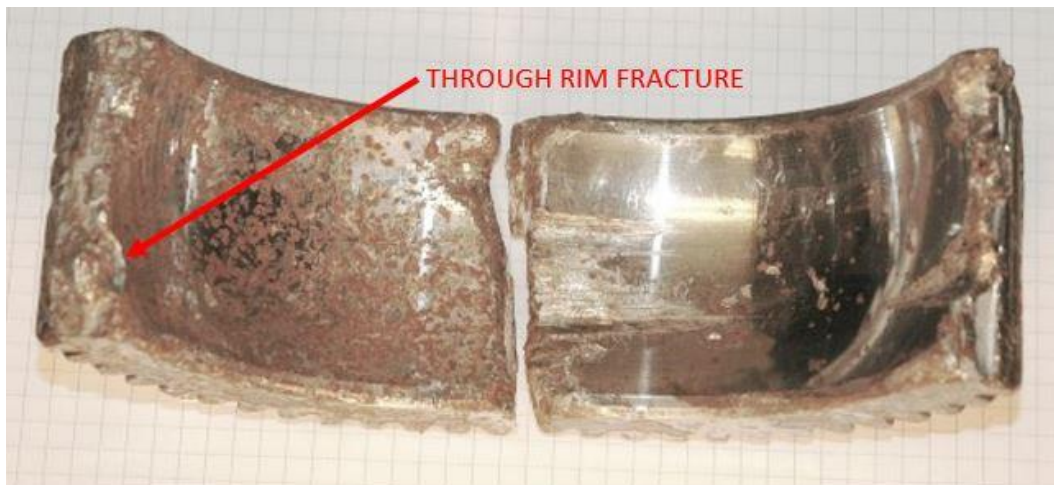
Figure 27: The two segments of the fractured second stage planet gear (serial number M4325). The fatigue fracture through the rim (through-thickness fracture) started in the outer upper race of the planet gear wheel where the red arrow is pointing (spall 4). Photo: AIBN/NDL

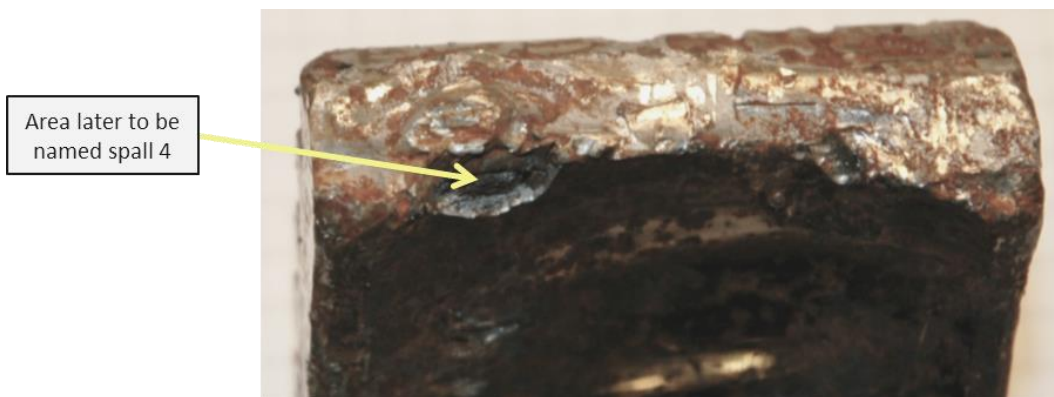
Figure 28: The fracture surface to the left in Figure 27. This surface appeared not to be ductile overload, but possibly fatigue. Photo: AIBN/NDL

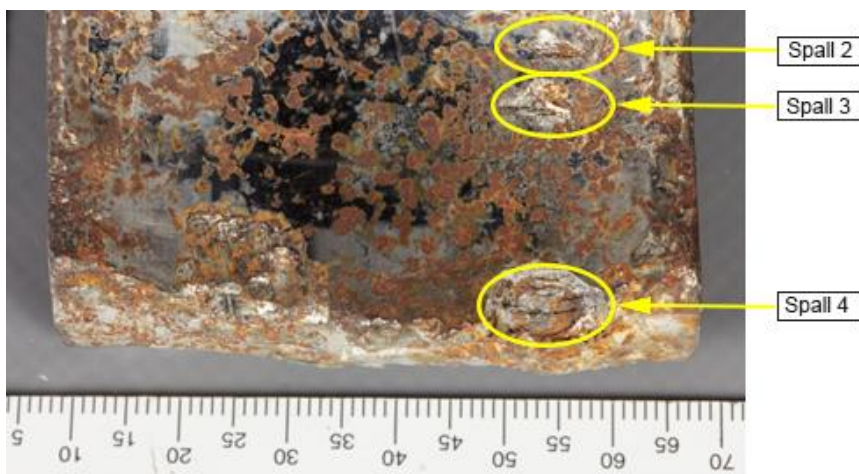
Figure 29: The fatigued surface as received at QinetiQ before cleaning. Along a line approximately 14 mm from the upper surface of the gear (right hand edge in photograph) some holes or spalls are observed, with the largest (named spall 4) located at the edge of the through-thickness fracture. Photo: AIBN/QinetiQ

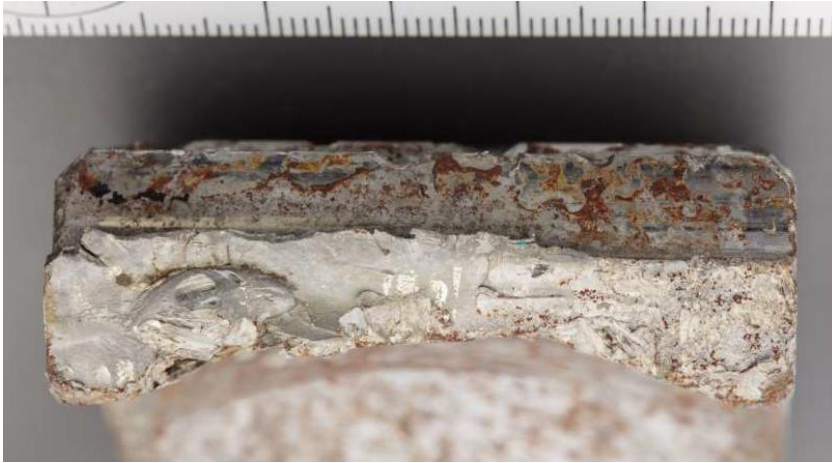
Figure 30: The cleaned through-thickness fracture surface. Macro marks (beach marks) are visible towards the upper edge of the gear (left hand side in photograph). Photo: AIBN/QinetiQ

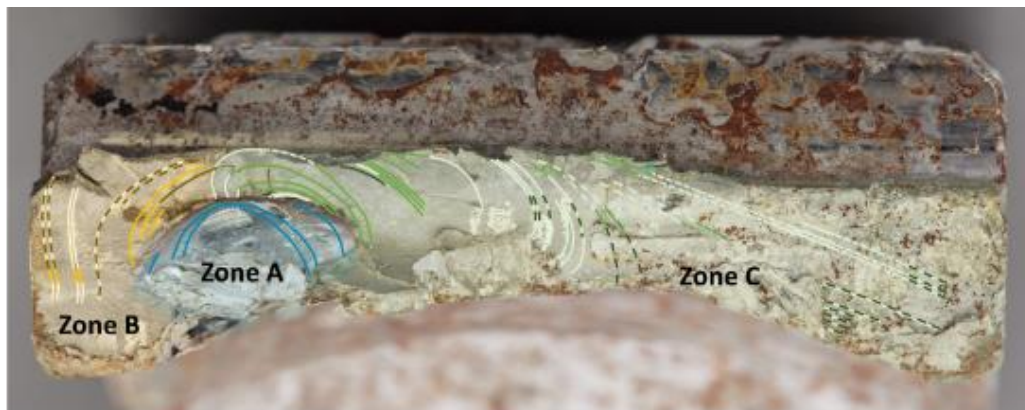
Figure 31: The fracture surface divided into three different zones. The macro marks/features observed are indicated: solid line – well defined, dashed line – less well defined. Photo: AIBN/QinetiQ

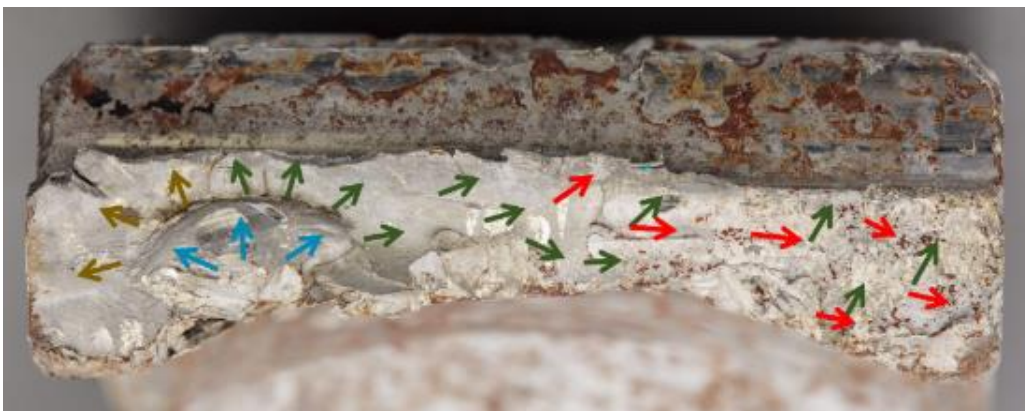
Figure 32: Crack propagation directions concluded from macro mark orientations in zones A (blue), B (brown) and C (green). Propagation in zone C concluded from striation and micro-crack orientations is shown by the red arrows. Photo: AIBN/QinetiQ

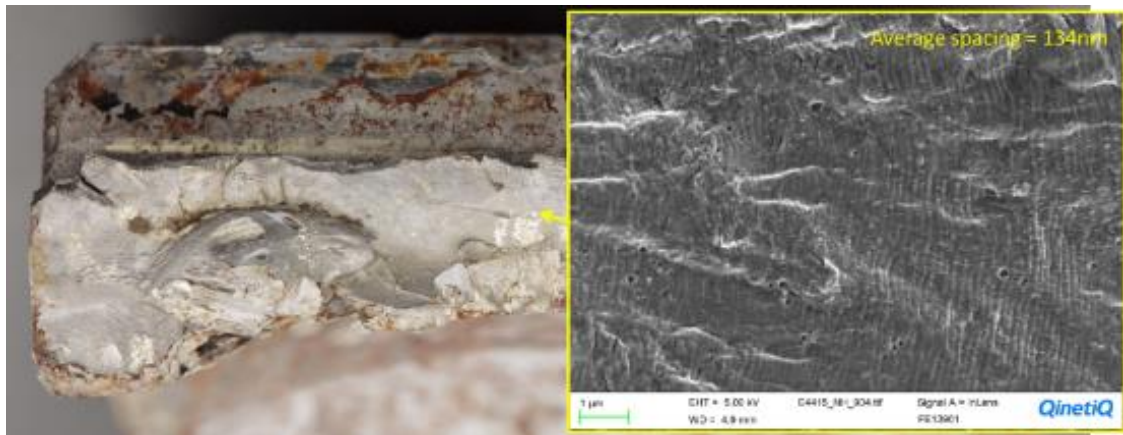
Figure 33: Fatigue crack progression marks – striations. Average spacing between the striations in this area are 134 nm. Photo: AIBN/QinetiQ

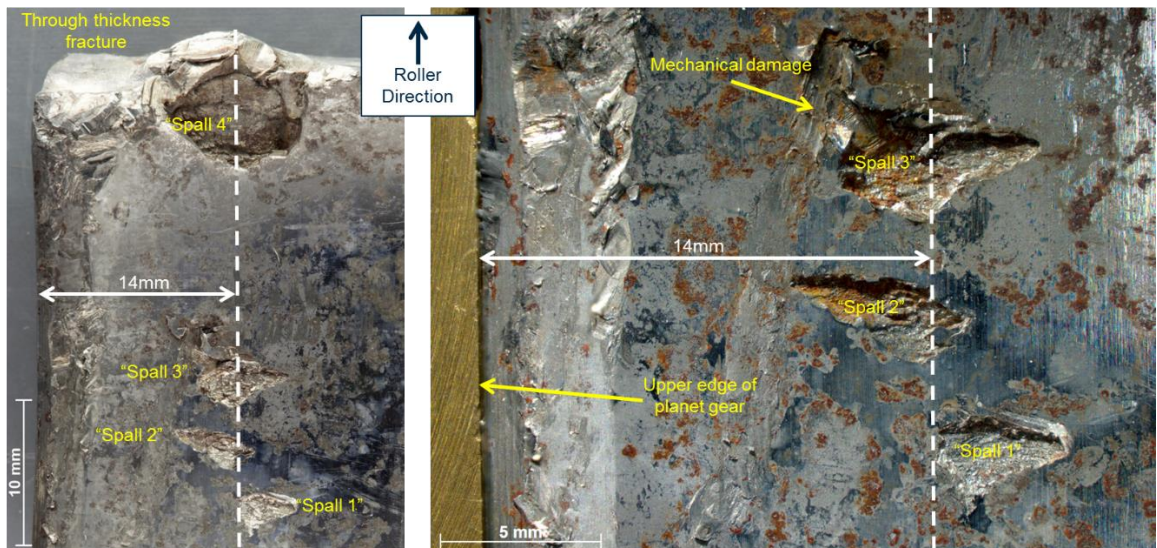
Figure 34: Showing spall 1, 2, 3 and 4 together with the max Hertzian stress line of 14 mm.  
Photo: AIBN/QinetiQ

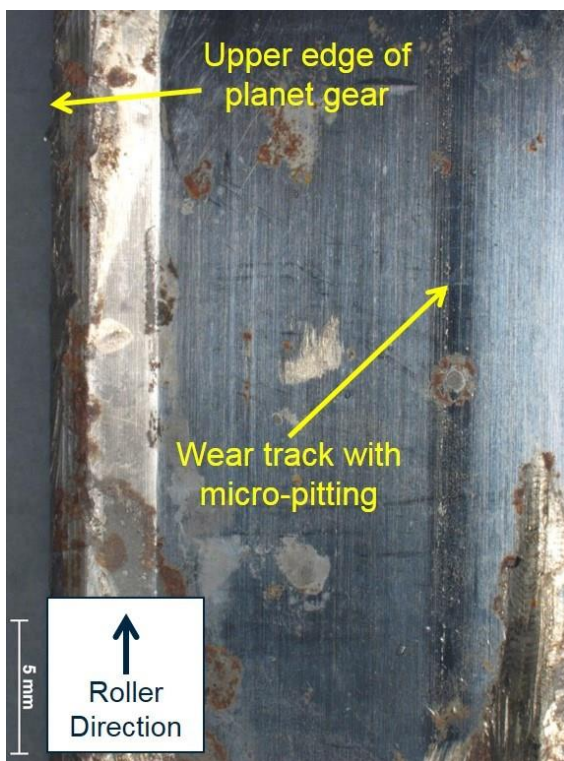
Figure 35: A wear track containing micro-pitting is also observed on the upper outer-race surface of the second planet gear fragment. Photo: AIBN/QinetiQ

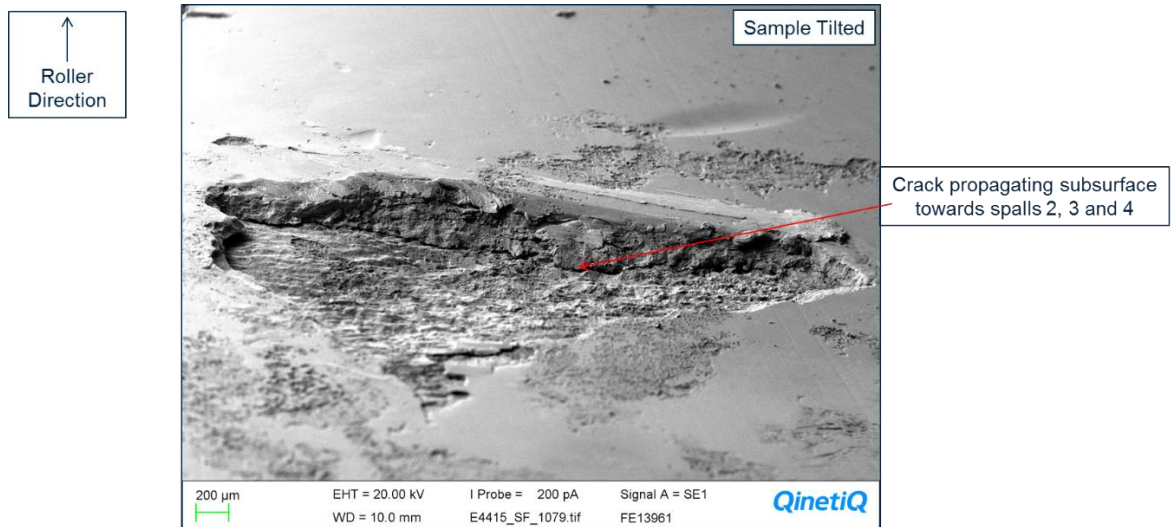
Figure 36: Spall one looking in the direction of spall two (in roller direction). A crack continuing under the surface is observed. Photo: AIBN/QinetiQ

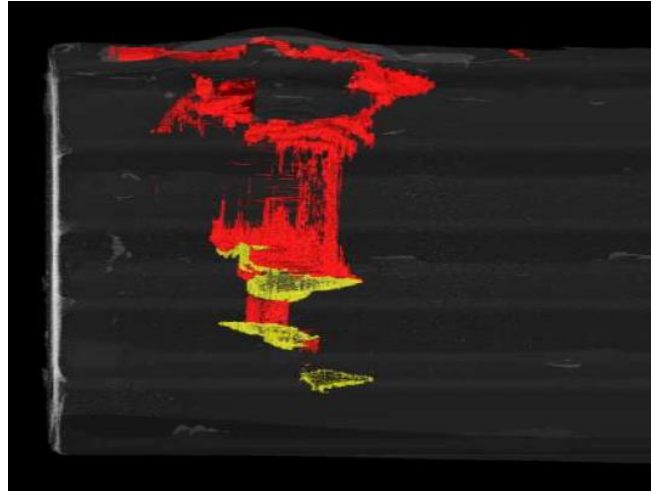
Figure 38: CT-scan of the specimen in Figure 34. The yellow areas are spall one, two and three. The red area indicates the resolvable part of the subsurface crack. Photo: Threshold CT-scan image from AIBN/Southampton University

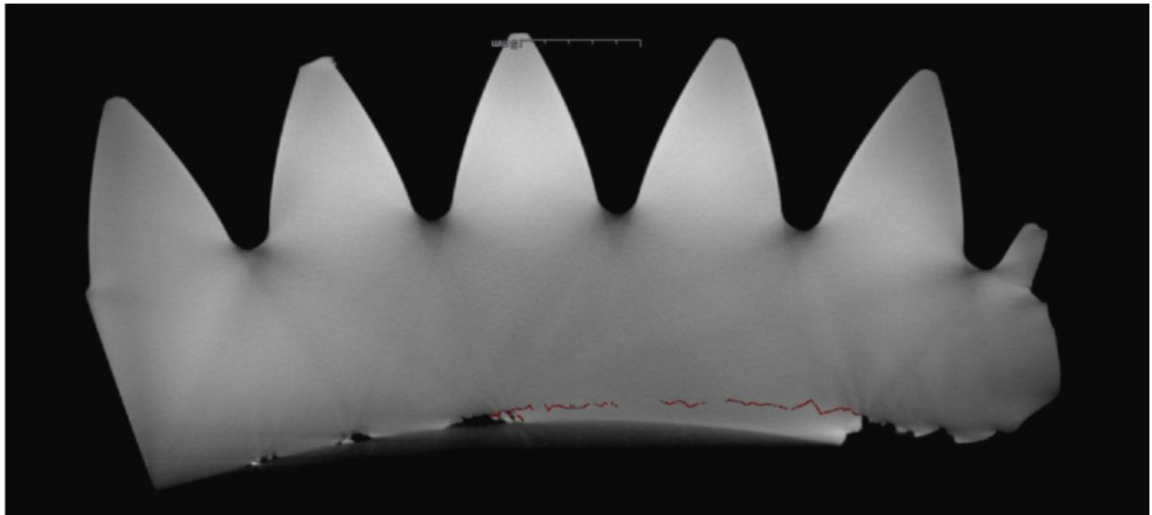
Figure 39: Longitudinal slice from CT-scan showing several cracks below the surface of the outer race. One crack runs below the surface between spalls (areas of surface damage). The main crack is marked in red. Photo: CT-scan from AIBN/Southampton University/QinetiQ

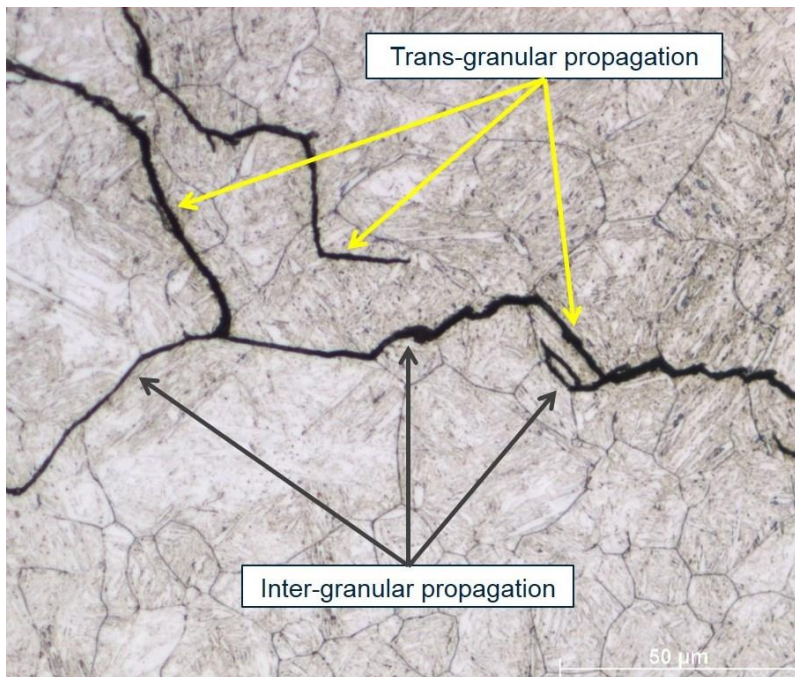
Figure 41: The subsurface crack propagation is both trans- and inter-granular. Roller direction to the left. Photo: AIBN/QinetiQ

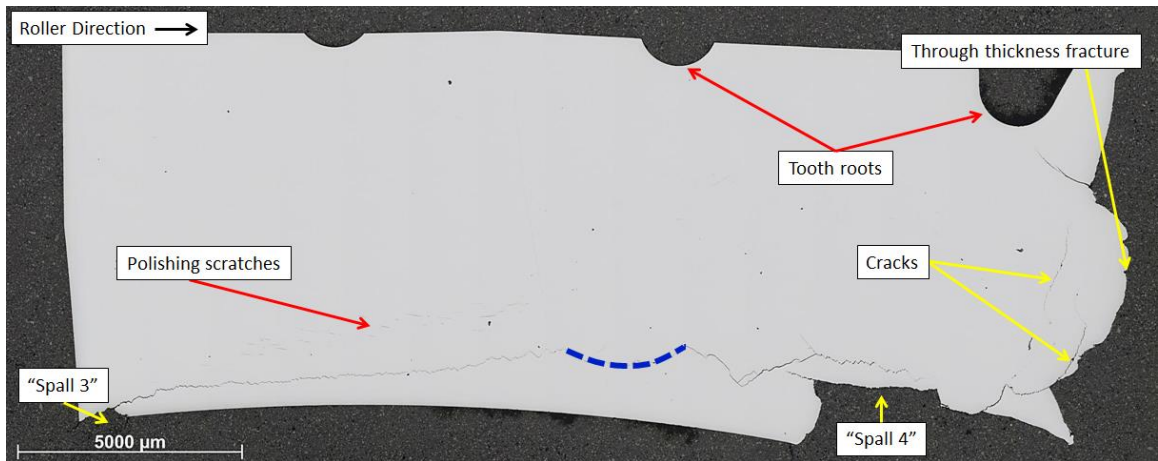
Figure 42: Sample FE13961 (see Figure 40). The micro-section is 16.8 mm from upper edge. Cracks deviating towards the race surface stop and thus do not release particles. Photo: AIBN/QinetiQ

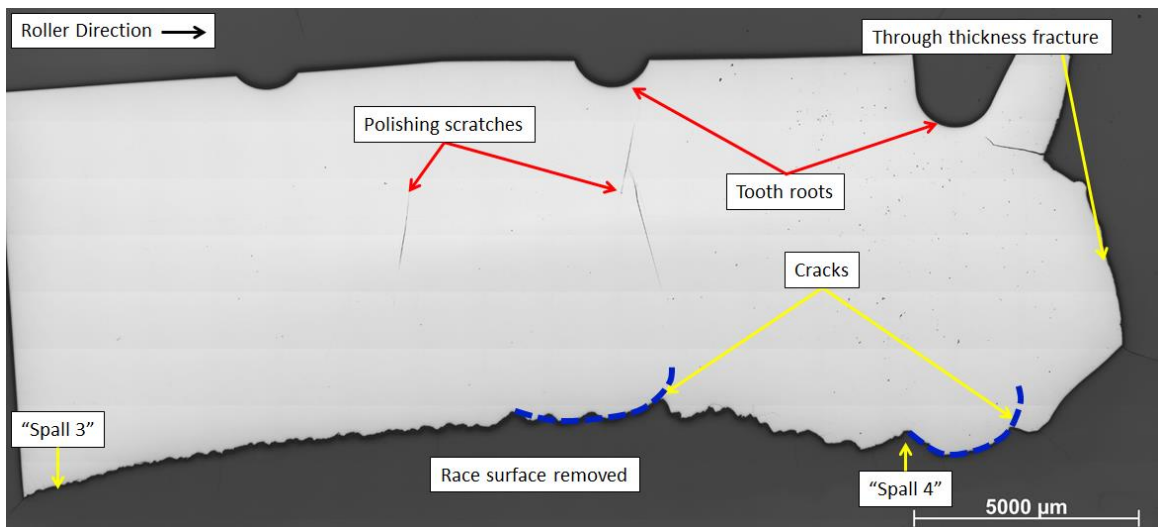
Figure 43: Sample FE13961 (see Figure 40). The micro-section is further polished to 15 mm from upper edge with the raceway removed. The micro-section shows deviations towards the gear teeth. Photo: AIBN/QinetiQ

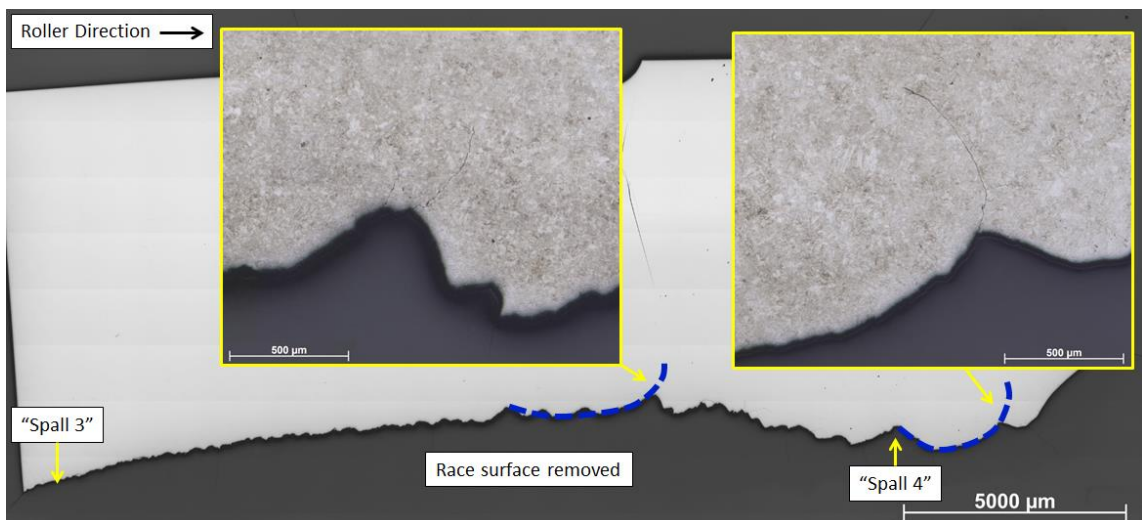
Figure 44: Sample FE13961 (see Figure 40). The micro-section shows a close up of deviations towards the gear teeth. Photo: AIBN/QinetiQ

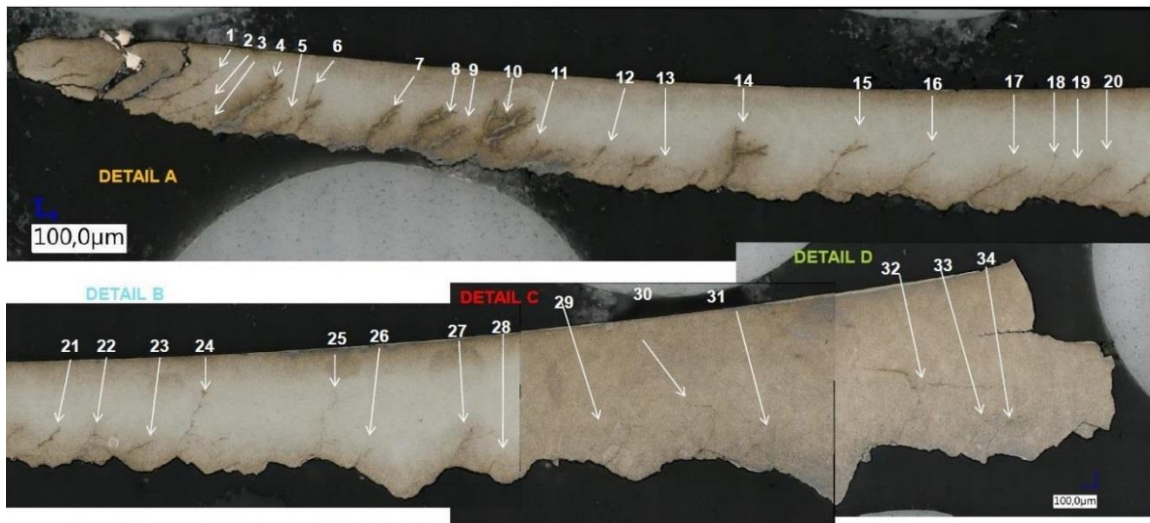
Figure 45: Polished section at the 14 mm line of the removed area (cap/calotte) between spall 3 and 4. Photo: Airbus Helicopters

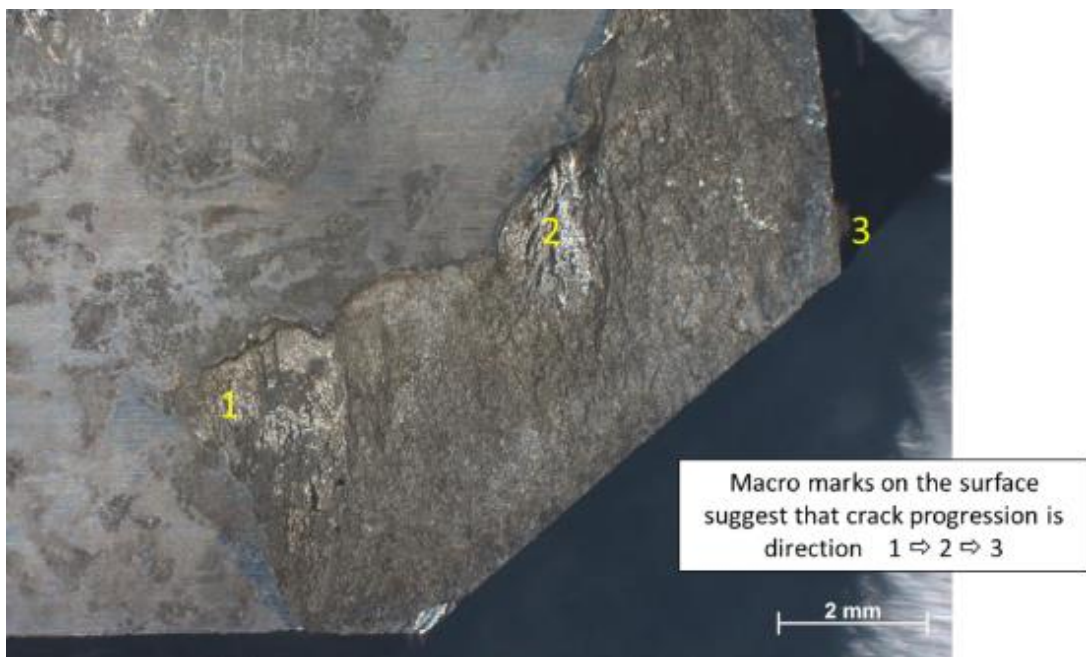
Figure 47: Figure showing the crack between spalls 1, 2 and 3 after removal of the race surface. Photo: AIBN/QinetiQ

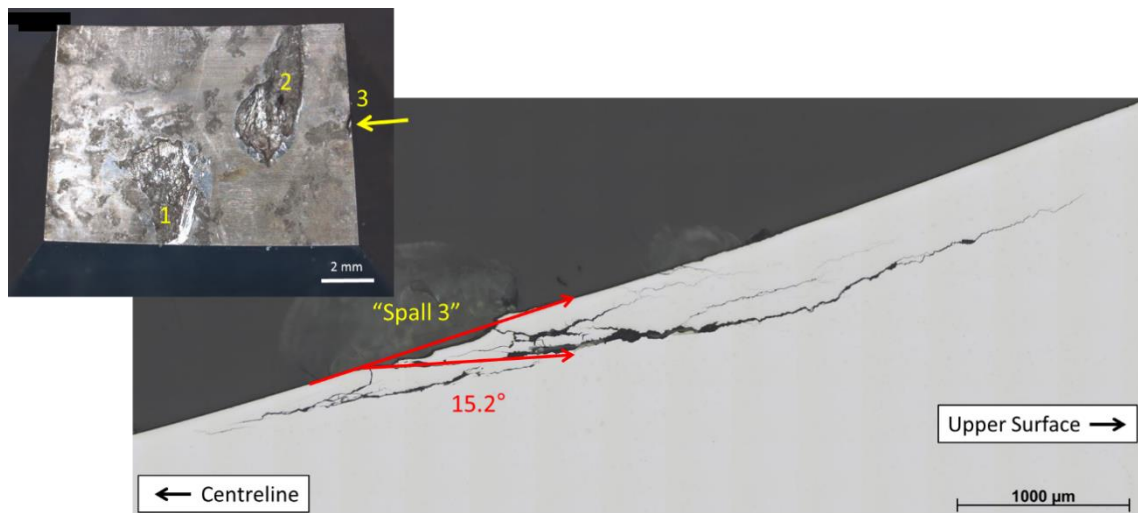
Figure 48: A transverse micro-section of spall 3 with the angle crack propagation of 15.2°. Photo: AIBN/QinetiQ

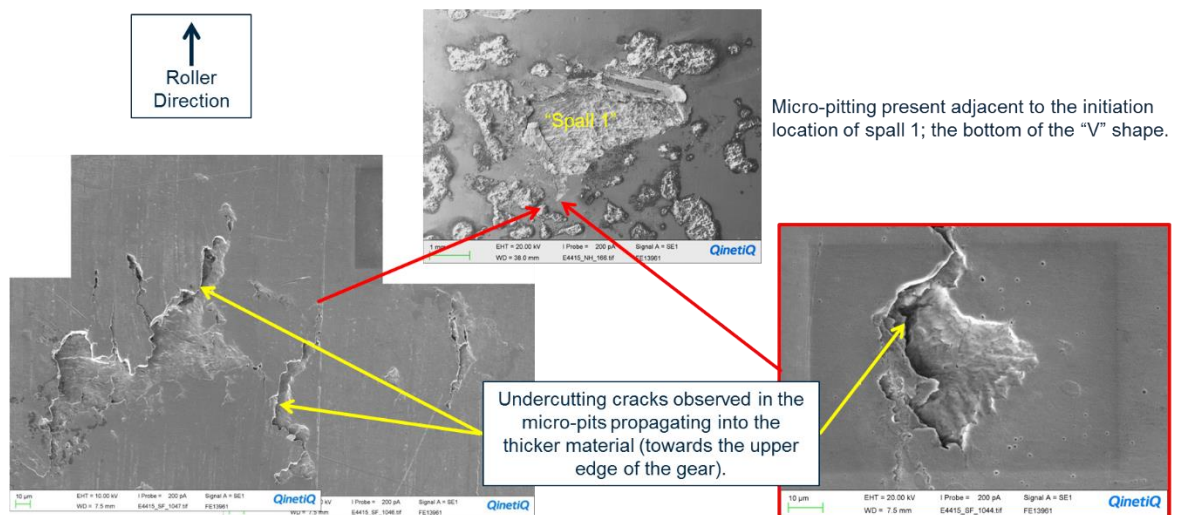
Figure 49: The micro-pits in the area in front of spall 1 Photo: AIBN/QinetiQ

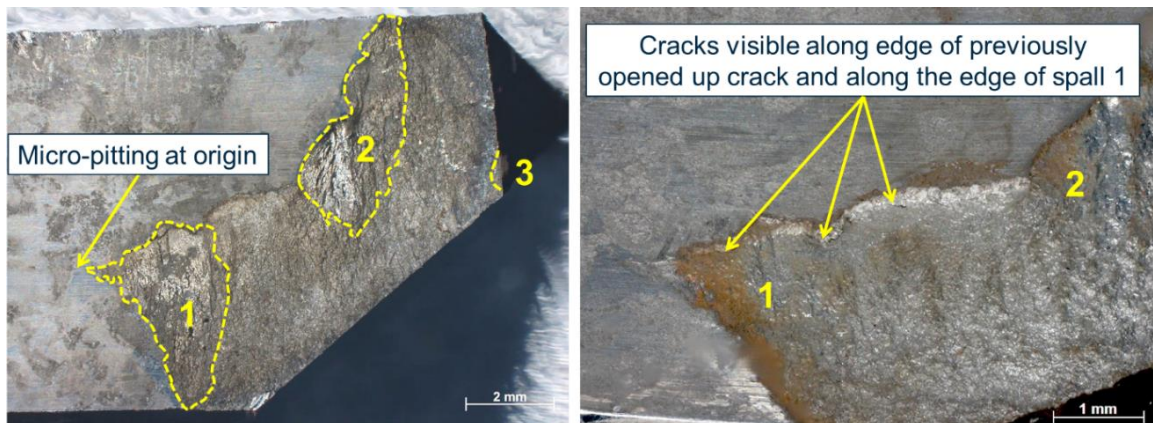
Figure 50: Fracture surface showing the extent of spills 1 and 2. Photo AIBN/QinetiQ

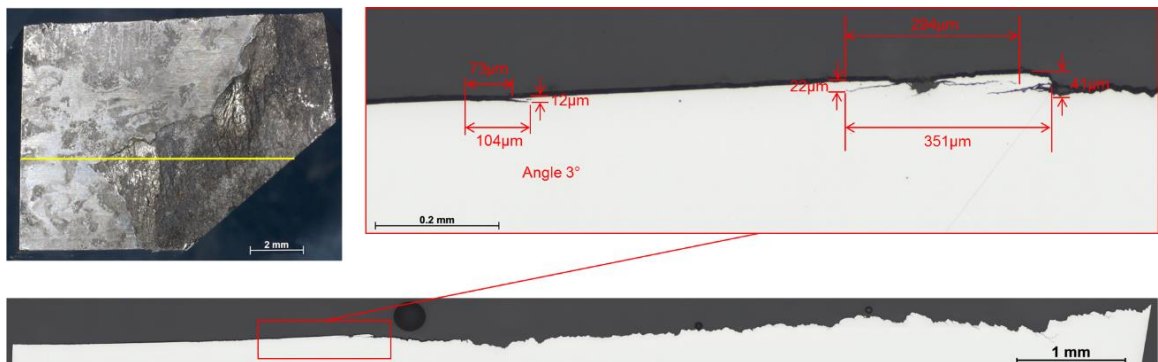
Figure 51: Micro-section 14.8 mm from top of gear showing Spall 1 and adjacent micro-pits with small cracks. The micro-cracks emerge from the micro-pits at a shallow angle into the material in the roller direction and inclined towards the upper edge of the gear. Photo AIBN/QinetiQ

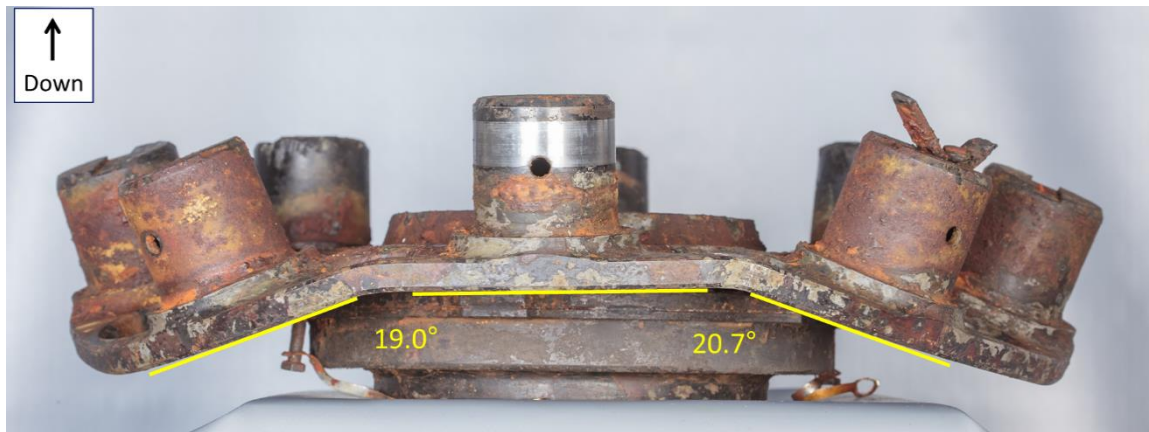
Figure 55. Deformation of carrier is symmetrical around the fractured planet gear. Photo: AIBN/QinetiQ

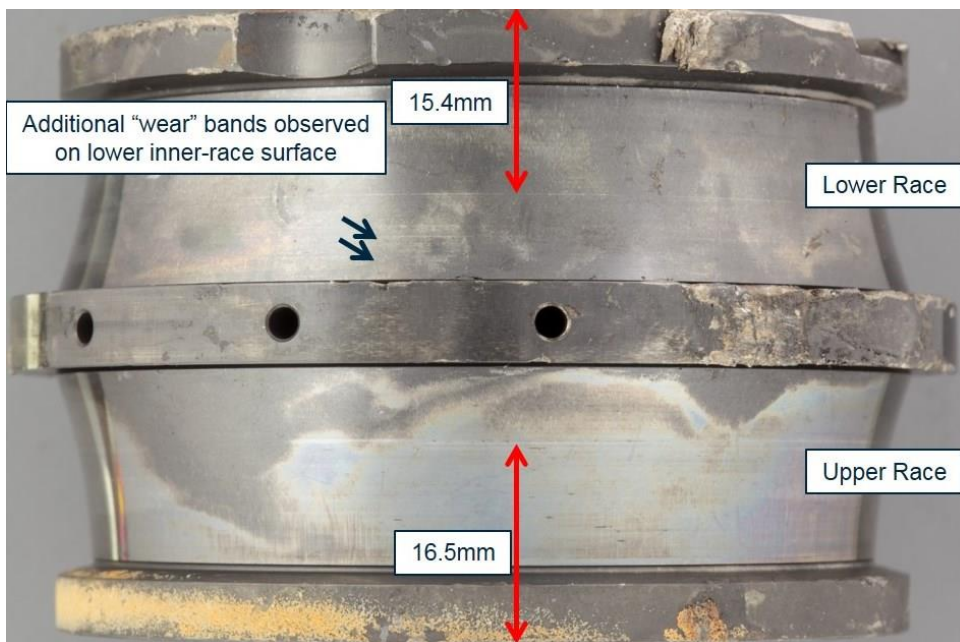
Figure 56: Circumferential ‘wear’ bands on the second stage planet gear inner race observed on both upper and lower race surfaces after cleaning. Photo: AIBN/QinetiQ

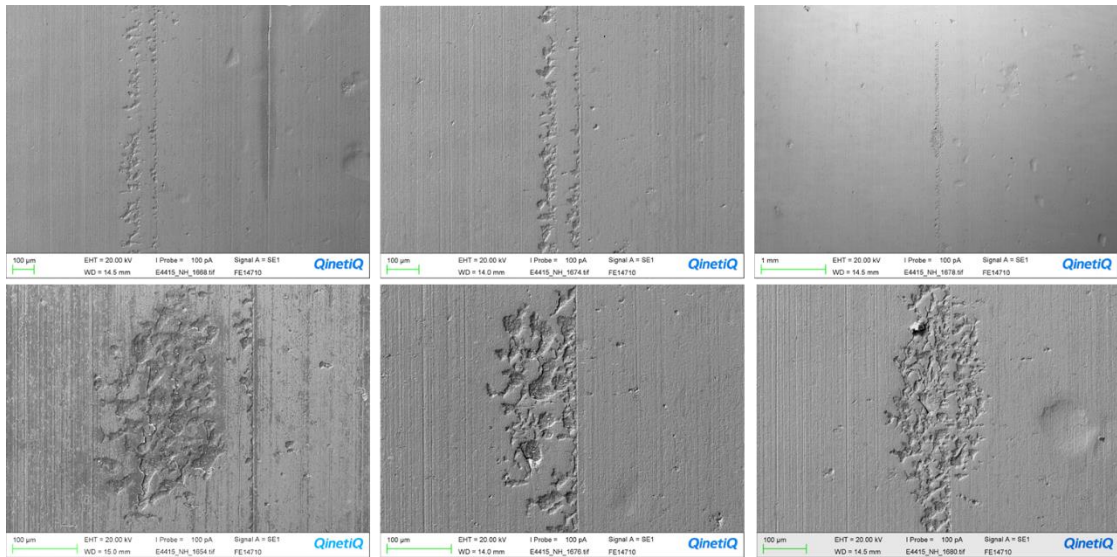
Figure 57: Examples of imperfections on the upper race surface. Photo: AIBN/QinetiQ

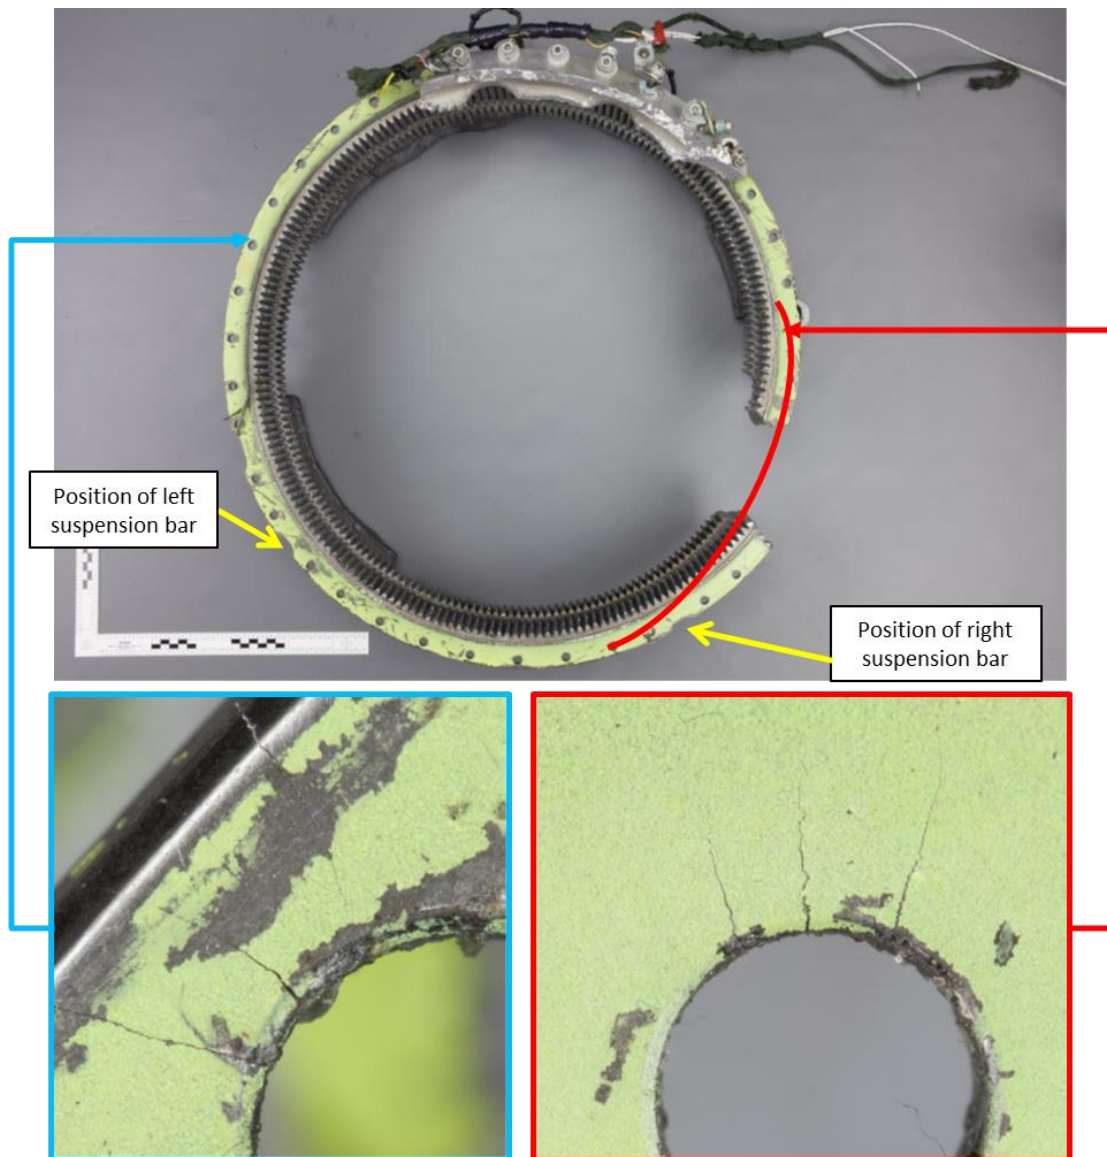
Figure 59: Epicyclical ring gear. Cracks at fastener holes suggests the flange of conical housing were intact when the fixed ring split and moved outwards. Photo: AIBN/QinetiQ

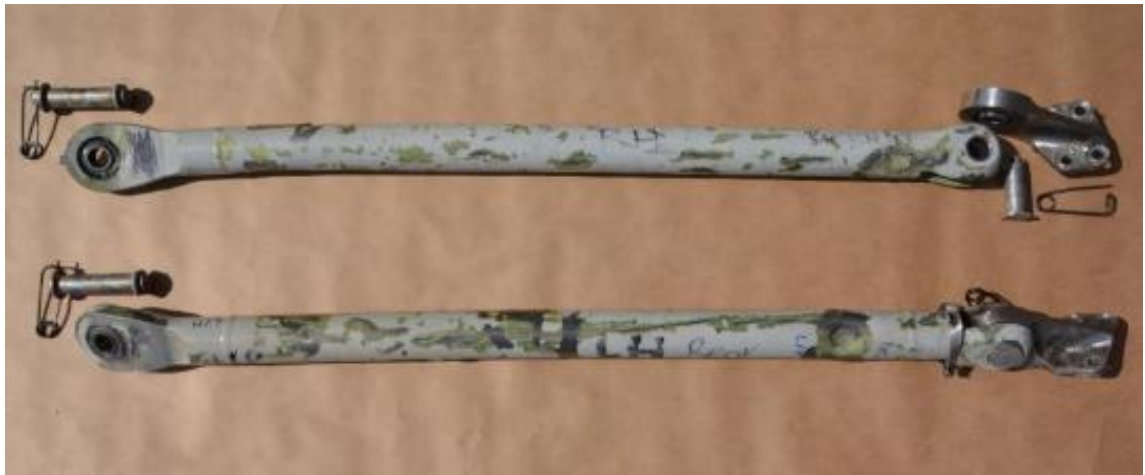
Figure 61: Left and right aft suspension bars with clevis pins, safety pins (only one shown in each position) and fuselage fittings. Both suspension bars have indentations from gear teeth.  
Photo: AIBN

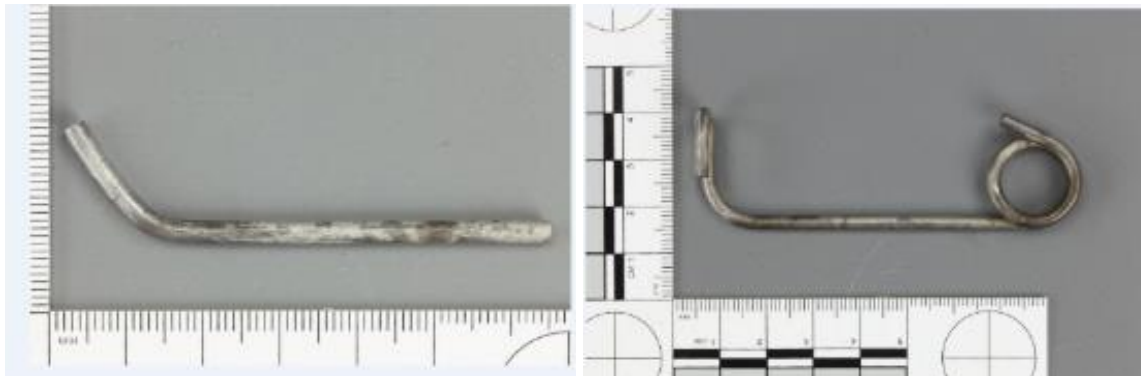
Figure 62: Two segments of safety pins found near the rotor mast. Metallurgical examination proved these to be from two different pins. Photo: AIBN/QinetiQ

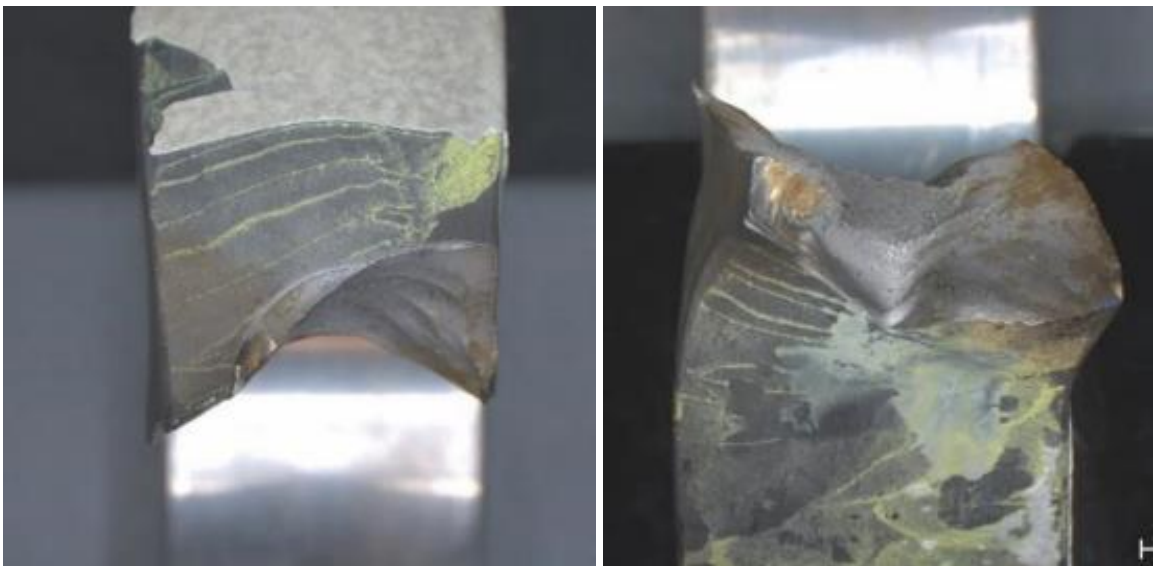
Figure 64: Upper forward suspension bar, mounting lug. Top fracture viewed from above (left photo). Bottom fracture viewed from below (right photo). Photo: AIBN/QinetiQ

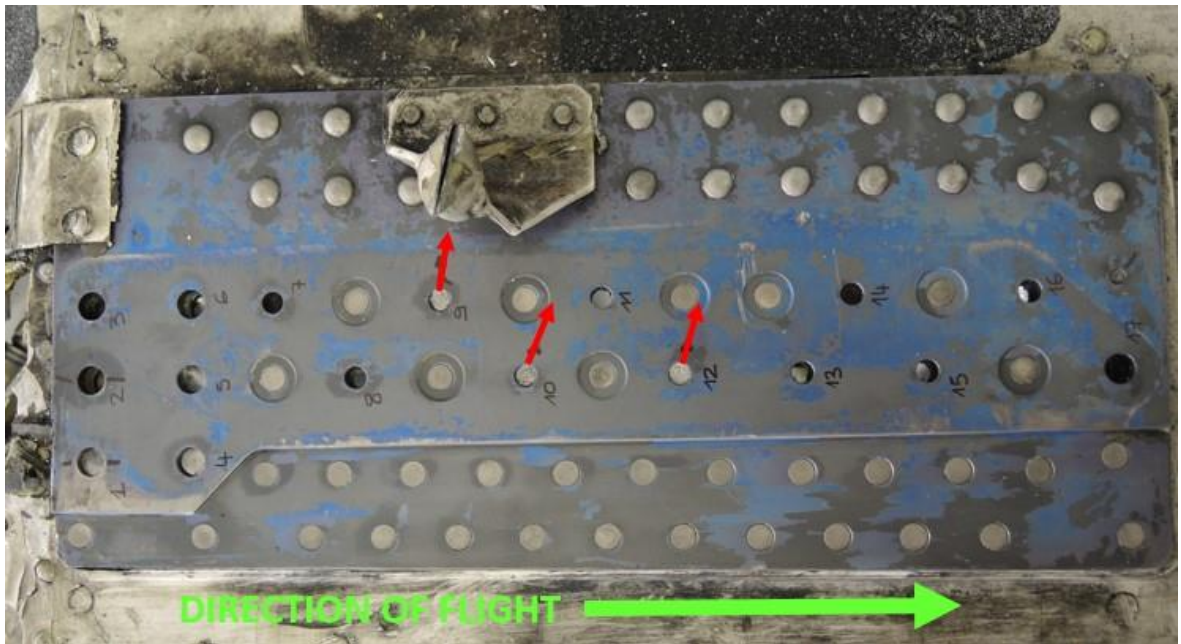
Figure 66: The flexible plate aft attachment had detached from the fuselage plate. The photo shows the support plate at the transmission deck. 7 out of 17 broken bolts were still in place. Red arrows indicate direction of overload in shear (towards the port side of the helicopter). Photo: AIBN

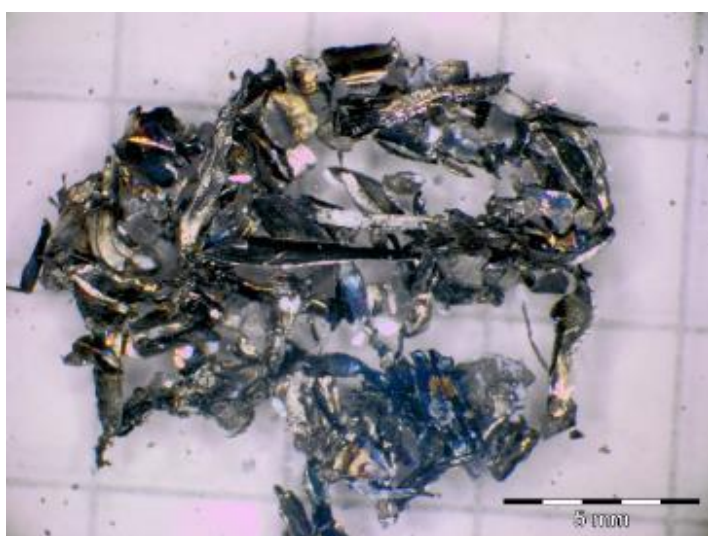
Figure 67: Metal debris from the MGB magnetic plug. Photo: AIBN/NDL

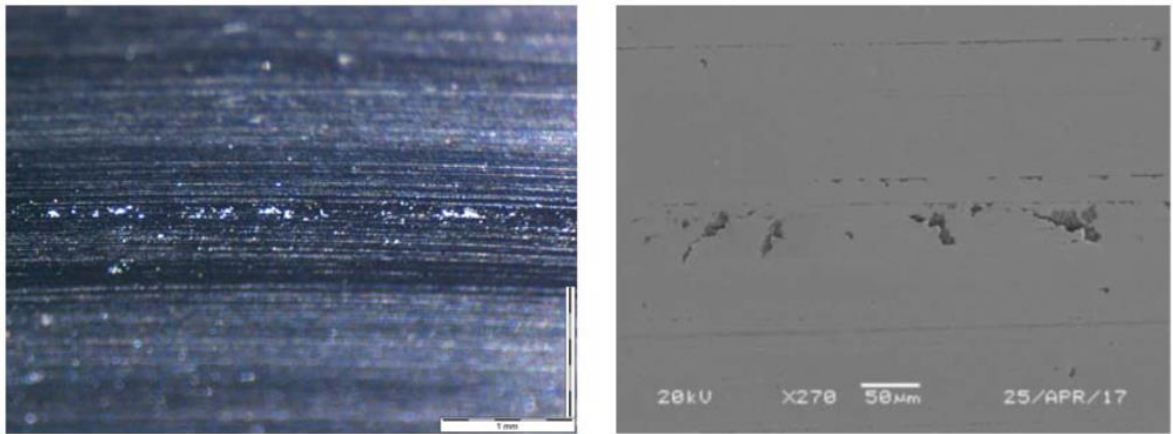
Figure 72: Micro-pitting within the dark line on gear M5769. Photo: Airbus Helicopters
