## **PRELIMINARY REPORT ON SERIOUS INCIDENT AT SVOLVÆR AIRPORT HELLE, NORWAY ON 2 DECEMBER 2010, INVOLVING BOMBARDIER DHC-8-103, LN-WIU OPERATED BY WIDERØES FLYVESELSKAP AS**

- Type and reg.:	Bombardier Inc. DHC-8-103, LN-WIU
Date and time:	Thursday 2 December 2010 18:18 hours.
Incident site:	Approx. 1.5 km north-northeast of the threshold of runway 19 at Svolvær Airport Helle (ENSH)(approx. N68°15'22" E14°40'44")
Weather conditions in accordance with last official observation at 17:50 hours, local time	METAR ENSH 1650 UTC 24030G44KT 8000 -SHRAGS FEW008 SCT012CB BKN014 05/03 Q1000 (Wind from 240 deg. 30 kt, gusting 44 kt, 8 km visibility, light rain and hail showers, few clouds at 800 ft, scattered cumulonimbus at 1,200 ft, broken cloud layer at 1,400 ft, temperature 5 °C, dew point 3 °C, QNH (barometric pressure) 1,000 hPa)
Light conditions:	Darkness
Operator:	Widerøes Flyveselskap AS
Flight type:	Scheduled passenger transport
Persons on board:	38 (2 pilots, 1 cabin crew, and 35 passengers)
Injuries:	None
Damage to aircraft:	None

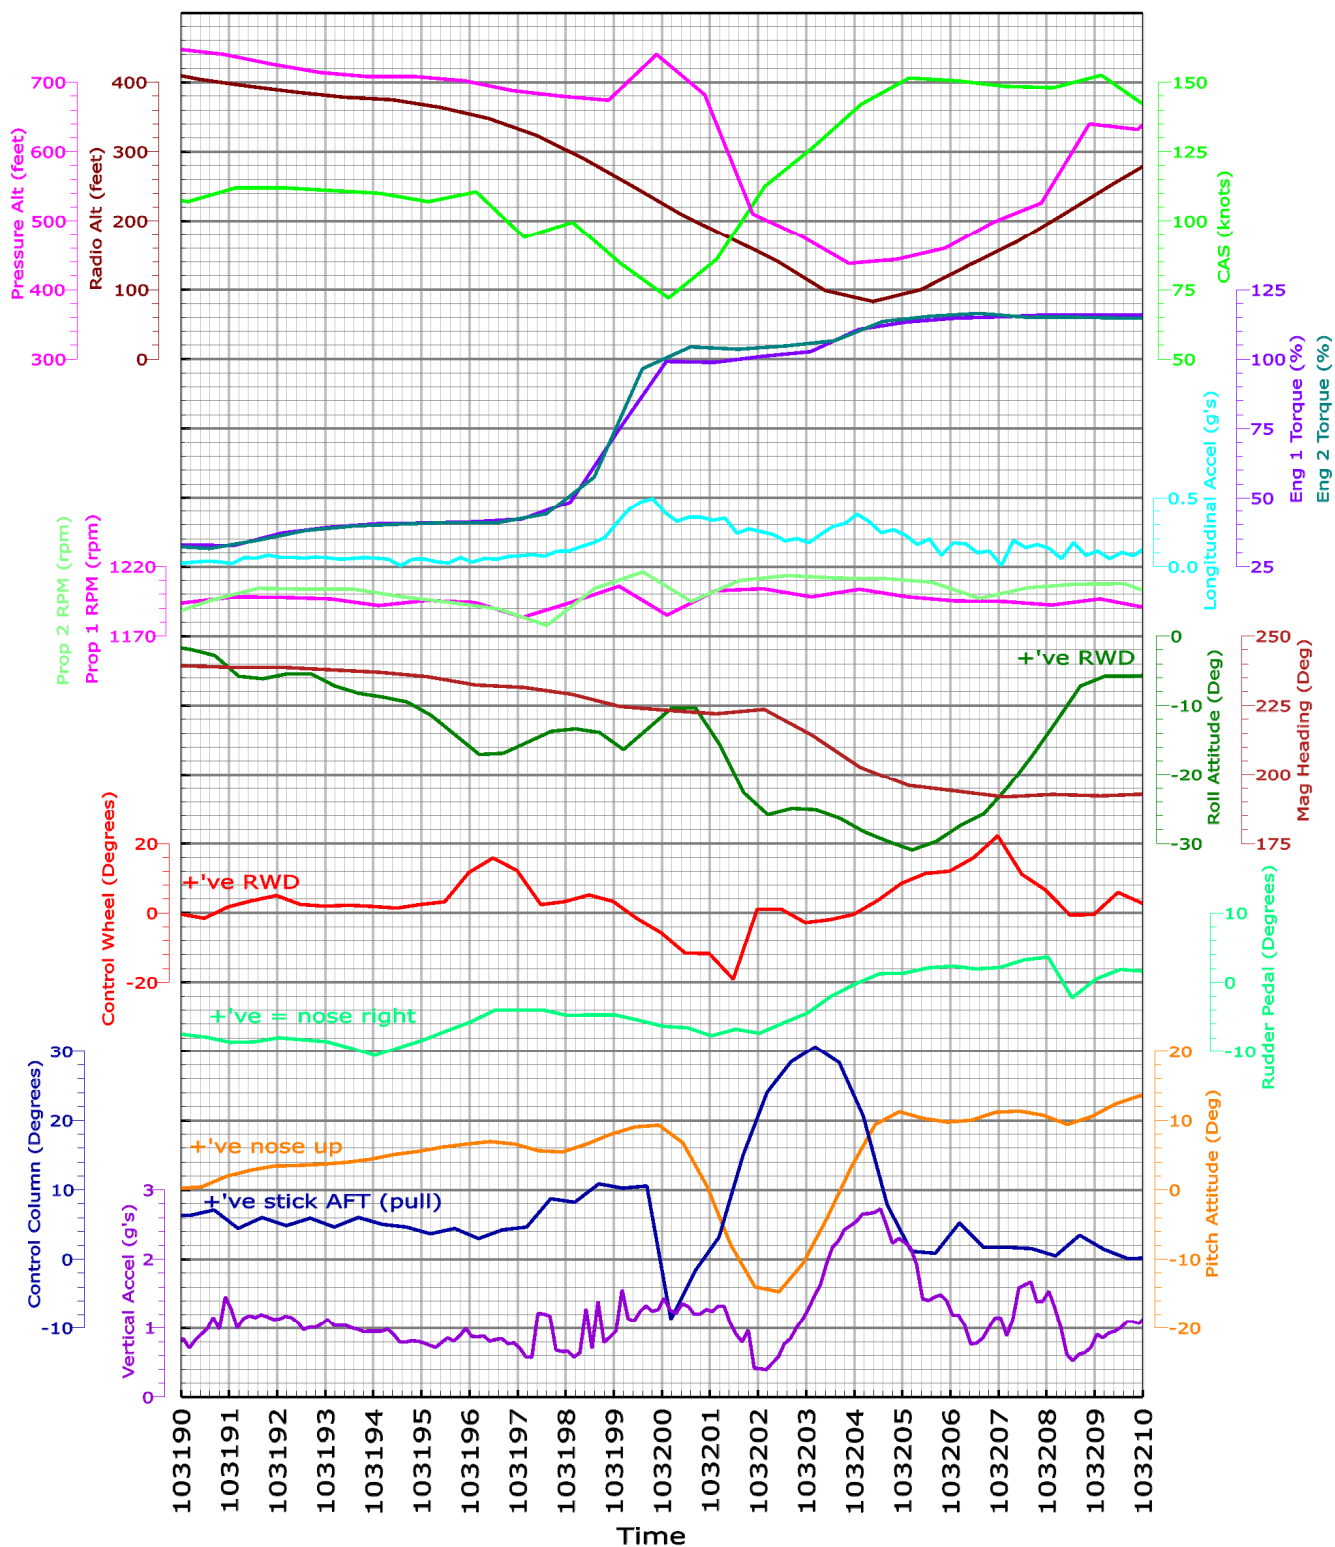
Figure 1: LN-WIU FDR Overview

- (14) At sample time 103204.4, the minimum radio altitude of 83 ft was reached.
- (15) At sample time 103204.5, the vertical acceleration reaches the maximum incident value of 2.7 g. According to the AFM, the maximum maneuver load limit with flaps extended is 2.0 g (2.5 g with flap retracted).

- (16) Between sample time 103204.4 and 103208.4, radio altitude increases from 83 to 212 ft at an average calculated rate of climb of 1935 ft/min. Airspeed settles at around 150 KCAS beginning at 103205.1 and the pitch attitude reaches 11.3° nose up and settles. The left and right elevator deflections settle at 3.9° and 0.7°, respectively, beginning at 103205.3, varying no more than 2° for the remainder of the analysis.

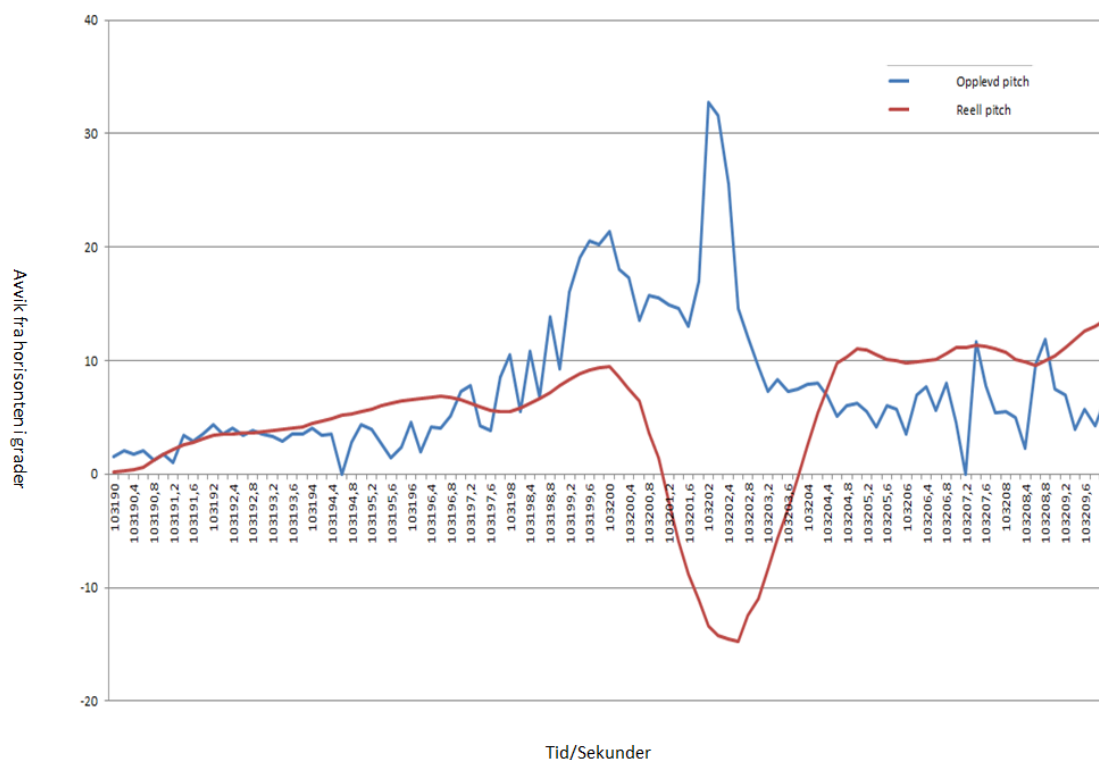
**Figur 2. Reell pitch versus opplevd pitch (resultantkraften) i grader avvik fra horisonten (0)**

I figur 2 er flyets reelle pitch (hentet fra flyets flight data recorder) under hele hendelsen plottet sammen med mulig opplevd pitch, basert på utregninger av resultantkraften. Resultantkraften antyder opplevd pitch nese opp under hele hendelsen, med økende tendens av nese opp inn mot øyeblikket hvor flyets stikke ble beveget forover (sekund 103199). Flyets reelle pitch begynte så å synke og var på det laveste nese ned ca. -15 grader. Samtidig økte resultantkraften og antydte nese opp med mer enn 30 grader på det høyeste (sekund 103202). Se figur 2.
