Passivhus Norden 2009

## Renovation of the Brogården area to Passive Houses

*Ulla Janson, Tekn. lic,  
Energy and Building Design, Lund University;  
ulla.janson@ebd.lth.se <http://www.ebd.lth.se>*

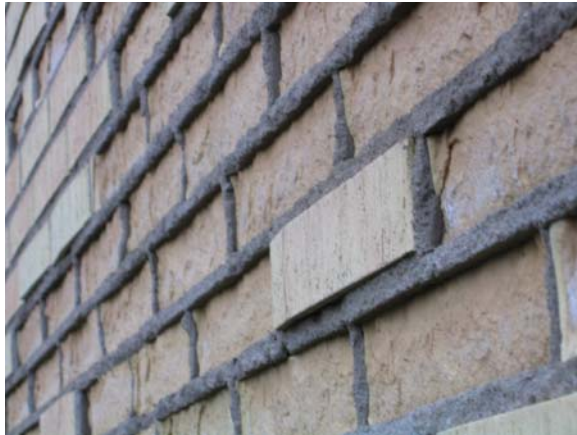
*Figure 3 Brick façade before renovation*

The apartment building is prefabricated with a load bearing concrete construction. The gables are made of concrete and the long side walls have a wooden construction. The façade brick material is worn out. This is due both to frost and to acid rain that enlarges the mortar and burst the bricks to pieces, see figure 3. Since the façade material needs to be changed anyway, this gives an opportunity to add insulation on the outer walls.

The original renovation concept included to save the wooden construction in the long side walls. Early investigation of the status of the building showed that the wooden construction had no damages. When the bricks were removed, the wooden construction showed to be in pretty poor shape and was decided to be removed. New long walls are built which also eased the building process for the carpenters. The new long wall construction contains of layers of insulation with a steel load bearing construction, see figure 4. The steel construction was chosen instead of a wooden construction to avoid any mould problems in the wood in the future. There is an installation layer on the inside of the wall to protect the plastic foil. On the outside surface is a thin brick surface mounted on a steel profile, see figure 4. It was important for the client to keep the impression in the area with the original colours and the brick façades.

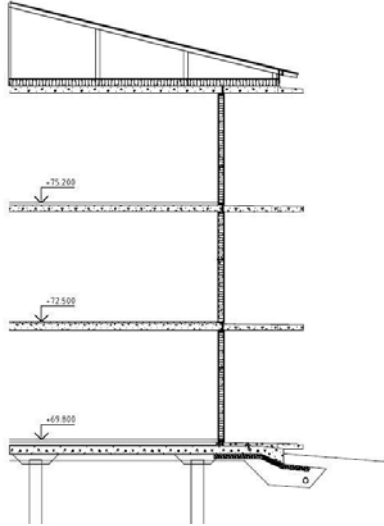
Figure 5 Original balcony construction

In the original construction, the balconies were a part of the building construction, see figure 5. This caused a large thermal bridge with low floor temperatures in the room inside of the balcony.

To avoid this thermal bridge, the balconies are moved. Since the long side walls needed to be new built, they could be moved to a new position. The outer part of the balcony is removed, giving an even line on the long sides where the new long side walls are placed. The balconies are standing on plinths, mounted on the outside of the façade.

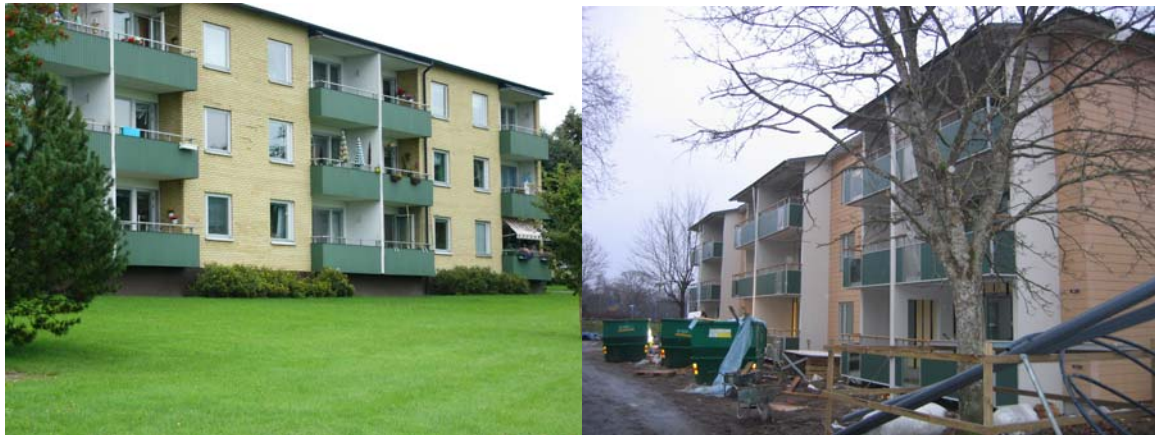
Figure 6 Balcony construction before and after renovation

The left picture in figure 6 shows the balconies before renovation and the right picture the balconies after renovation.

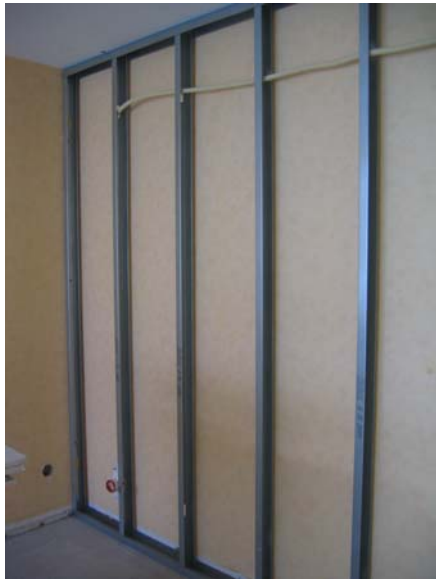
Figure 7 Sound insulation of inner wall

The walls between the apartments are originally made of 150 mm of concrete. Renovating the climate shell to Passive House standard not only decrease the U-values, but also decrease the noise from outdoors. To avoid any annoyance among the tenants caused by disturbance from the neighbours, the partition-walls are insulated, see figure 7.
