Continuous condition monitoring of pipelines and risers

Ole Øystein Knudsen, SINTEF

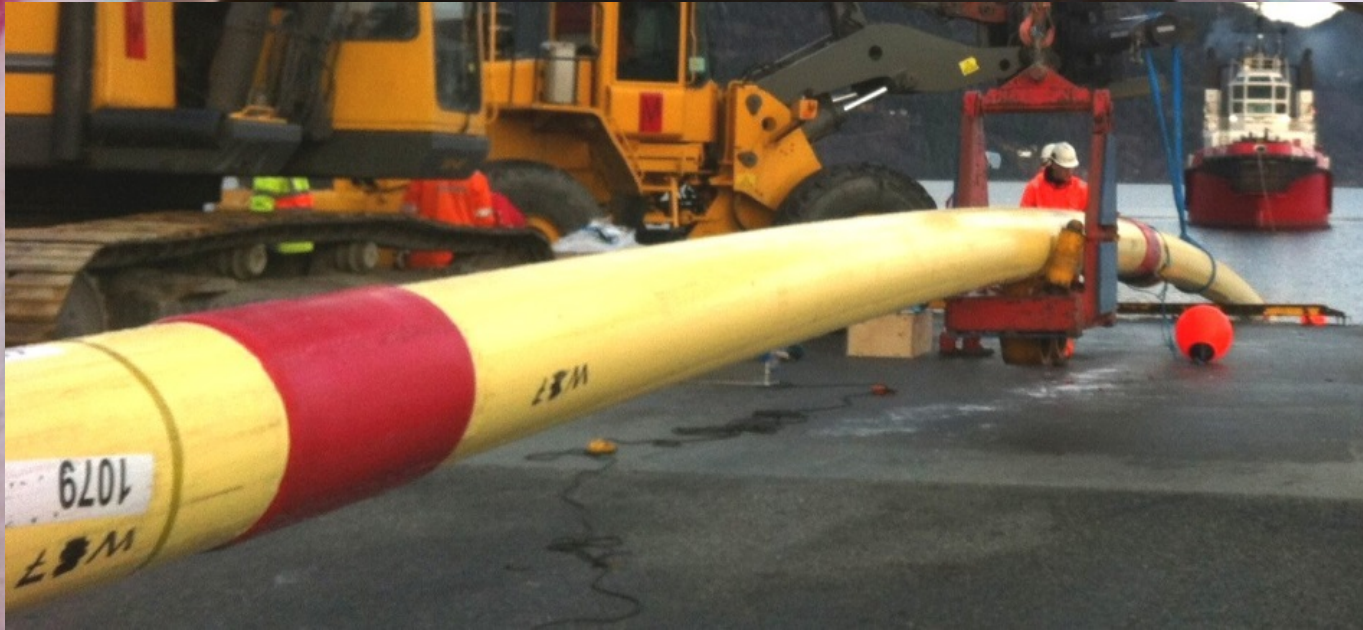
The SmartPipe

- Steel thickness = $\frac{9}{16}$ i.e. 14.3mm
 - OD = $10 \frac{3}{4}$
 - ID = $9 \frac{5}{8}$

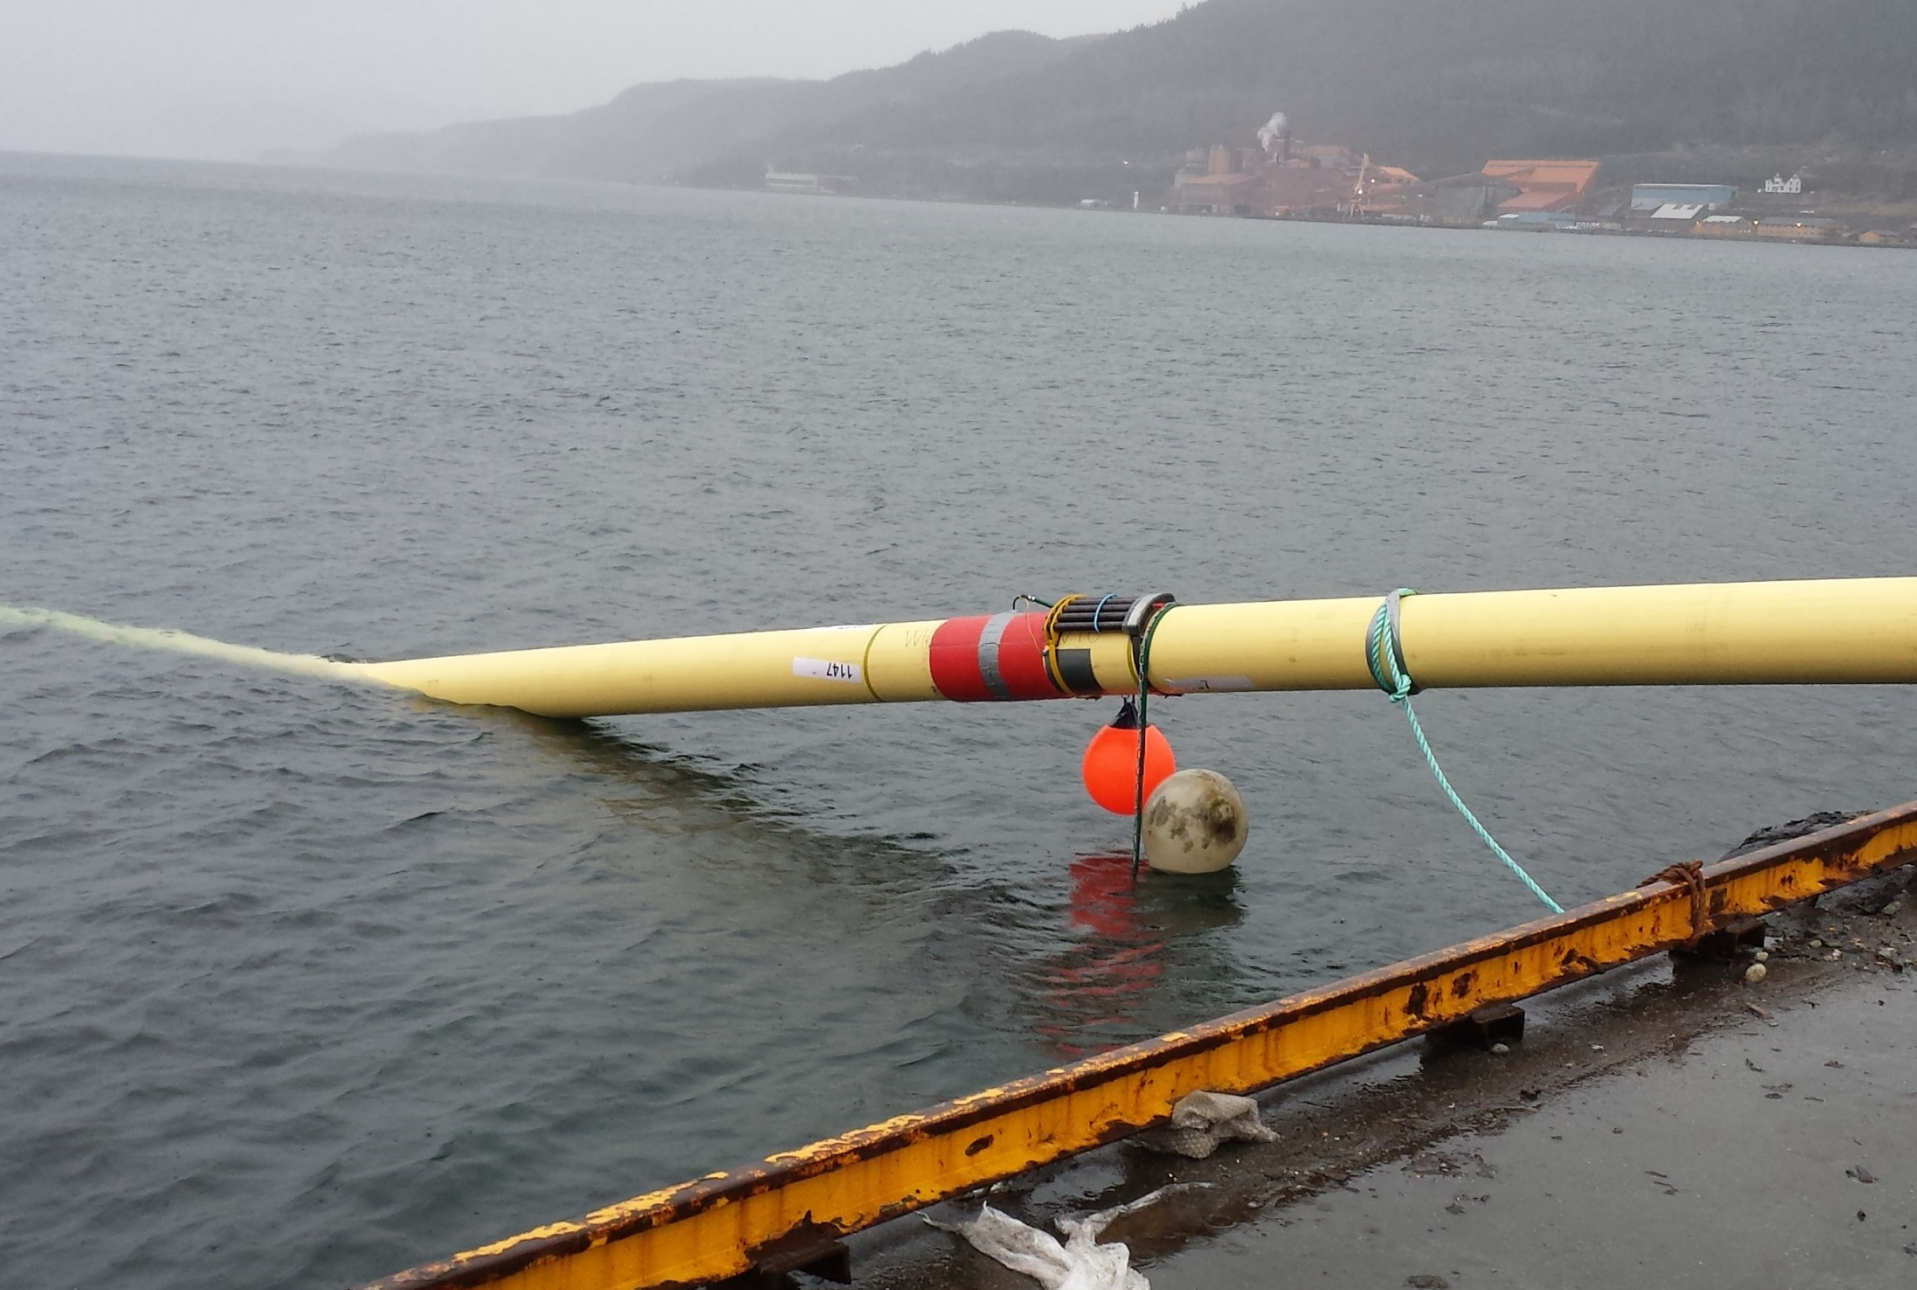
1147

MM

Antenna

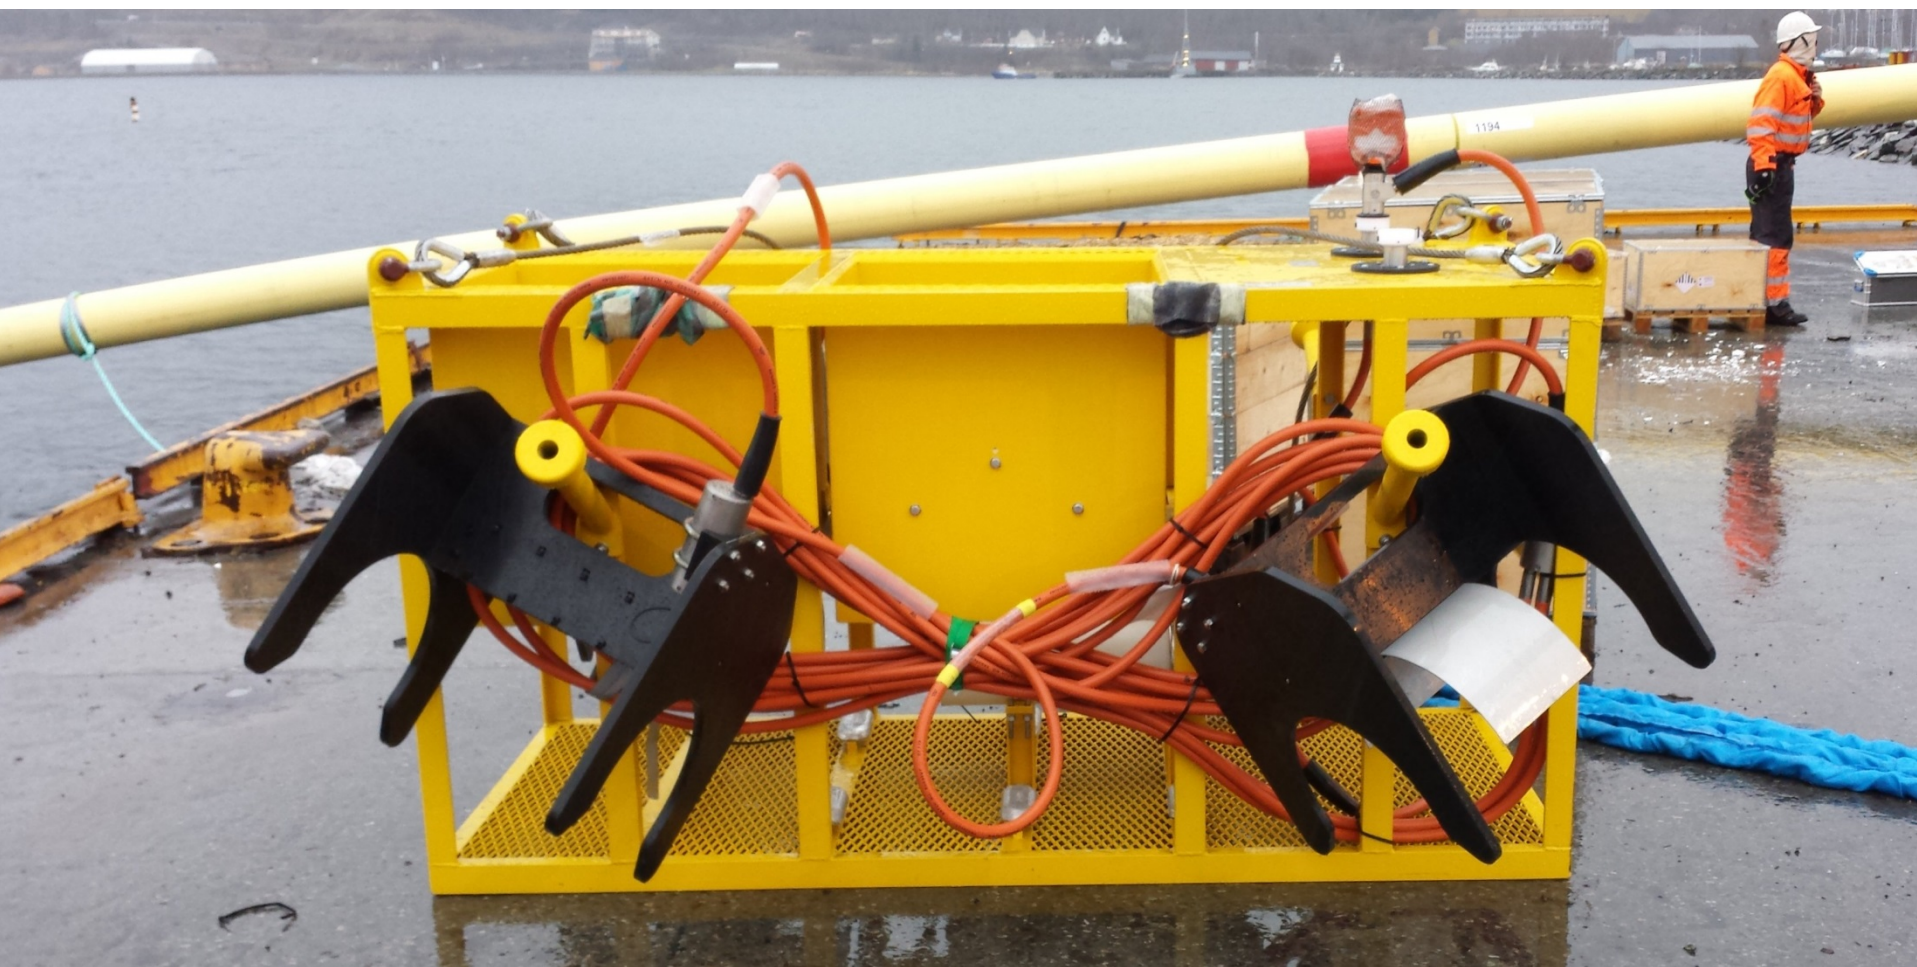
Communication

- Communication at least 200 m along the pipe
- Able to communicate with 8 nodes along the pipe
- Attenuation of the communication signal is as expected or better

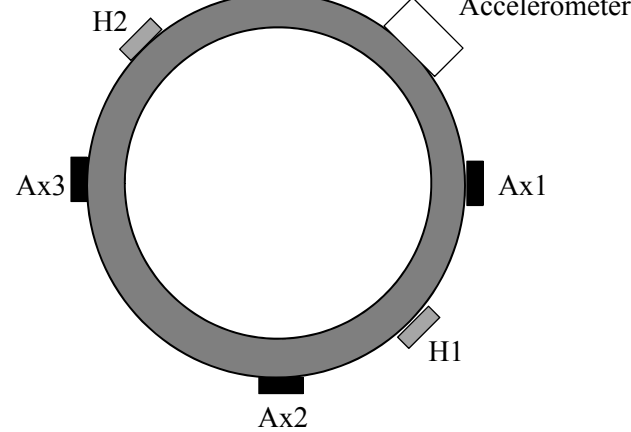
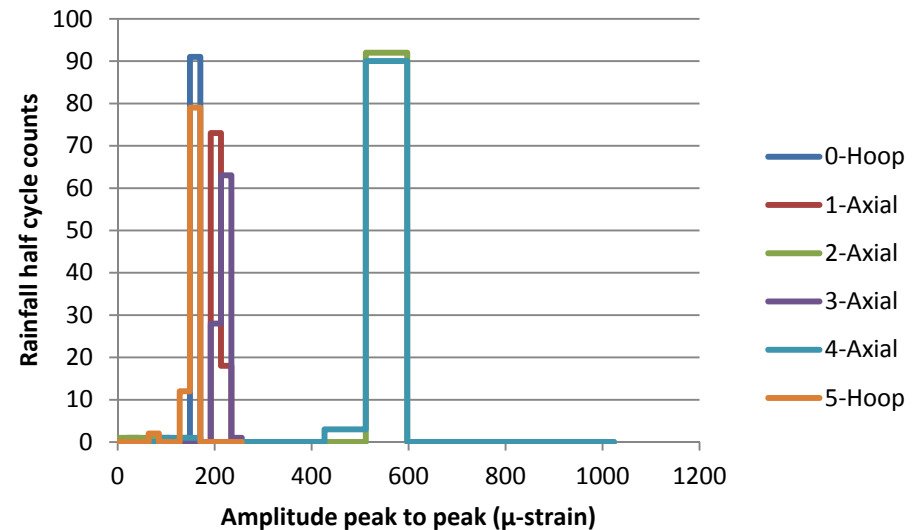
Fatigue monitoring test

- Pipe set in vibrational motion on land before the installation
- Counting vibration half cycles in different strain ranges
- Strain gauges mounted around the pipe as shown
- 93 half cycles
- Ax2 and Ax4 registered 92 and 93 half cycles

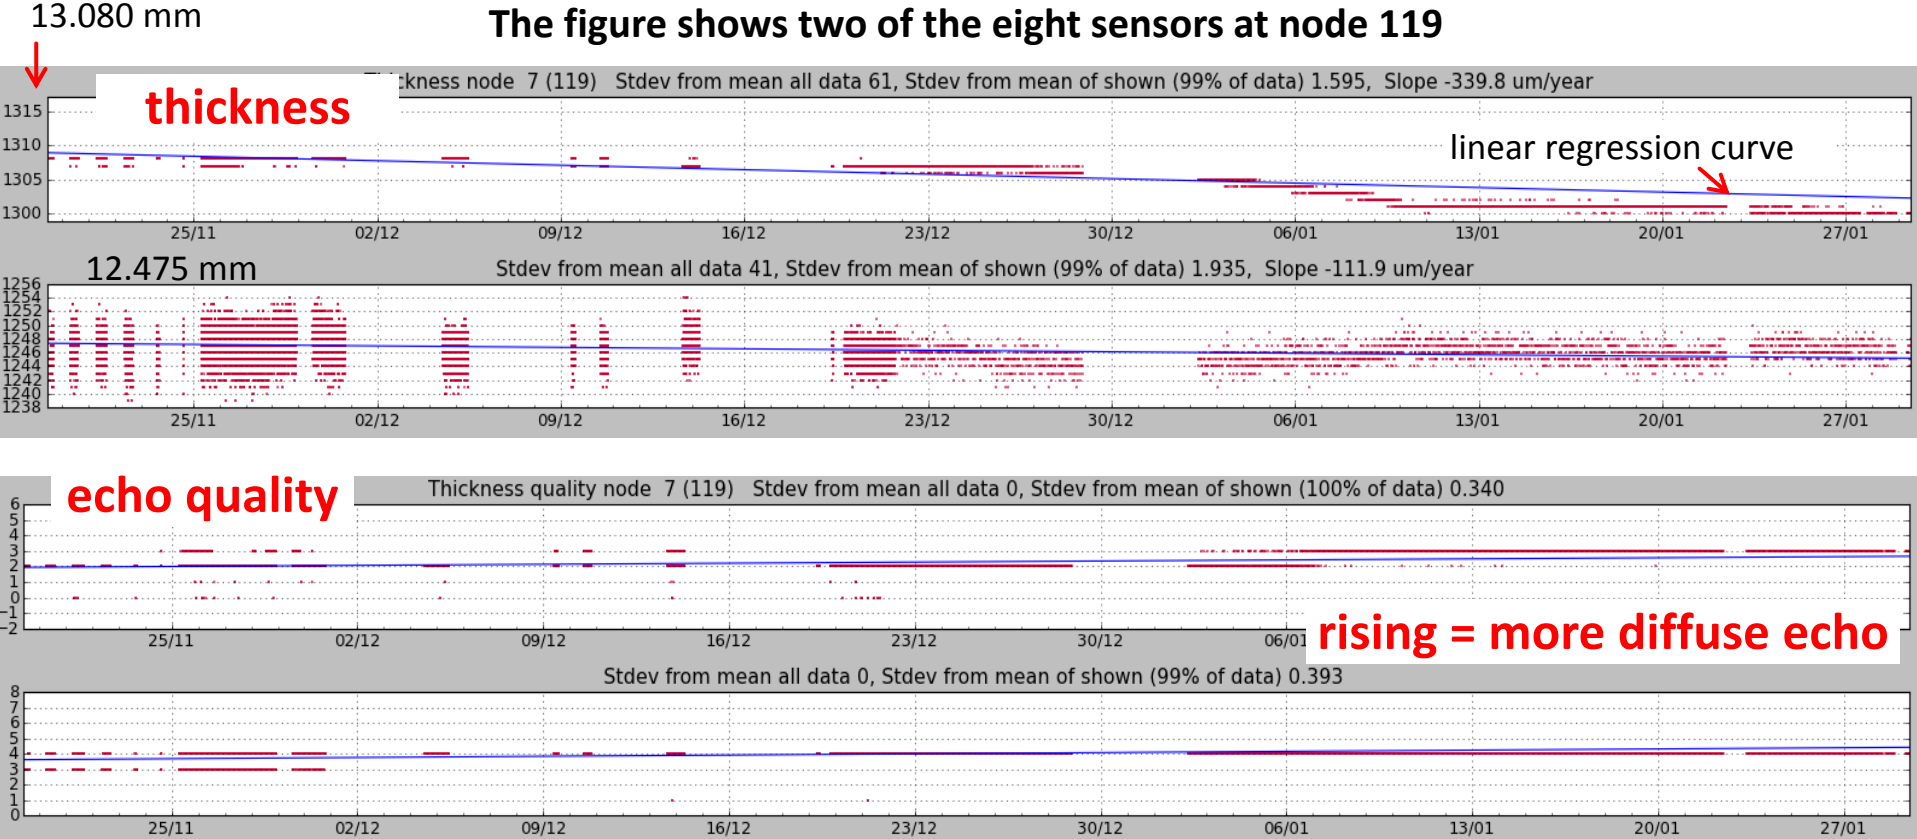
The figure shows two of the eight sensors at node 119

- For most sensors the data shows a falling thickness and falling echo quality (rising quality number).
- The mean change of thickness corresponds to 100um/year which is within expected range (steel in ocean water).
- The echo quality is expected to fall as the steel surface corrodes.
- Some sensors are more noisy than others but the averaged value seems to be correct.
- Some sensors show outliers that have been removed from these plots.

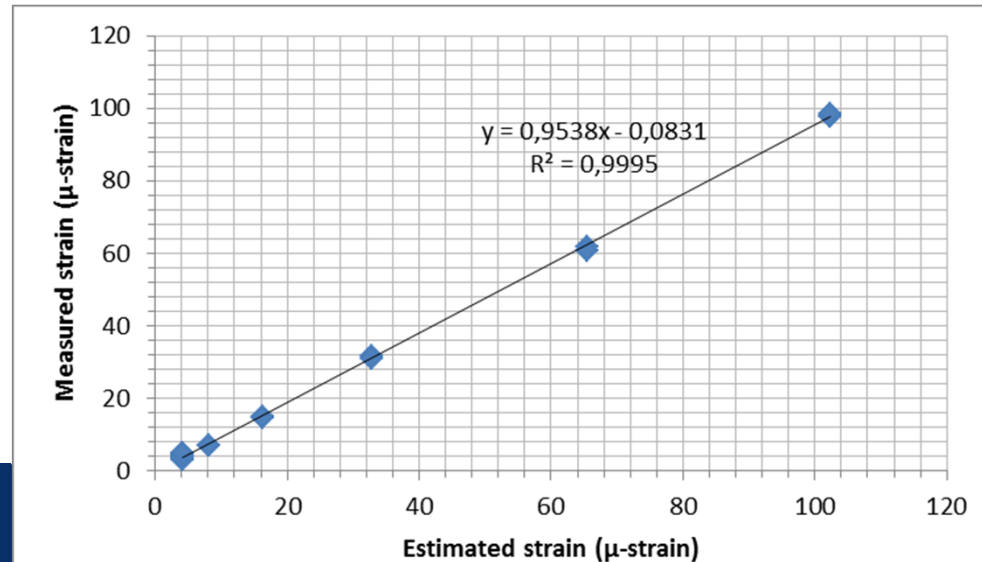
Strain test

- Tensile testing machine
- Compressive mode
- 10 to 250 kN
- Calculated strain plotted vs measured strain
 - 5% scaling deviation
 - Resolution better than 10 μ -strain

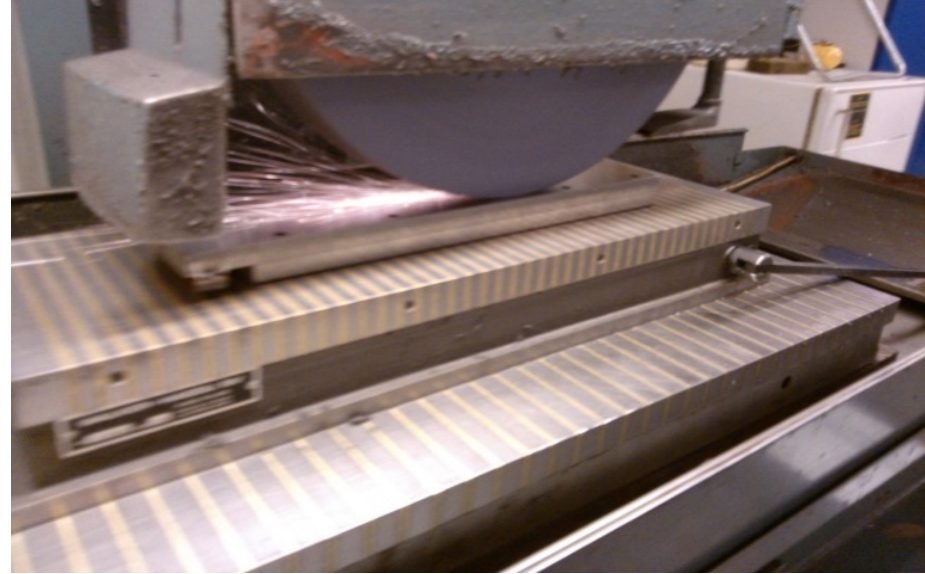
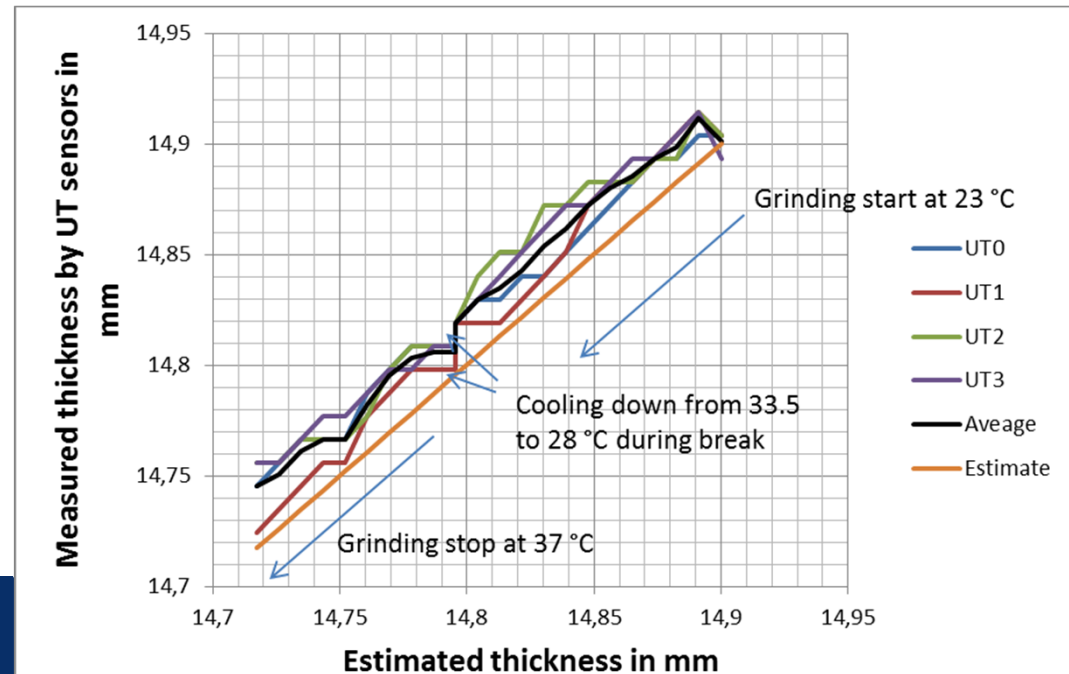
Wall thickness

- Sensor belt mounted on steel panel
- Grinded on the backside in ca 10 μm steps
- Sensor measurement vs μm screw gauge
- 180 μm grinded away
- Average of 4 measurements has a resolution better than 10 μm
