MARINE EXPERIENCES WITH ALUMINIUM

Ole Øystein Knudsen
SINTEF

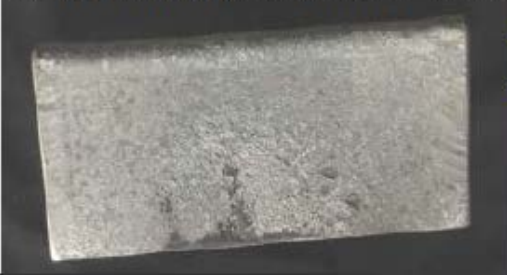
Plate from splash water zone

Extruded tube from permanent immersion zone

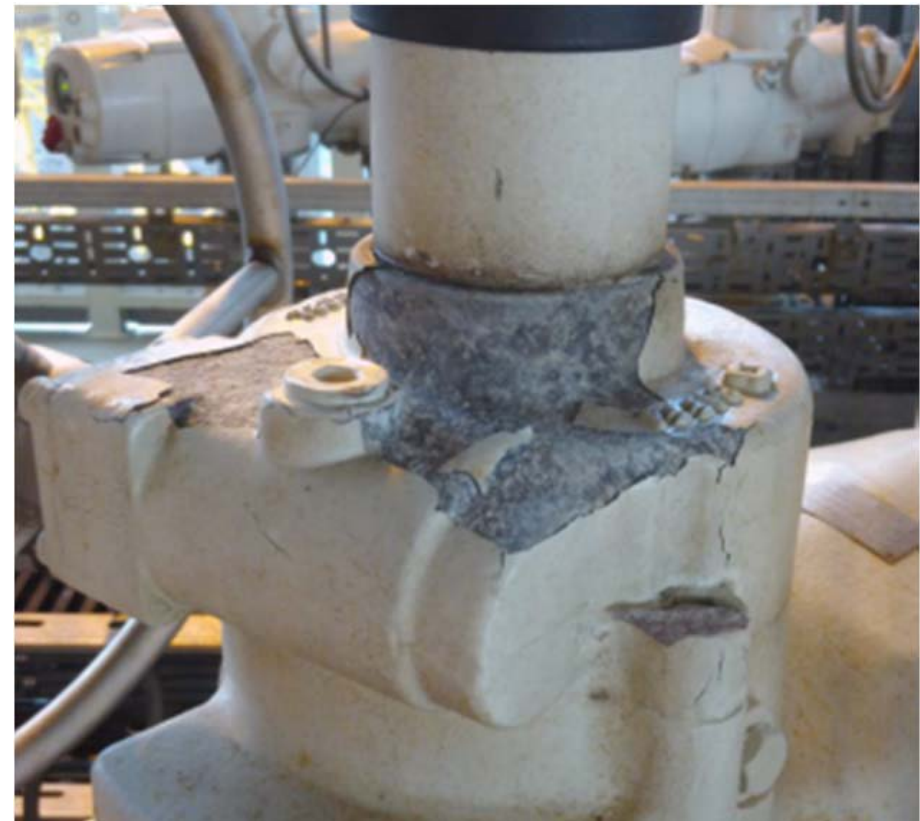
Wrong alloy

- Severe corrosion on cast aluminium actuator
- The alloy contained about 1% Cu
- Standards for selection of Al alloys
 - NORSOK M-121
 - DIN 81249

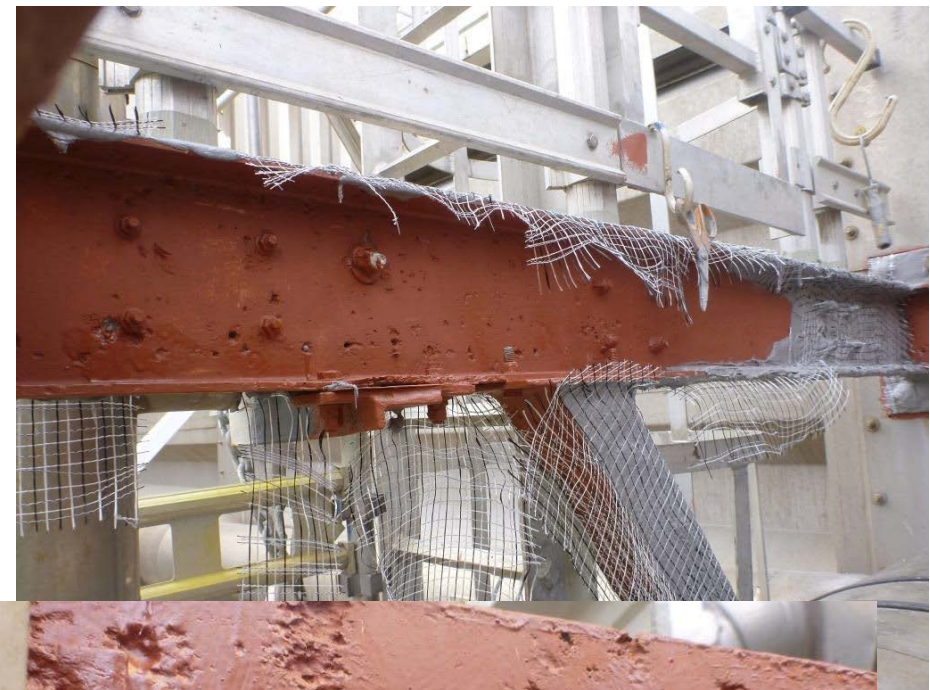
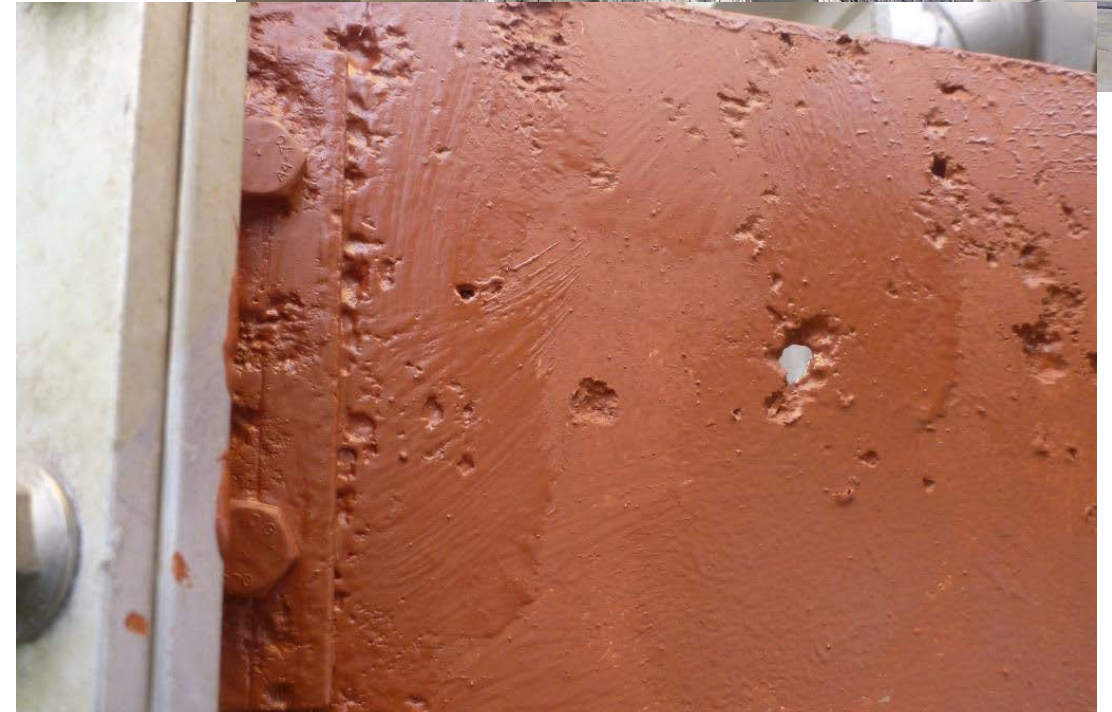
Stagnant water

- Passive fire protection with absorbed salt water
- The water acidifies with time and becomes aggressive to aluminium

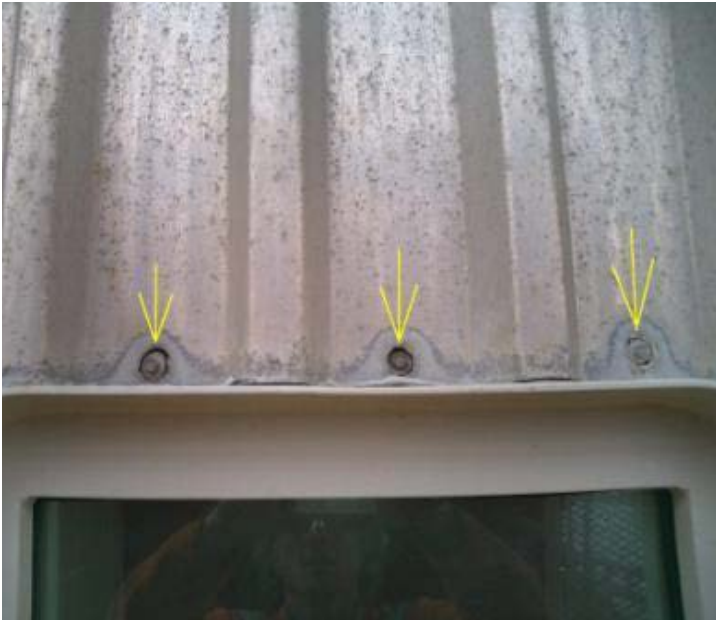
Under/around stainless bolts

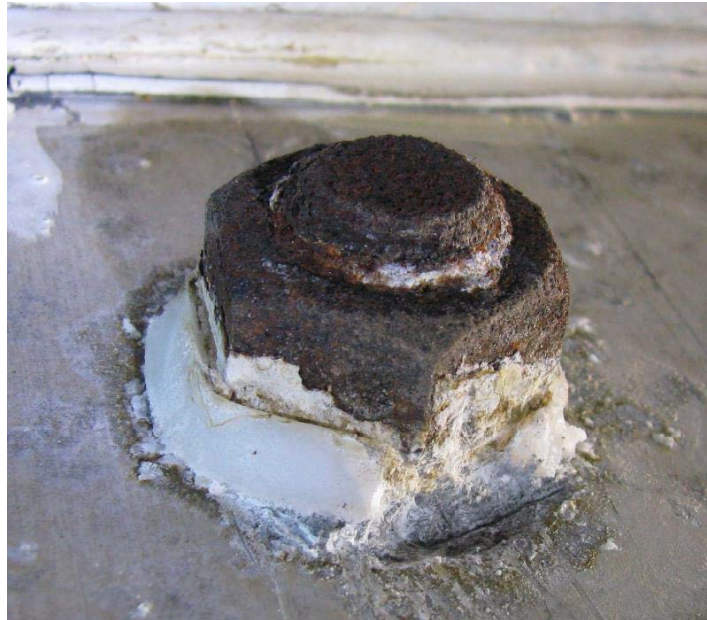
Low alloy bolts

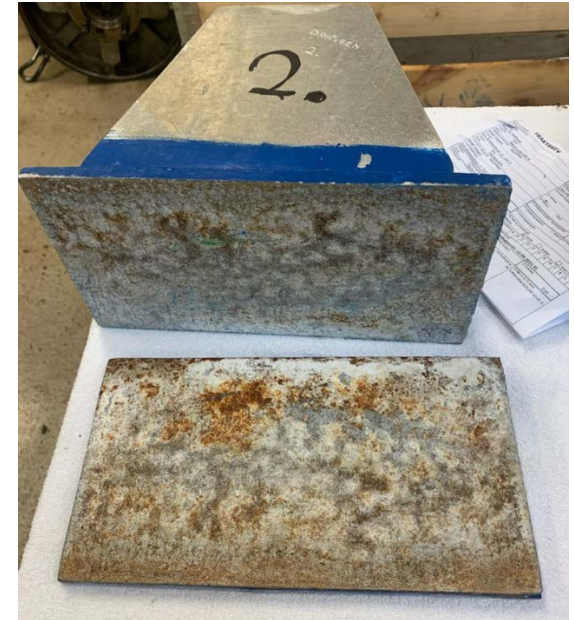
Steel-aluminium weld

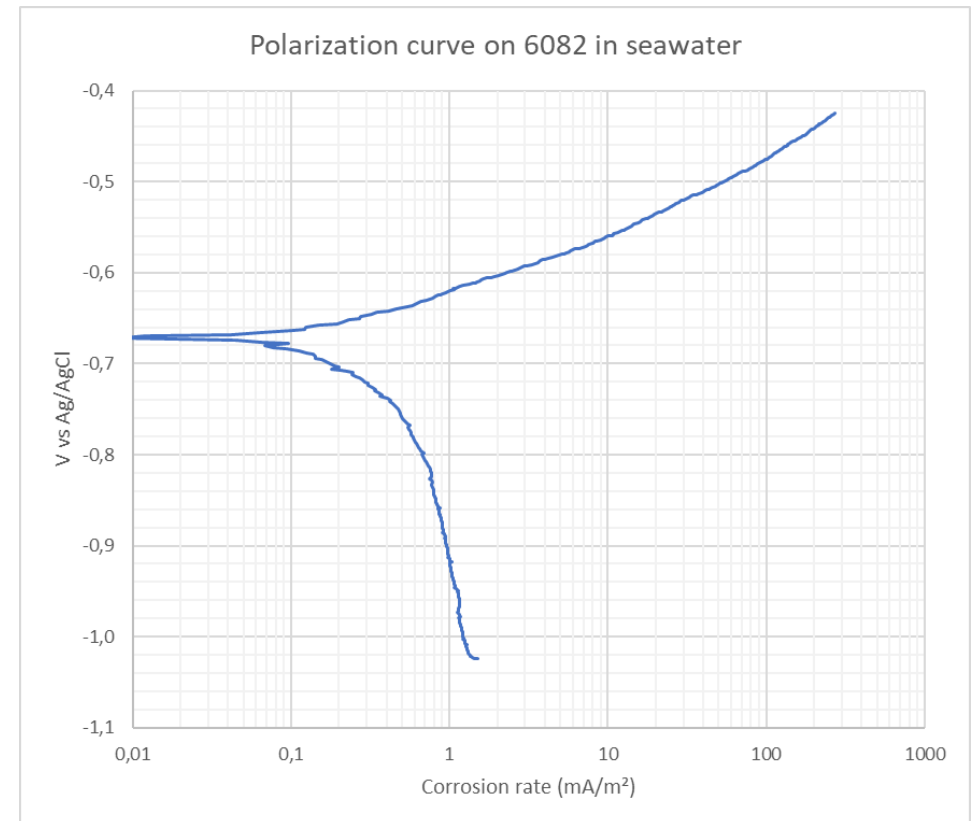
Galvanic corrosion

- Pitting potential for aluminium alloys is about $-0,7\text{ V}$ (Ag/AgCl reference)
 - Corrosion potential of steel in seawater:
 - C-steel: about $-0,6\text{ V}$
 - Stainless steel: about 0 V
 - Galvanic coupling to steel will polarize the aluminium above the pitting potential
- ➔ galvanic corrosion

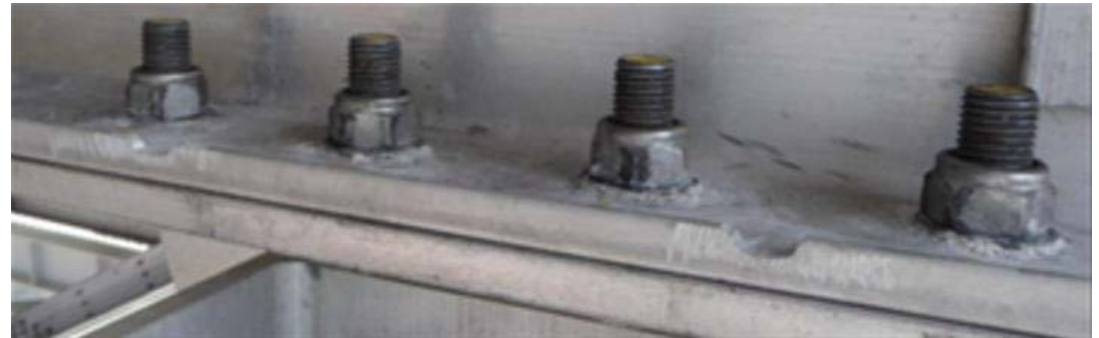
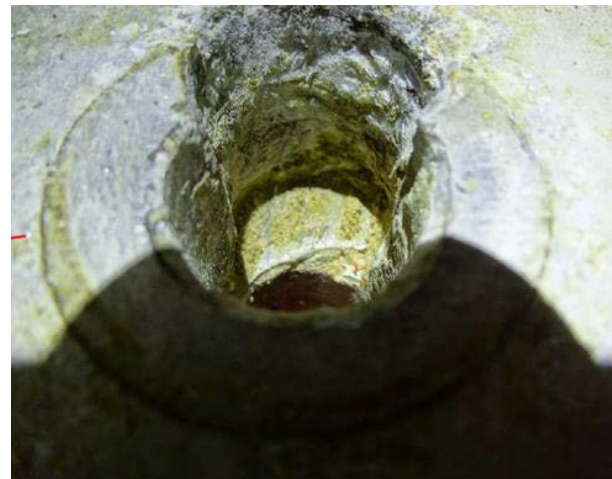
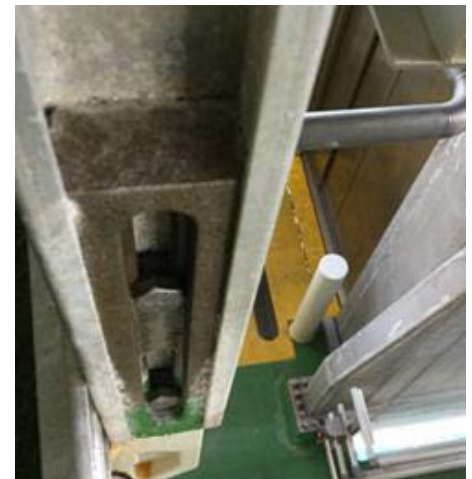
Galvanic corrosion in atmospheric conditions

- Designs where water may accumulate on the aluminium
 - Vertical lip on horizontal flange
 - Bolt holes that eventually fill with water
 - Non-draining surfaces
- Stagnant salt water on aluminium results in acidification (pH about 4) and corrosion

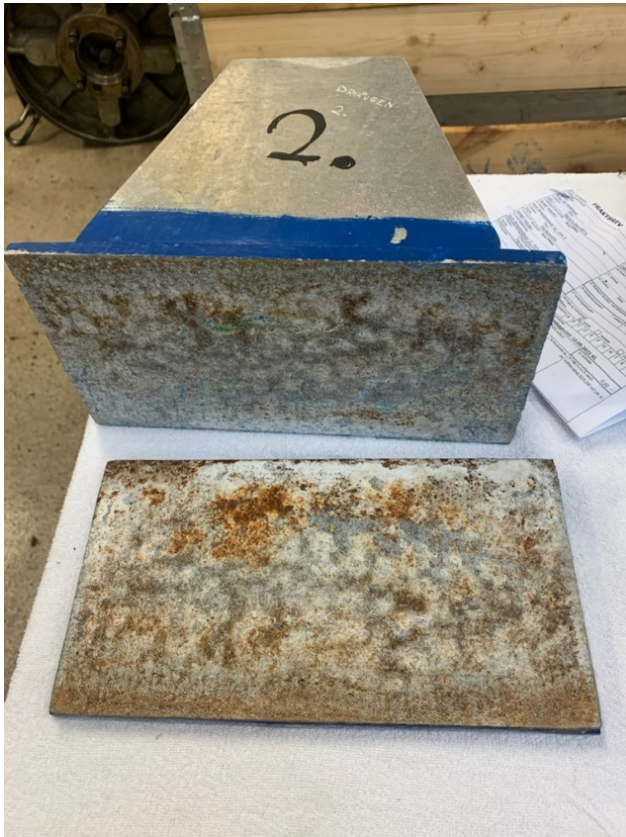
Galvanic corrosion in Al-steel explosion weld

Fracture along the weld interface

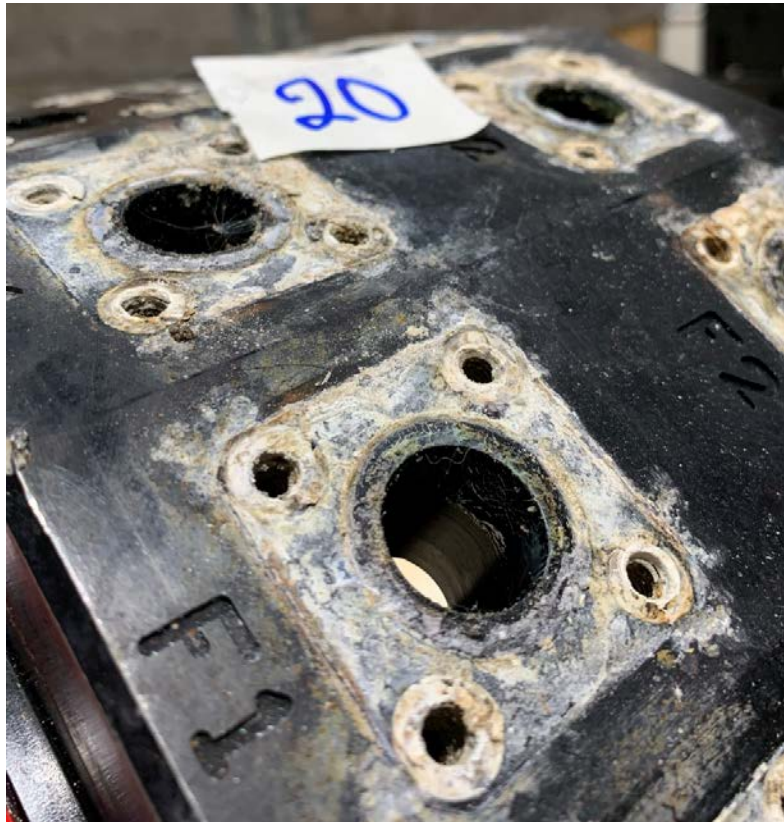
Galvanic corrosion in submerged conditions

- Aluminium parts on subsea ROV
- Stainless steel parts mounted on anodized aluminium (thick film anodized, 50 μm)
- Corrosion in the crevices
- CP probably not able to penetrate the crevice due to high resistance

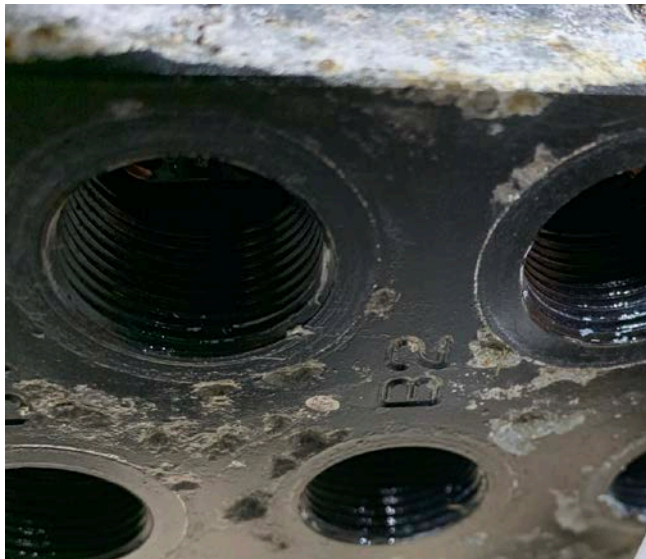
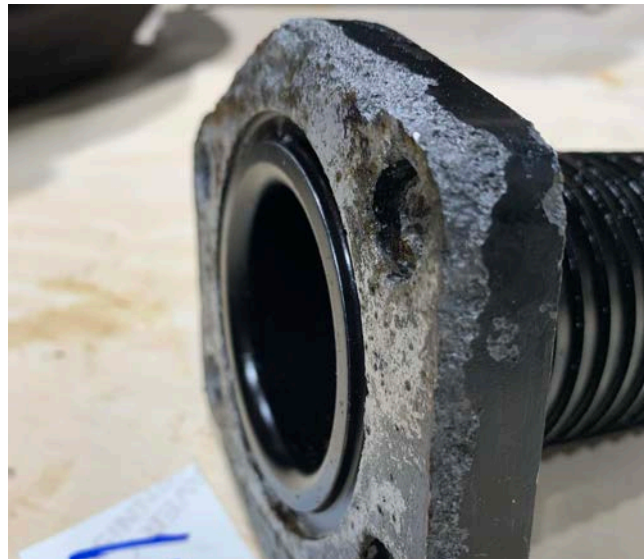
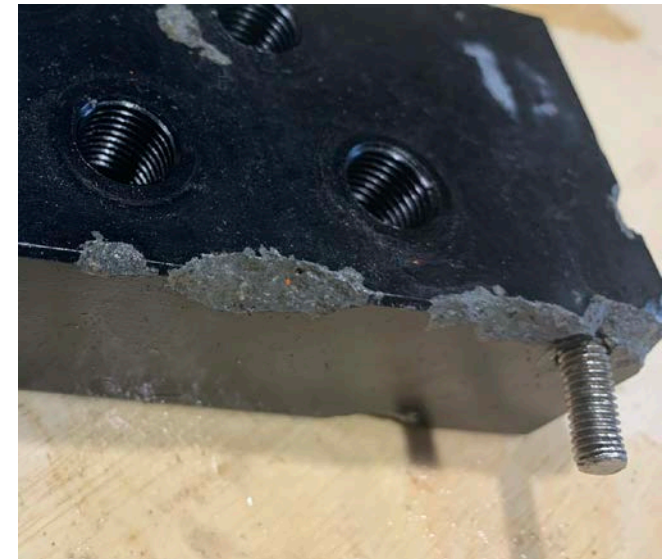
Galvanic corrosion in submerged conditions

- Galvanic corrosion in damages/weaknesses in anodized layer
- No cathodic protection? Severe attacks locally
