MonArc Project Report 2018

Monitoring of Arctic Infrastructure
(MonArc – project duration 2017-2019)

KEYWORDS:
 Infrastructure,
 permafrost,
 foundations,
 monitoring, climate
 change, Svalbard, Arctic.

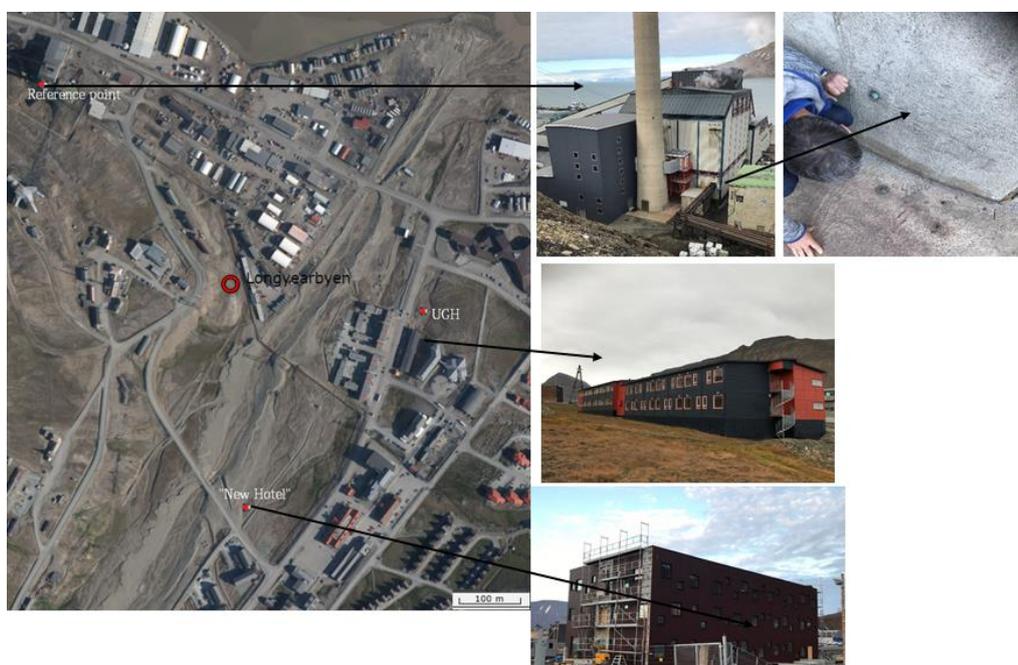
Monitoring continued as planned in Longyearbyen, addressing the UNIS Guest House and The Vault Hotel as in 2017, and using the same fixed point (a bolt on the Power plant). The monitoring objects are depicted in (Figure 1).

Figure 1. Points for survey in Longyearbyen.

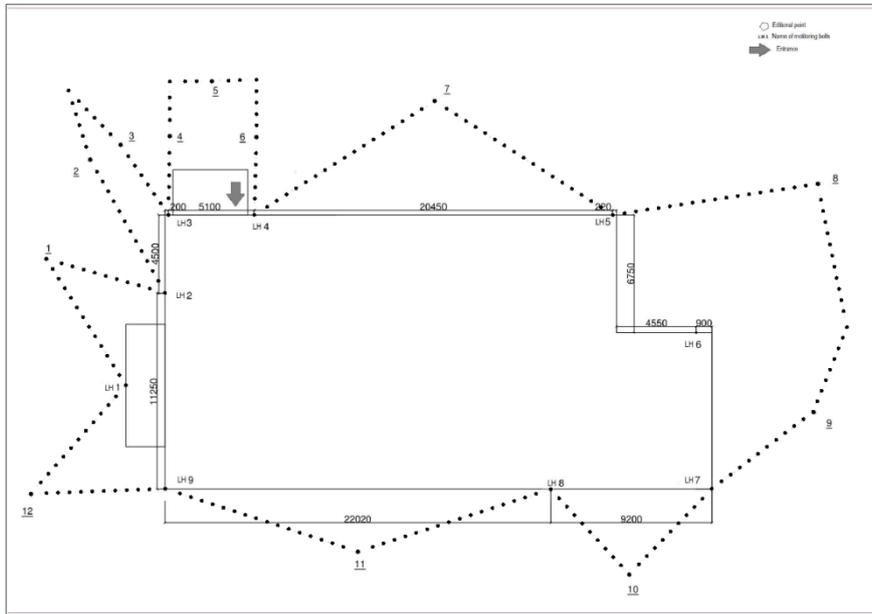
Monitoring bolt LH 6 at The Vault Hotel was excluded from the measurements as it was not possible to get access with the measuring due to new elements of the drainage system. A modified monitoring plan at The Vault Hotel is presented in Figure 2.

Figure 2. Sketch of monitoring positions at The Vault Hotel (showing locations of bolts and leveling stations).

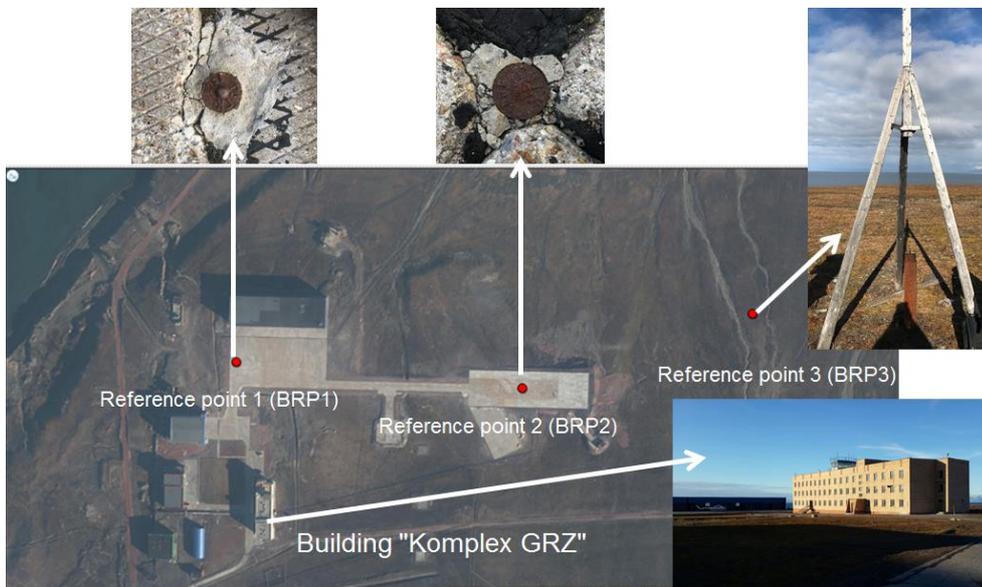
The three-story building "Komplex GRZ" and the three reference points (2017) remained in the monitoring program in Barentsburg (Figure 3).

Figure 3. The three-storied building "Komplex GRZ" and location of the reference points.

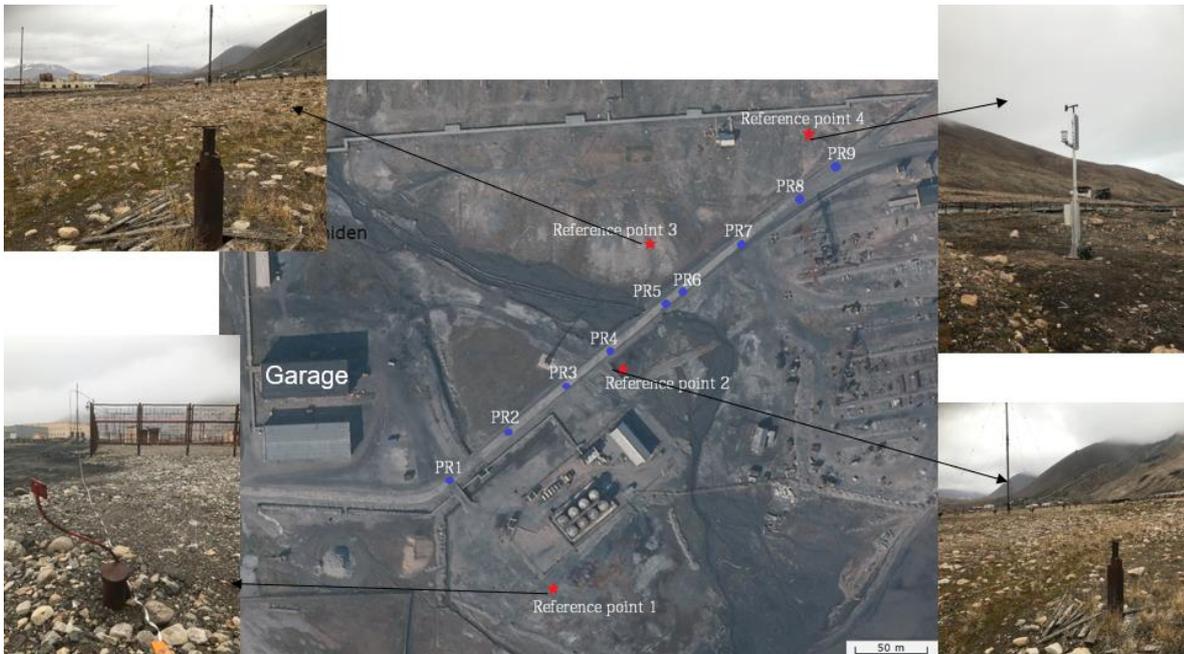
The four reference points from 2017 remained in Pyramiden. An additional "Reference point N5" was established close to the Reference point 4. Seven monitoring points remained on the road (from the garage to the Reference points 3 and 4), monitoring points PR1 and PR2 (on the road) were excluded from

monitoring work as the bolts at these locations was damaged/ lost (probably due to snow cleaning during winter). The multi-purpose garage (Figure 4) was monitored again.

Figure 4. Locations of the monitoring objects in Pyramiden: the multi-purpose garage, reference points, and monitoring points on the road (PR1–PR9).

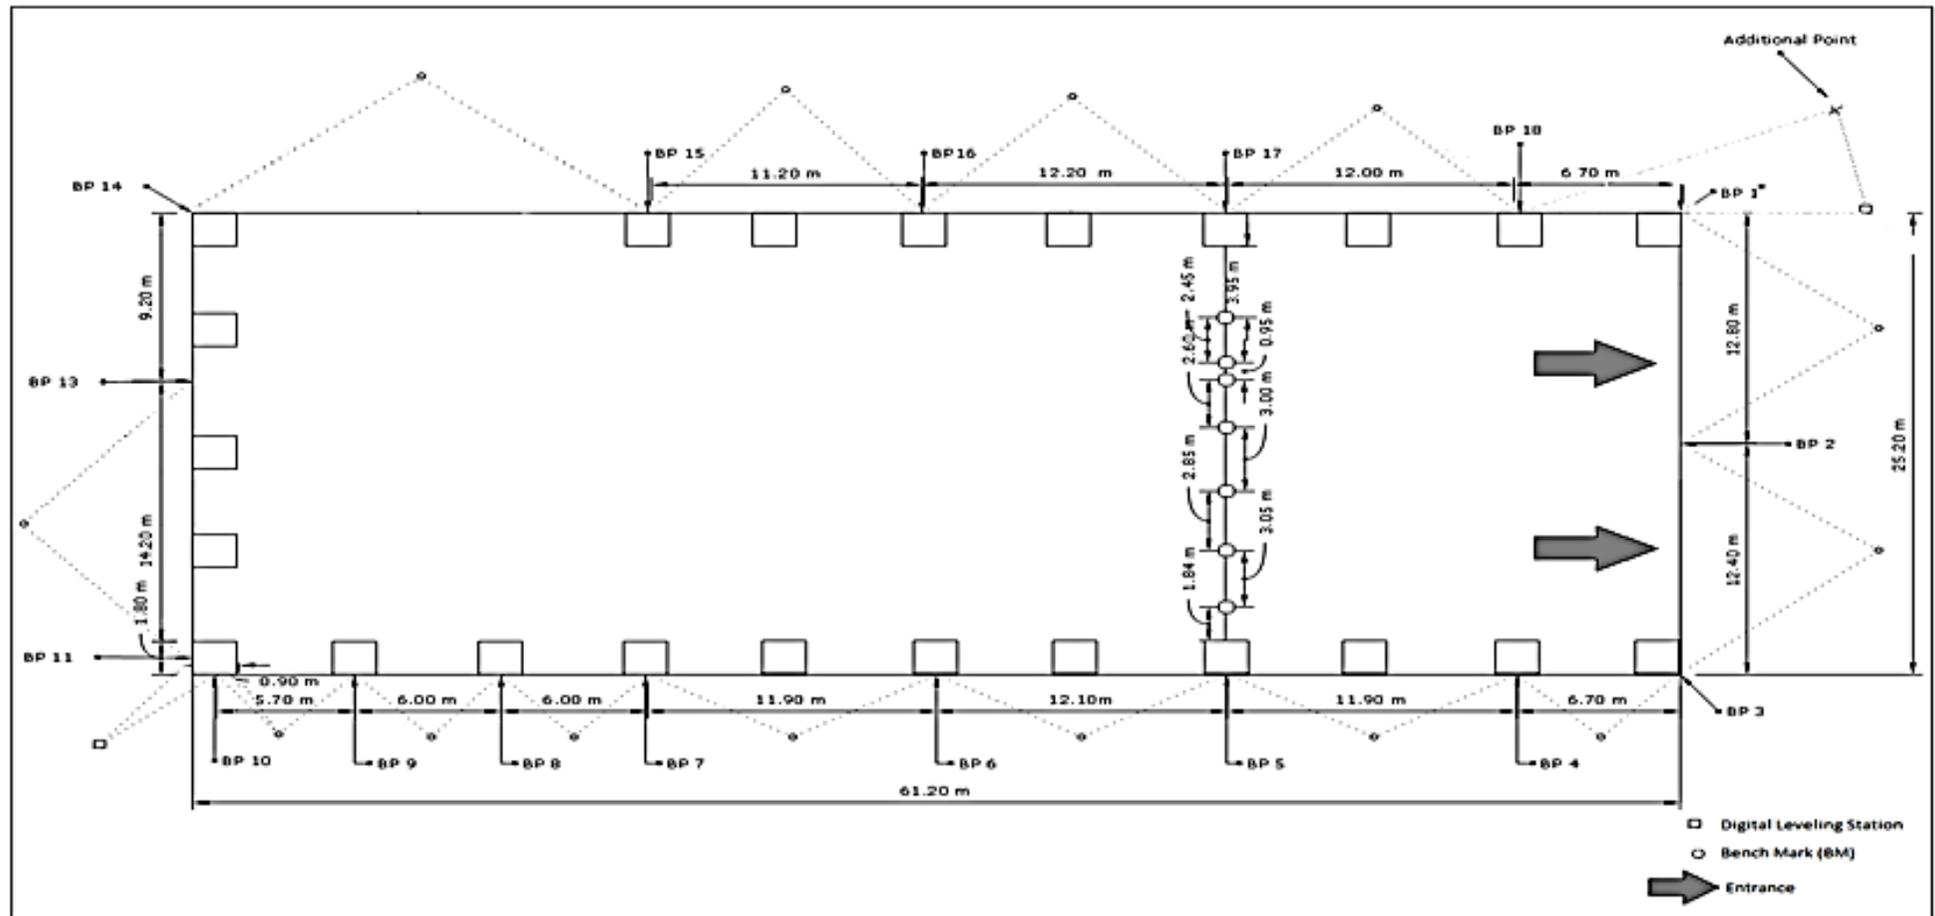
Geodetic track around the multi-purpose garage was divided in two parts (the right and the left track). The following monitoring bolts were excluded from the monitoring due to lack of access: PB1, PB10*, PB12. A new bolt "PB1*" was installed above the location of the previous PB1, which had disappeared (see Figure 5).

Figure 5. Sketch of monitored points and tracks at the multi-purpose garage (locations of bolts and leveling stations).

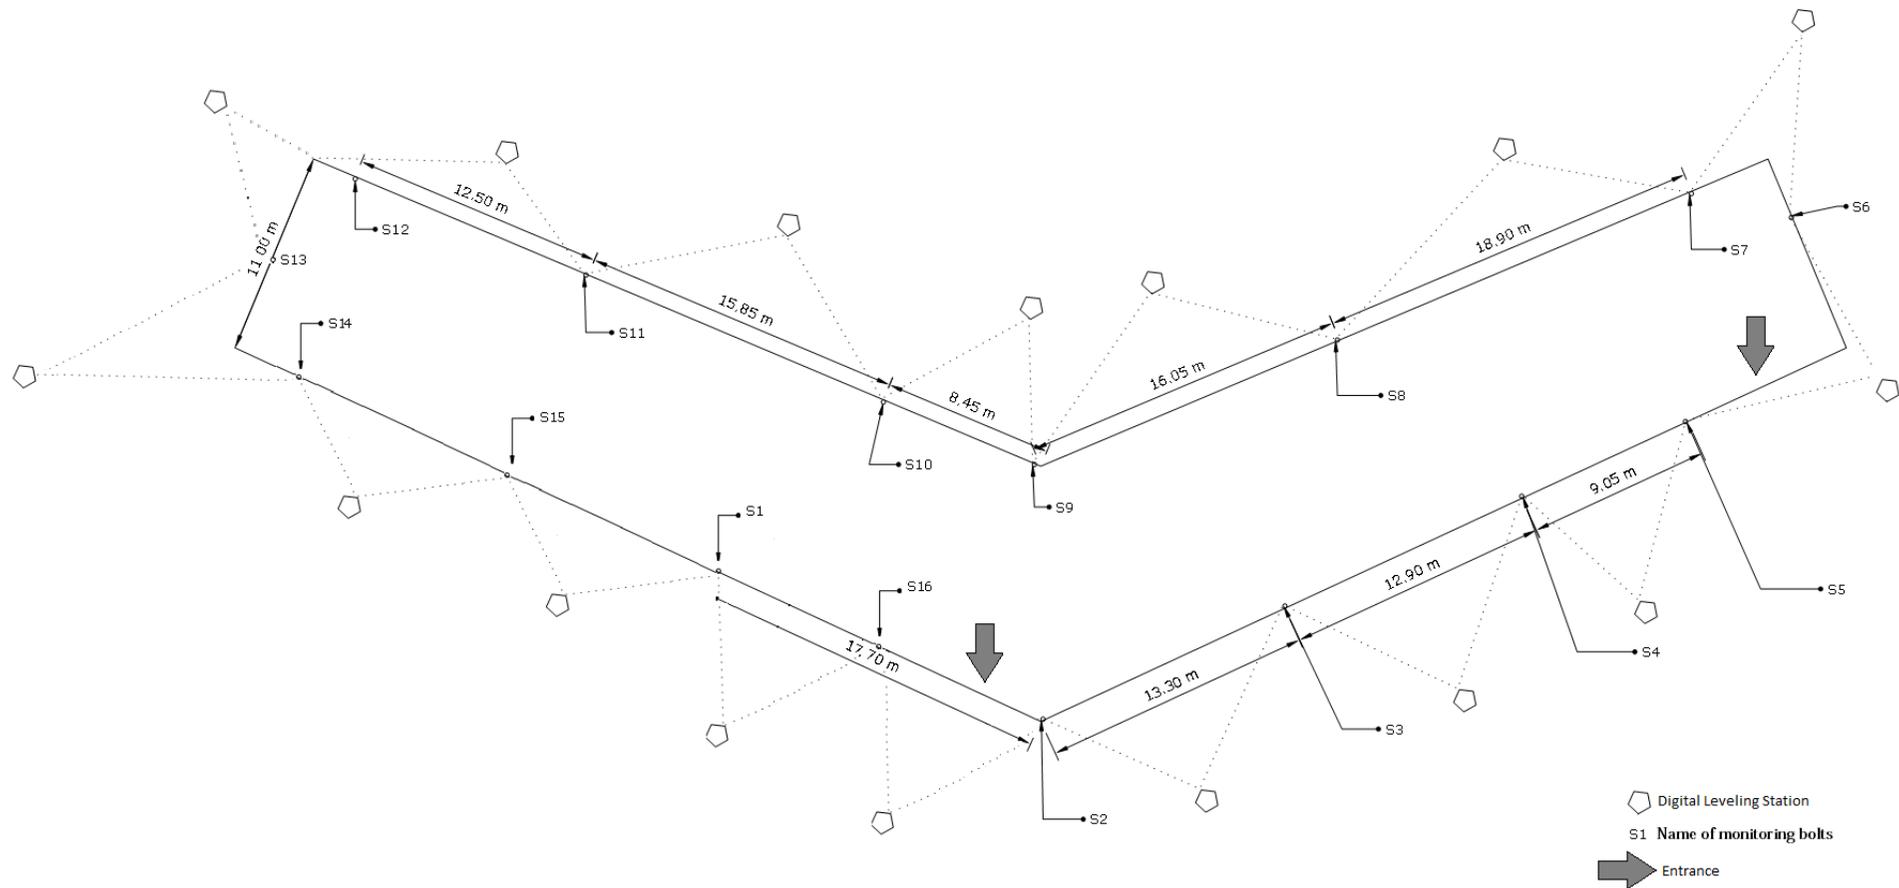
Two additional monitoring bolts (S13–S16) were added and surveyed at the barack "Låven" (Figure 7).

Figure 7. Locations of bolts and leveling stations at the barack "Låven".

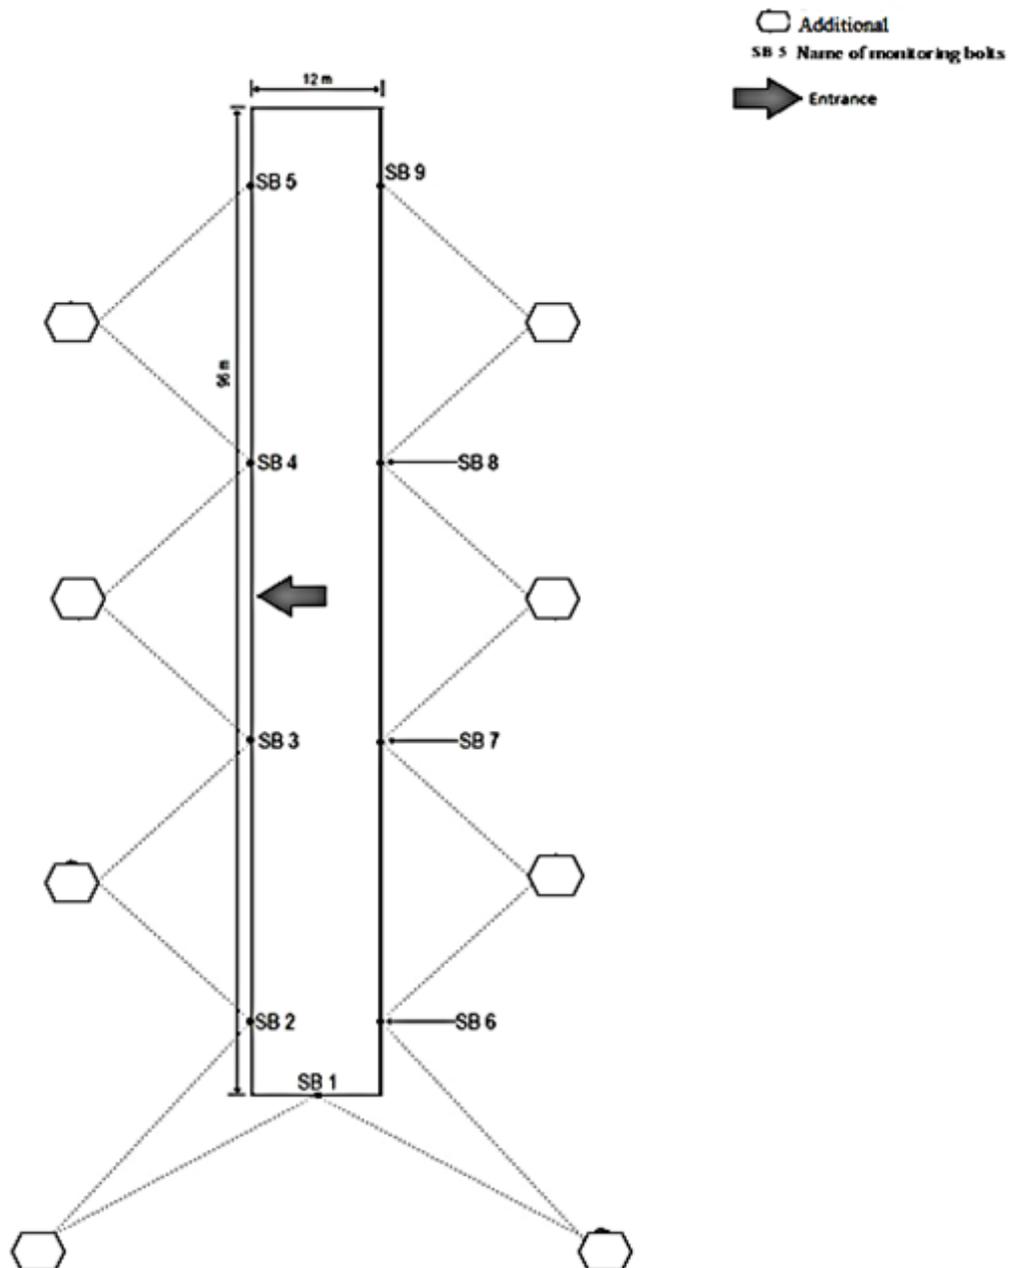
Barack "2002" was surveyed for the first time, with the setup as shown in Figure 8. The height measurements were performed in relation to the reference point mentioned above.

Figure 8. Locations of bolts and leveling stations at the barack "2002".

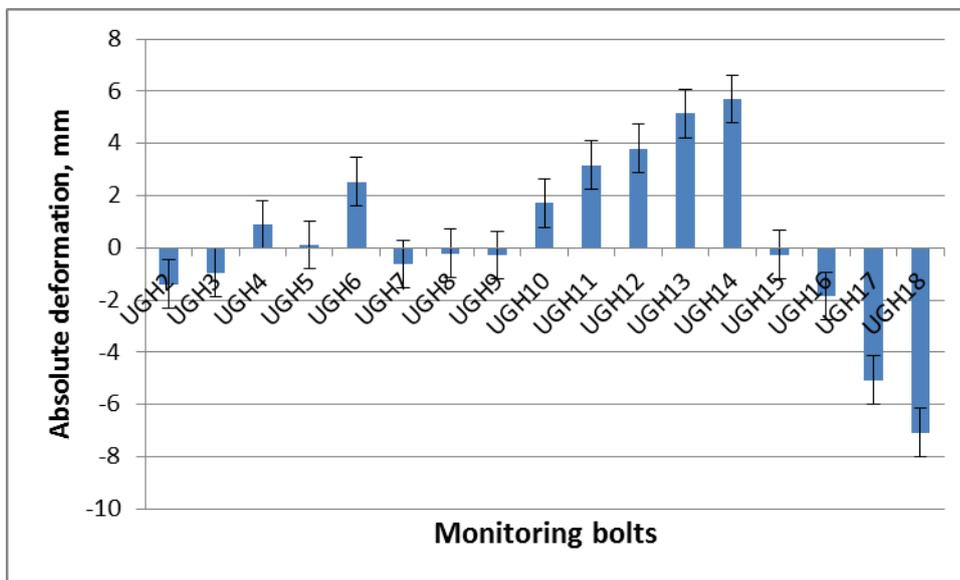
The reference points in Longyearbyen did not change their position over the 2017–2018 (fixed points were stable). Stationary points were not installed on the road from the reference point (LRP1 1) to UNIS Guest House (UGH 1) due to practical issues, hence accuracy of measurements was different in 2017 and 2018. In 2017, the standard error m_{2s} on the road was 1.22 cm, and difference of measurements in both directions was 0.6 cm. survey was conducted according the 3rd class of accuracy. In 2018, survey was conducted according to the 1st class of accuracy. Hence, it is not possible to define the change of elevation of the monitoring point UGH 1. In present assessment, position of UGH 1 is assumed to be stable between 2017 and 2018, and equal to the value obtained in 2018. This can be the reason that the elevation of some of monitoring points increased, which practically means that the pile foundations are lifted up (see Figure 9).

Figure 9. Absolute displacement of monitoring bolts at UNIS Guest House in 2017–2018.

Presented displacements of monitoring points at UNIS Guest House and The Vault Hotel should be considered as estimates only, a confirmation and possible more accurate data are expected to be obtained in the 2019- field season.

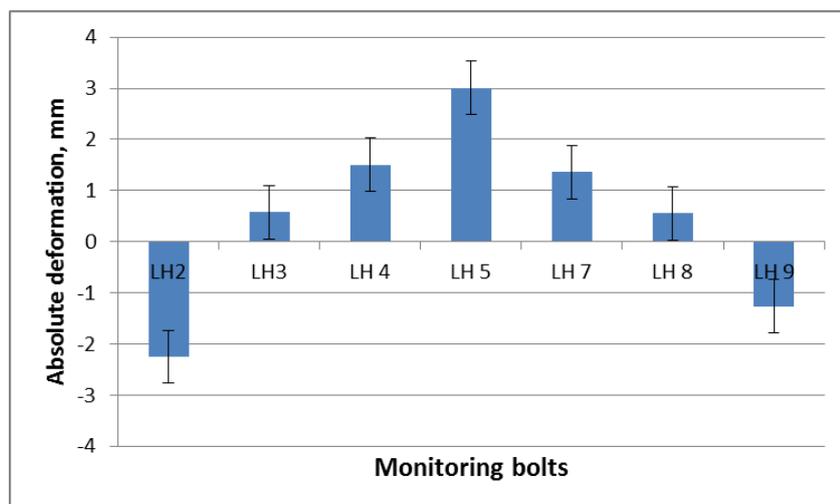
Similar results were obtained for monitoring point LH 1 at The Vault Hotel, where difference of measurements (in back and forth directions) is higher than the standard error. Elevation of LH 1 is assumed to be stable in 2017–2018. Displacements of several monitoring points at The Vault Hotel have positive values (Figure 10), which signalize that the pile foundations are lifted up.

Figure 10. Absolute displacements of monitoring bolts (and errors of measurements) at The Vault Hotel in 2017–2018.

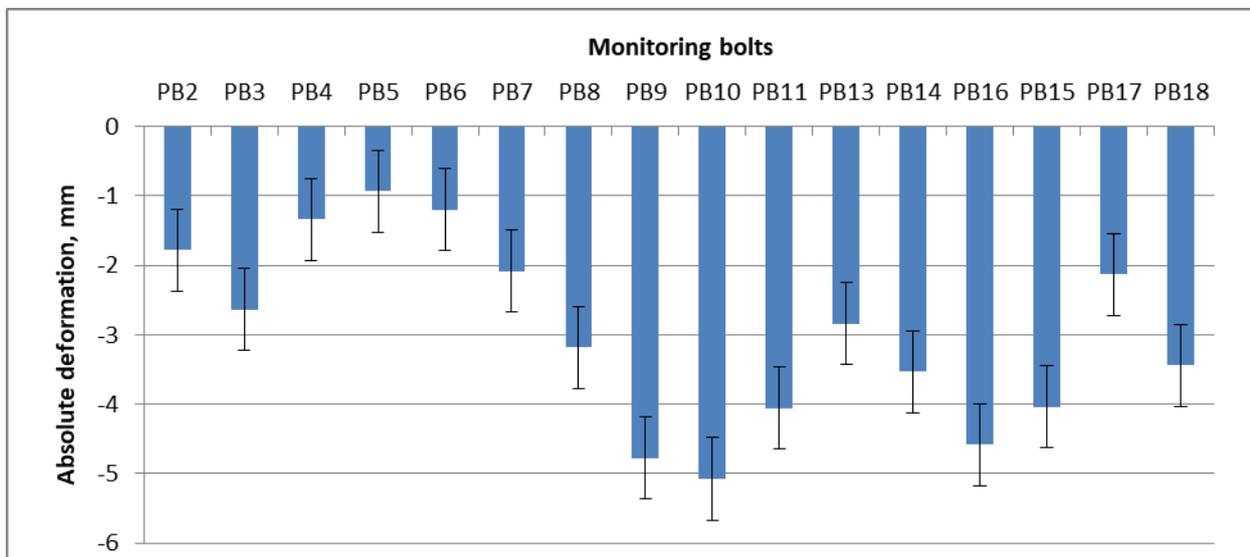
* – these values were obtained with inverted bar staff, hence a difference of 20 mm was introduced. This value of 20 was taken into account to calculated absolute values of displacements for the points PB11, PB13 presented in Figure 11.

** – these values include heights of the base plate, which is 60 mm; thickness of the base plate was taken into account to calculate the absolute values of displacements for points PR3–PR8 presented in Figure 11.

Assessment according to (3) showed that only the reference points PRP1 and PRP4 were stable; and PRP2 and PRP4 were not. Hence additional reference point PRP5 was established for future surveys and comparisons. Absolute displacement of the monitoring points on the outer walls at the multi-purpose garage is presented in Figure 11. The Direction of the bar staff was changed on inverted (i.e. the bar staff was turned on the upside down) on the points PB11, PB13. Hence the difference of measurements (which equals to the diameter on monitoring bolt) was taken into account on Figure 11. One can see that the highest displacement is at the monitoring points PB9–PB11, where the drainage of water (collected on the roof) goes into the ground. Another area with large settlements is at the points PB16–PB19, this may be caused by a heavy tank installed inside on the building close to these points.

Figure 11. Absolute displacements of monitoring points (and errors of measurements) on the outer walls at the multi-purpose garage in Pyramiden.

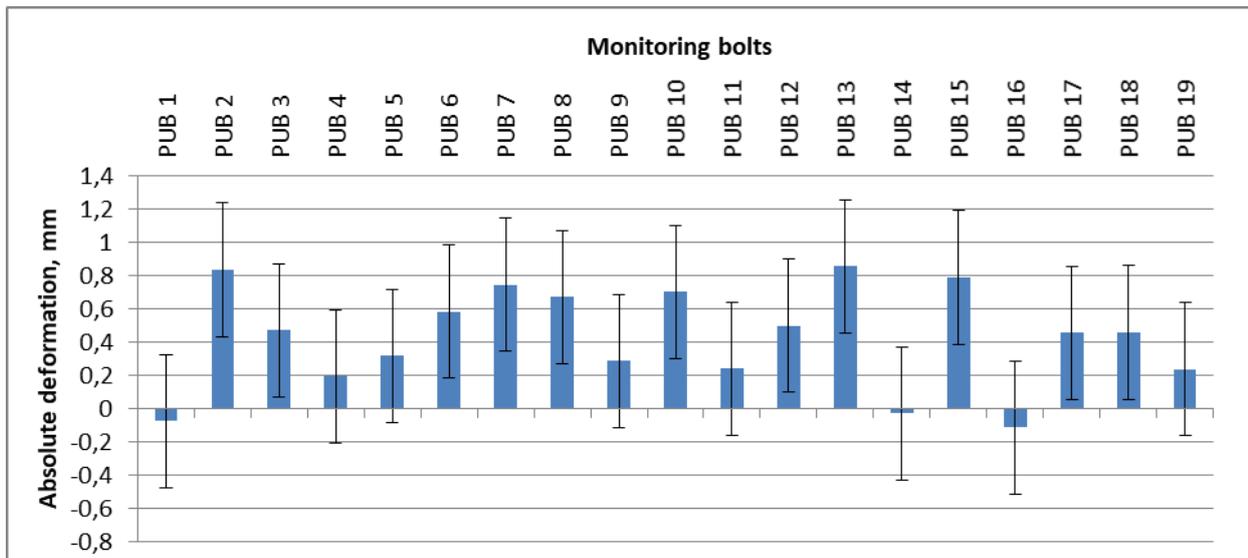
Absolute displacement and errors of measurements of the monitoring points under the multi-purpose garage are presented in Figure 12. Standard errors were not assessed in 2017, hence the presented 2017–2018 comparison can serve as an estimate only. However, it seems as the settlements under the central part of the garage are smaller than at the outer walls.

Figure 12. Absolute displacements and errors of measurements of the monitoring points under the multi-purpose garage in Pyramiden.

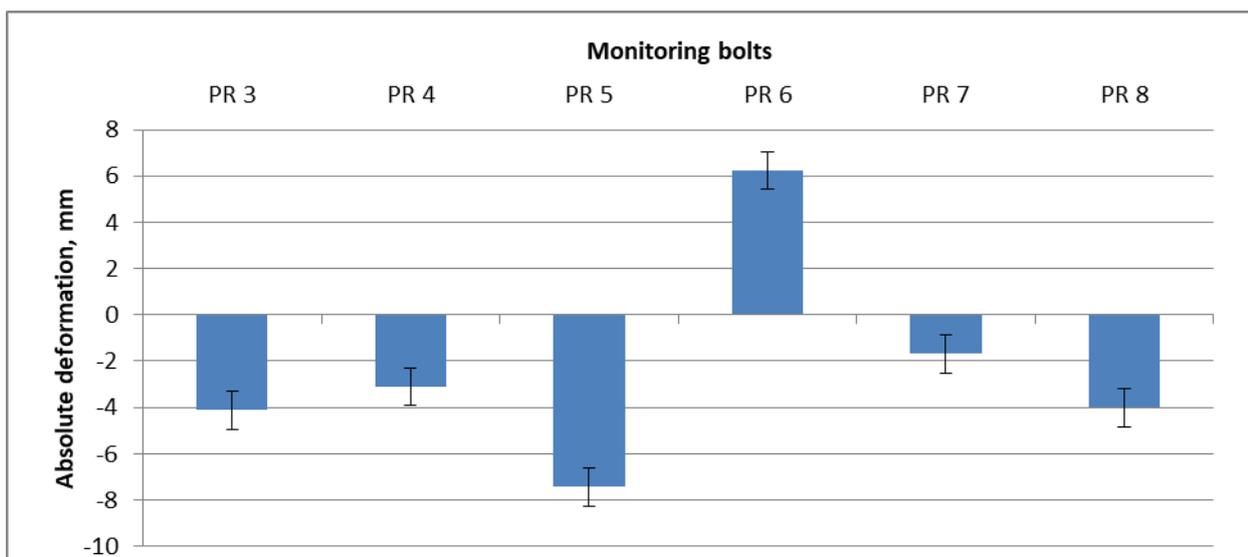
Absolute displacement and errors of measurements on the road from multi-purpose garage to the reference points is presented in Figure 13. During the 2017 survey, the bar staff was placed on a base plate, in 2018 the bar staff was placed directly on the monitoring bolts. Occurred difference in measurements was included in calculations. Largest displacement (settlement) found on the road is 8 mm. Also, heave of the road was detected near the point PR 6, which can be caused by water flow in a drainage culvert nearby this point.

Figure 13. Absolute displacement (and errors of measurements) of monitoring bolts on the road from multi-purpose garage towards the reference points.

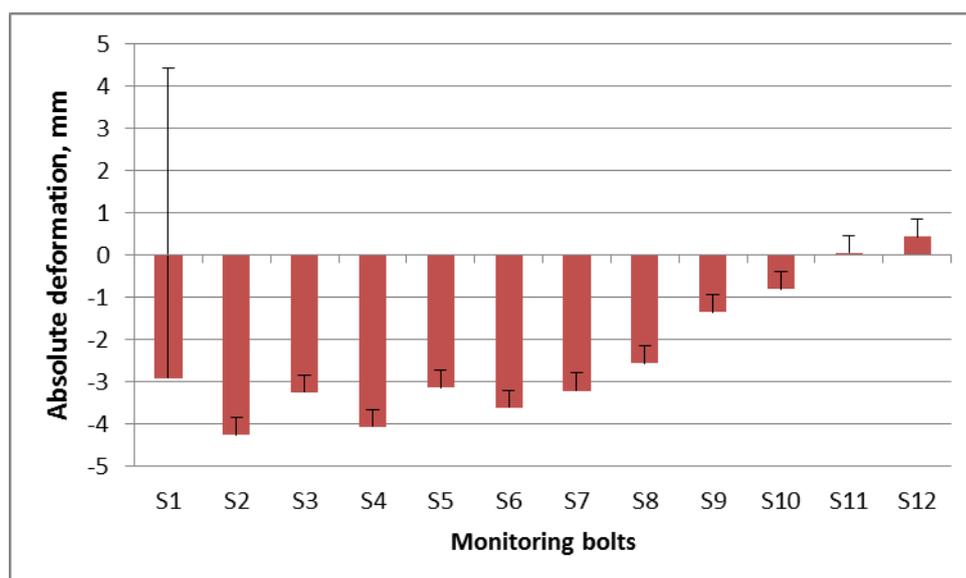
The standard error is higher than the difference of measurements (in back and forth directions) for the first monitoring point (S1). Displacements for the barack "Låven" are presented in Figure 14. One can see that most of the monitoring points have settled (except S1), and the settlements do not exceed 4 mm.

Figure 14. Absolute displacements (and errors of measurements) at the barack "Låven".

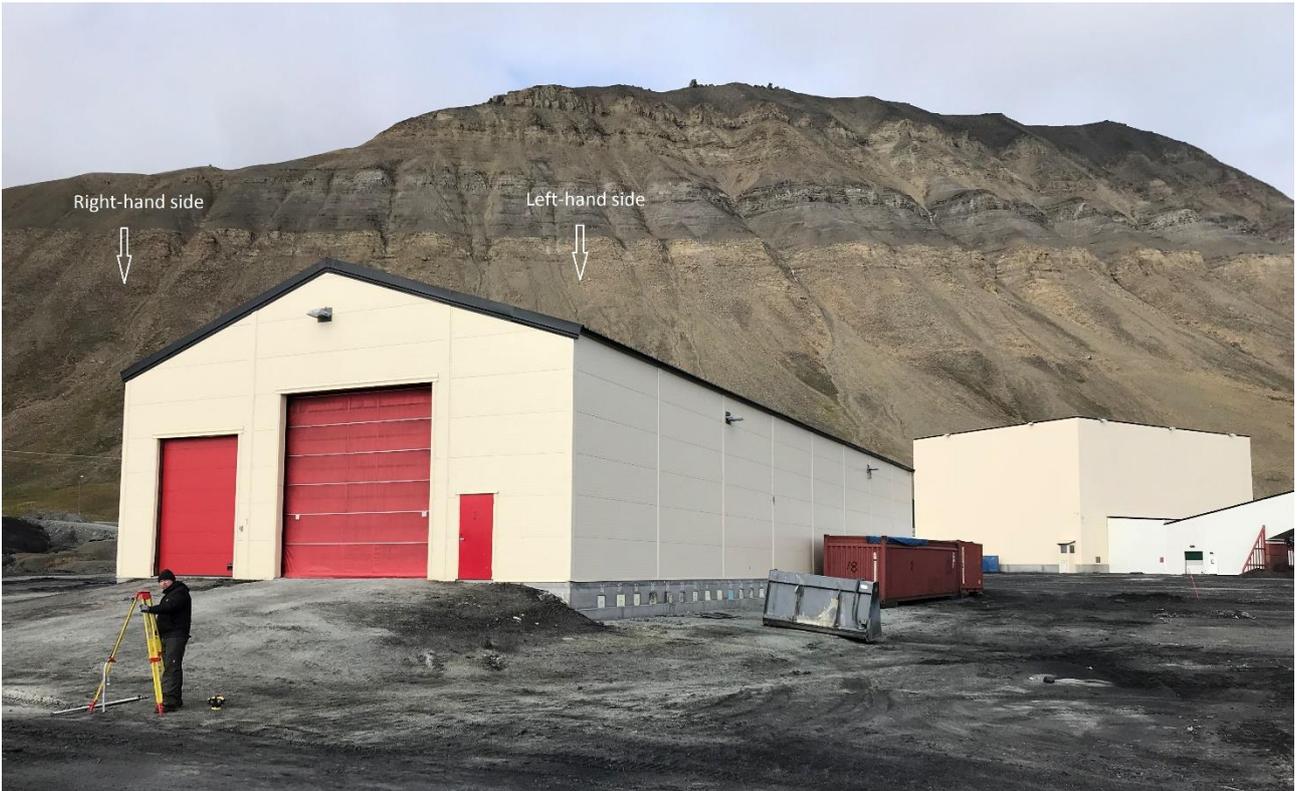
Multi-purpose garage “Magnetittlageret” is located on a shallow concrete foundation (thick plate), which has several parallel ventilation channels going across the building length axis (see Figures 18–19 in [1]). We measured the settlement of the foundation relative to the foundation surface of the first channel (i.e., top of the channel). Each side of the garage (Figure 15) was measured separately. Elevations of monitoring points relative to the first points on each side of the garage for 2017–2018 are presented in Figure 16–Figure 17.

Figure 15. Multi-purpose garage “Magnetittlageret”.

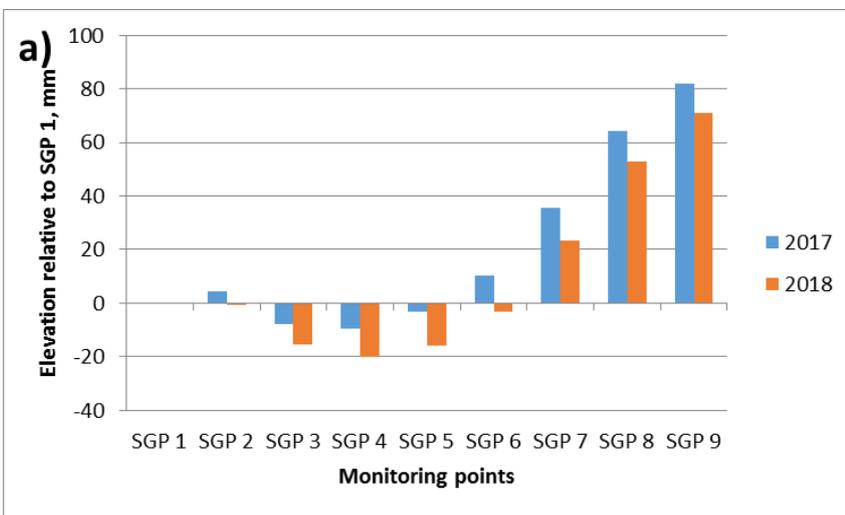
Figure 16. Displacements (SGP 1–SGP 9) at right-hand side of multi-purpose garage “Magnetittlageret”.

One can see significant differential vertical displacements on both sides of the garage. Largest displacements are noted on the right-hand side when one facing the entrance (towards the airport) of the garage side and vary from 5 to 13 mm, displacements for the left-hand side vary from 3 to 11 mm.

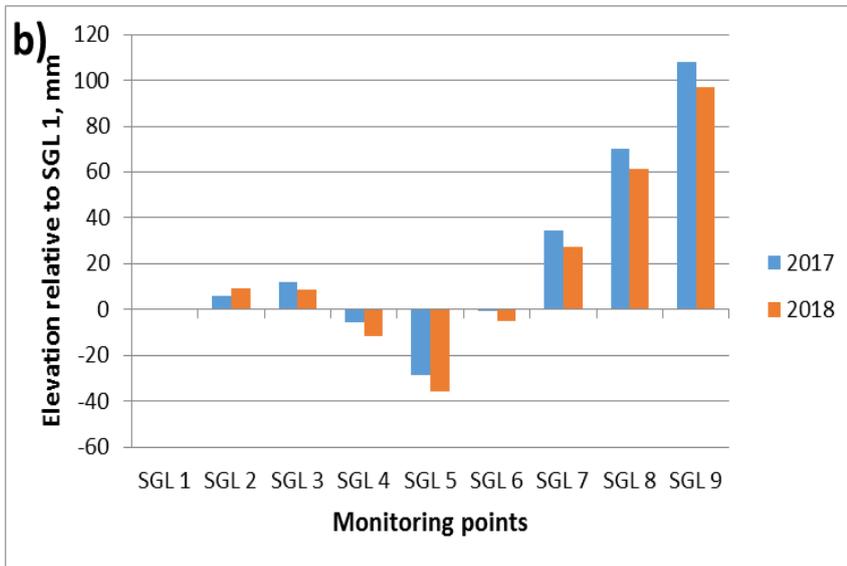
Figure 17. Displacements (SGL1–SGL 9) at left-hand side of multi-purpose garage “Magnetittlageret”.

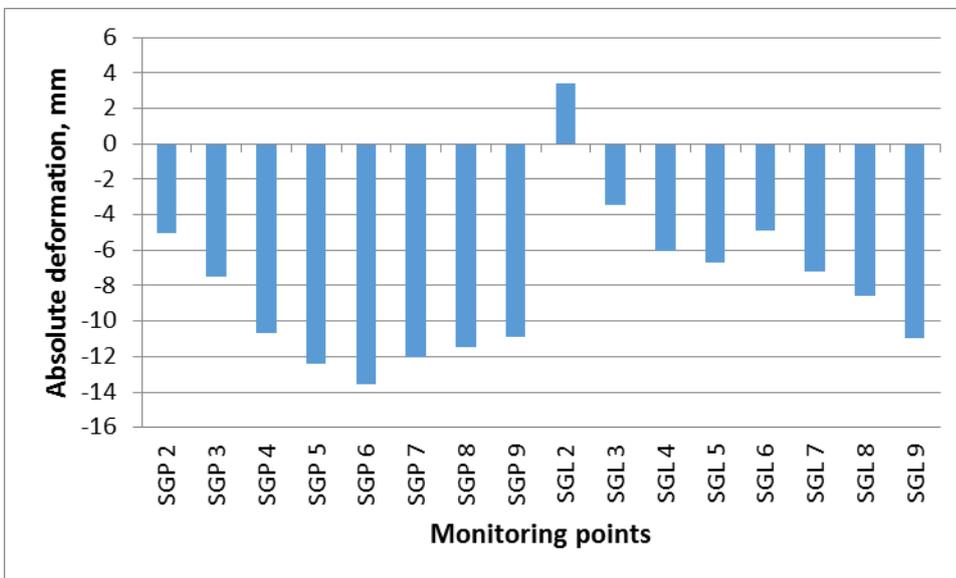
Absolute displacements on both sides of the garage are presented in Figure 18.

Figure 18. Absolute displacements of the monitoring points at the multi-purpose garage “Magnetittlageret”.
