RISK OF NATURAL HAZARDS ON TECHNICAL-INDUSTRIAL CULTURAL HERITAGE IN SVALBARD

Probability analysis including considerations for climate change

Lappeenranta–Lahti University of Technology LUT
Master's Programme in Circular Economy, Master's thesis
2023

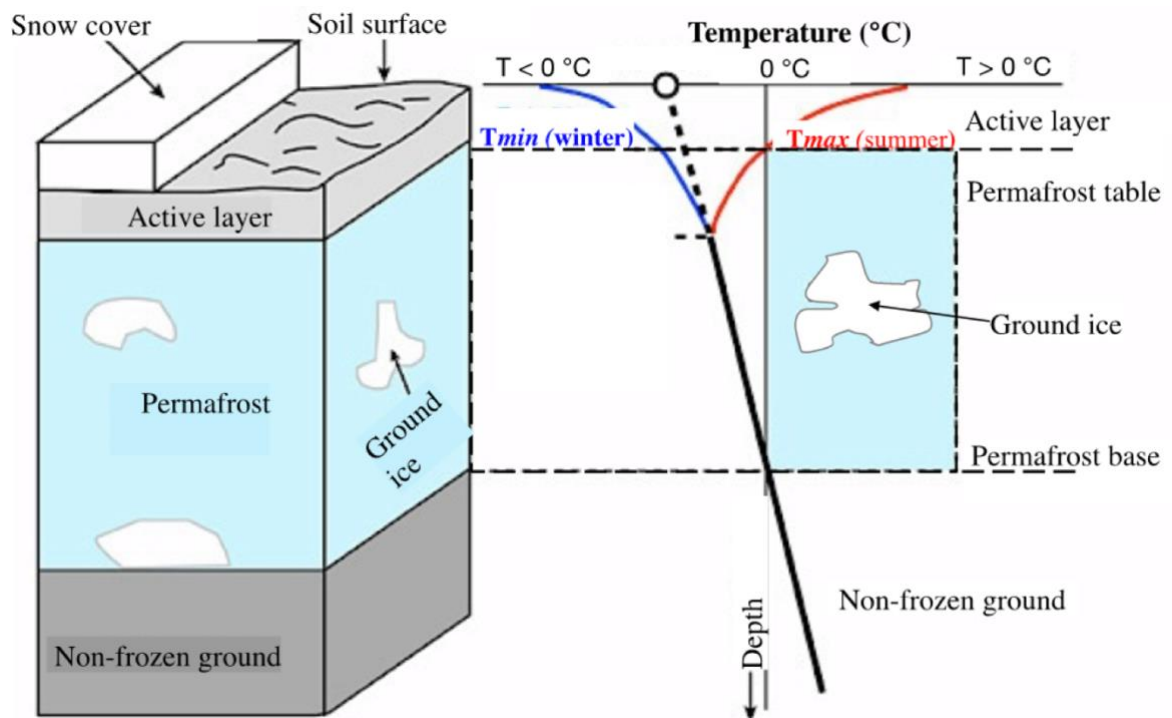
Figure 2. Illustration of permafrost ground thermal regime. Permafrost regime consists of a layer of frozen ground (light blue) surrounded by seasonally frozen and non-frozen ground (grey). The surface layer, known as active layer (light grey), is affected by the seasonal variation in air temperature (represented by the black line, with blue and red indicating seasonal temperature curves). Permafrost may contain clusters of ground ice (white). From Matveev (2019).

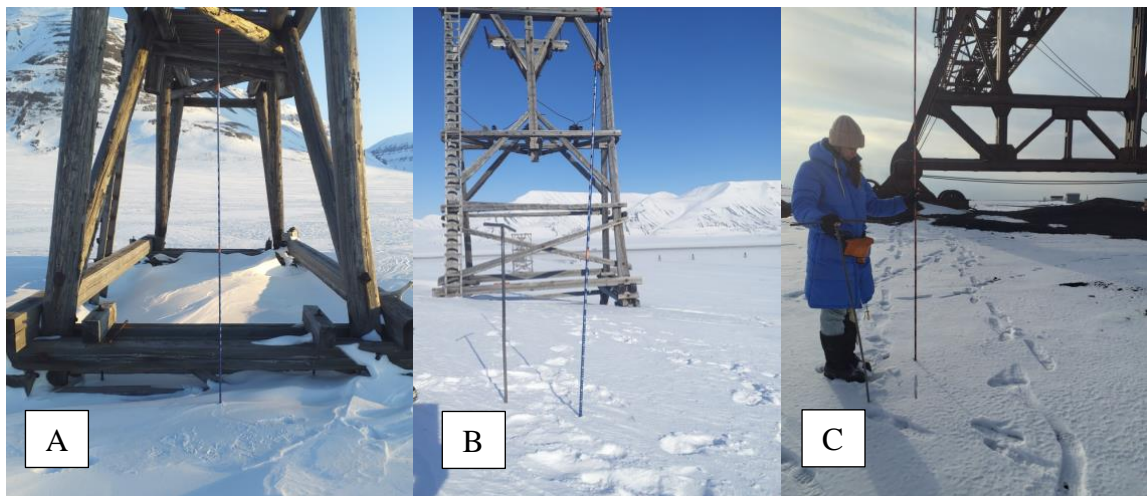
Figure 6. Snow depth measurements taken using two different types of probes: an avalanche probe (pictured in A, B, and C) and a thicker iron active layer probe (visible in B and C). Photos by Peter Hamrock and the author.

The objects inspected during the fieldwork were the case study objects identified by the PCCH-Arctic project (Appendix 1). Furthermore, Cable car line 6 was studied in detail by taking measurements from every 5th Cable car post, and additional measurements were also taken from Cable car line 5-6. The snow depth data collected will be used to identify any patterns or trends in snow accumulation and snow depth. Snow thickness can be linked to permafrost degradation for the cases where there are ground depressions around the CH objects, as they can accumulate water and thaw the permafrost even more. Snow depth measurements can be found from Appendix 2.

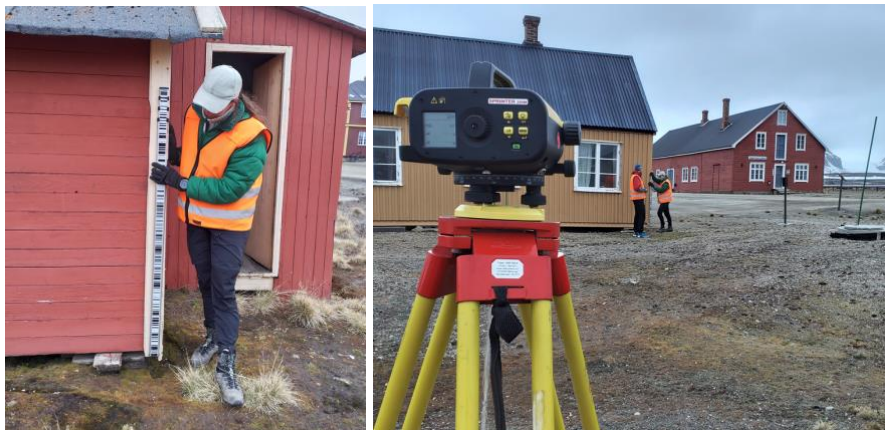
Figure 8. Laser level measurements in Ny-Ålesund. Photos by Noemi Pasquini.

Fieldwork was conducted in Ny-Ålesund from June 22 to June 26, 2023, to measure the foundations of selected CH objects, including Green Harbor House, London Houses, Post House, and the Airship Mast, using a laser level (Figure 8). The primary goal was to assess the settlement of these objects on permafrost, and the levelling data collected during this fieldwork established the first ever baseline measurements for these objects.

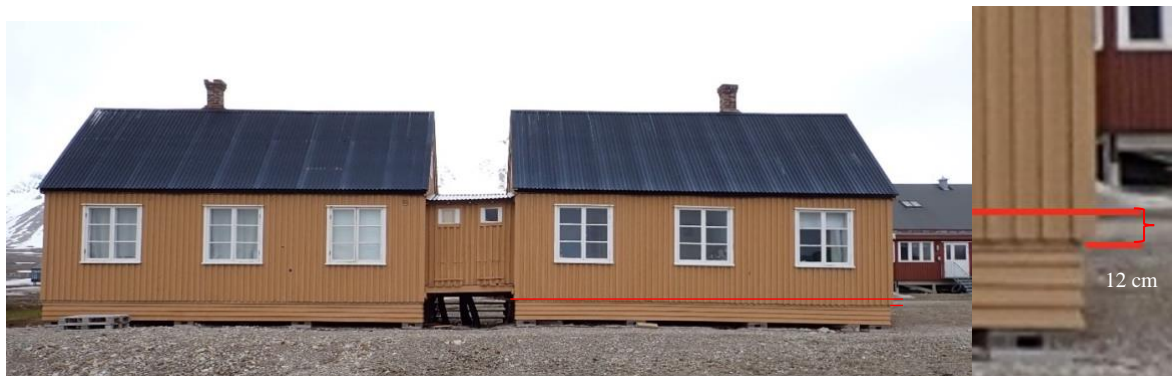
Figure 9. Settlement at London houses in Ny-Ålesund. Photo by Anatoly Sinitsyn/SINTEF.

While the data cannot yet be utilized to explain the year-to-year settlement patterns of the objects on permafrost, it does reveal differences in the foundations from one corner to another within the same building, forming the basis for evaluating the geotechnical performance of the foundations. For instance, in the case of London House 1, which underwent renovation and levelling in 2010, the northwest corner is 12 cm lower than the northeast corner (Figure 9). According to general guidelines regarding structures on

permafrost, over 10 cm settlement in the foundation after 30 years of load application is regarded as a foundation failure (Instanes, 2017). Hence, the 12 cm level difference observed for London House 1 over a mere 13-year period is clearly unacceptable. Additionally, settlements of foundations have the potential to cause ruptures in the connected piping system, impacting both drinking water and sewage. A rupture of a drinking water pipe can contribute to permafrost degradation due to water flow, leading to further settlement in the foundations, while a rupture of a sewerage pipe can pose significant health risks.

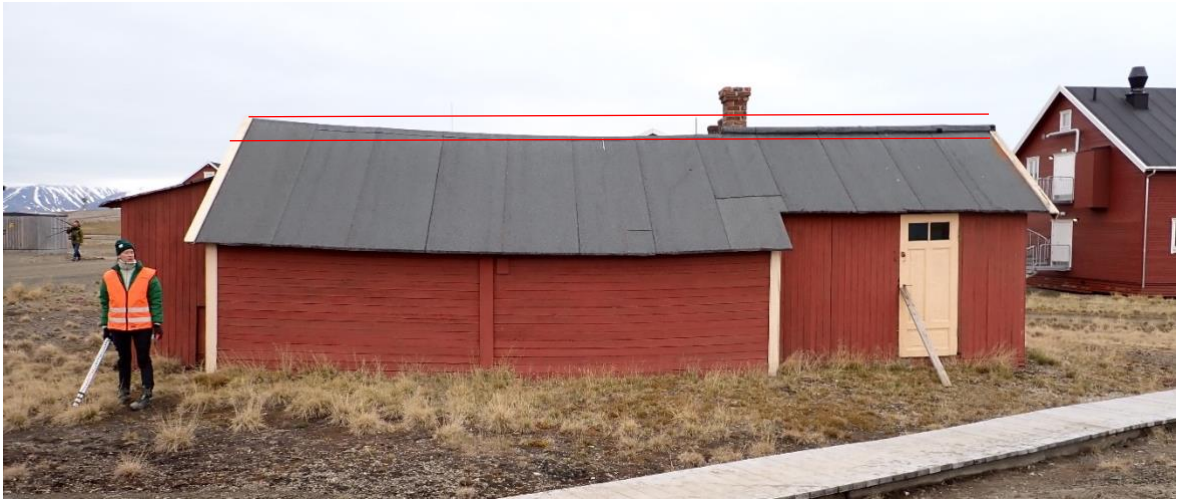
Figure 10. Differential settlements of Green Harbour House in Ny-Ålesund, June 23, 2023. Photo by Anatoly Sinitsyn/SINTEF.

Visual observations of Green Harbour House revealed that there were both settlement within the building and settlement in the surrounding terrain (Figure 10). Settlements within the house can be attributed to two factors: rot decay of timber in the foundation, particularly the frame positioned directly on the ground. Surrounding terrain is settled because of permafrost degradation, which is likely influenced by uneven snow accumulation around the house.

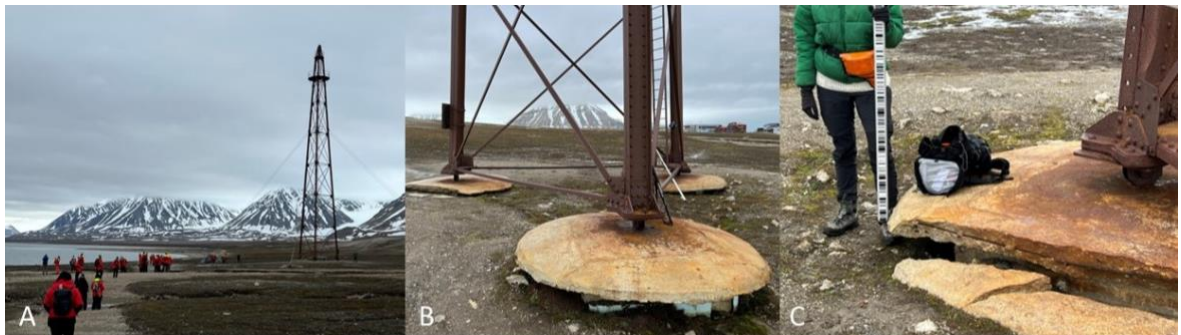
Figure 11. Terrain settlements at Luftskipsmasta, June 26, 2023. Photo by Anatoly Sinitsyn/SINTEF.

Observations and measurements at Luftskipsmasta (Figure 11) revealed terrain settlements around of 20 cm. It, however, does not seem that the active layer has reached the bottom of the foundation. Reported depth of active layer thickness in the area (Byelva) increased from 180 cm to 200 cm during the last decade (Hanssen-Bauer et al., 2019), which creates significant concern on the stability of Luftskipsmasta in the nearest future.

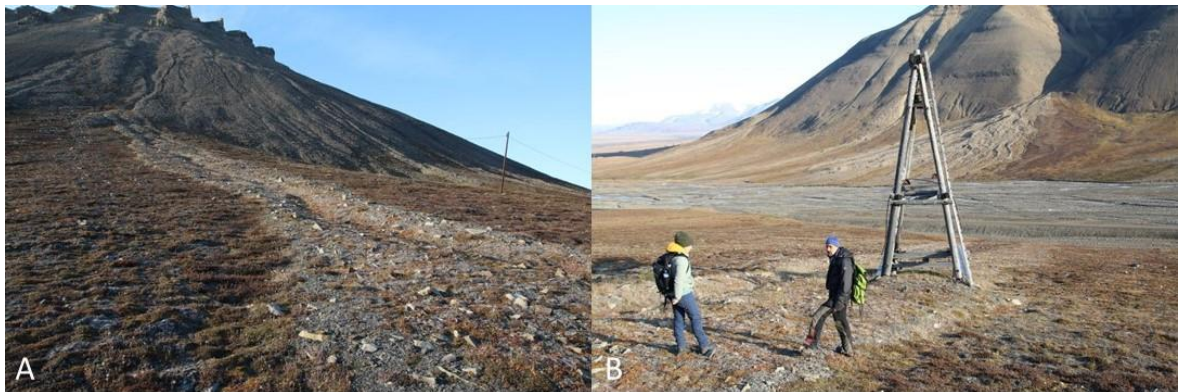
Figure 12. Post nr. 9 at the Cable car line 5 that has survived a debris flow, September 3, 2021. Photos by Anatoly Sinitsyn/SINTEF.

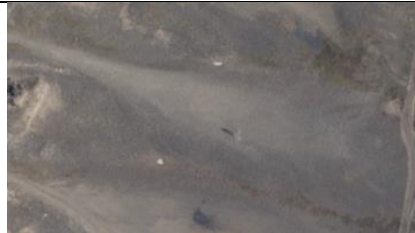
Debris flow	A track with levees on both sides can be observed, characterized by the presence of coarse-grained debris, forming on a slope where loose material is available. Within the same catchment, multiple debris flows can occur, resulting in the formation of a debris flow fan. At the end of the deposit, lobes can be seen where the debris flows come to a stop, and it is not uncommon to find plugs within the tracks caused by subsequent events. (Rubensdotter et al., 2015; Geldard, 2019; Rubensdotter, 2022.)	Most commonly triggered on slopes above 30° (Andre, 1990). Fine-grain materials like till, fluvial and periglacial sediments.

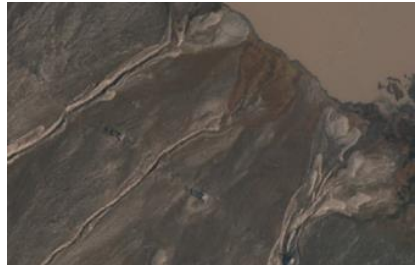
Solifluction	Solifluction is the slow downslope movement of unconsolidated soils within the active layer, which is influenced by freeze-thaw processes. The movement of soil leads to the formation of distinct lobes or extensive sheets of solifluction deposits. (Rubensdotter et al., 2015; Geldard, 2019; Rubensdotter, 2022.)	Predominantly on low gradient slopes.

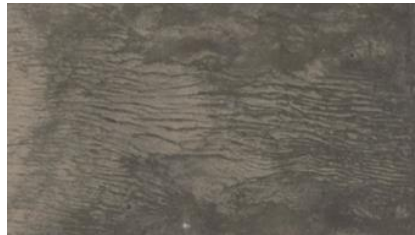
Rockfall	Rockfall deposit is observed beneath a rockfall source area, characterized by a steep surface profile and limited horizontal movement. The deposit consists of angular grains that correspond to the geological composition of the surrounding valley slopes. Notably, the surface texture and color display a gradual vertical transition across the deposit. The grains closer to the rockfall source exhibit lighter shades, while those further downslope appear darker. (Rubensdotter et al., 2015; Geldard, 2019; Rubensdotter, 2022.)	Most commonly on steep slopes.	Single bigger rocks

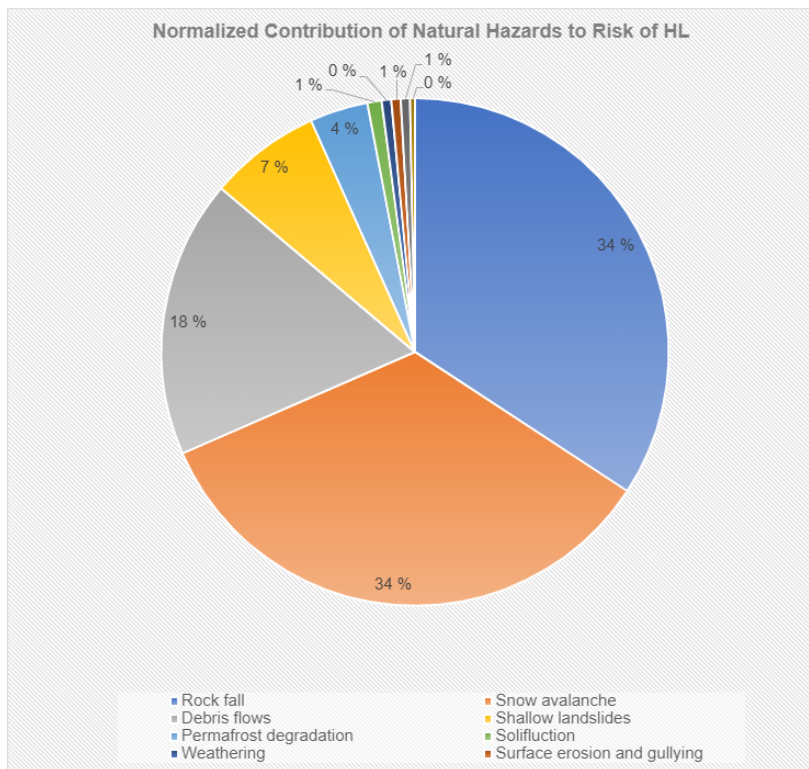
Figure 16. Aggregated risk of Heritage Loss (referred as HL in the figure) from natural hazards to the post nr. 6 on Cable car line 1b (PCCH-Arctic Risk Assessment Excel Tool).

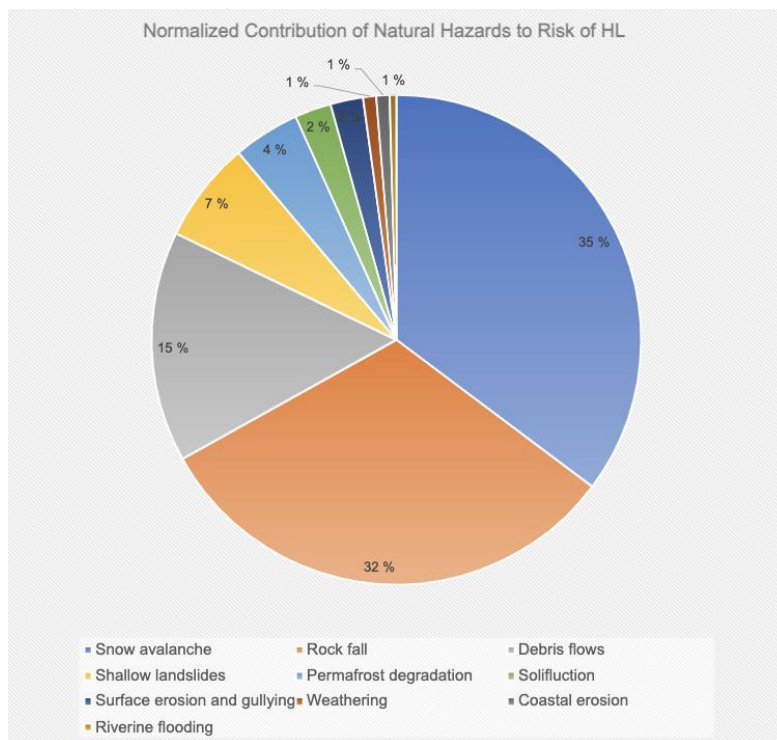
Figure 17. Aggregated average risk of Heritage Loss (referred as HL in the figure) for Cable car line 1b (PCCH-Arctic Risk Assessment Excel Tool).

In addition to the analysis of individual CH objects, the study examined the Cable car lines (eight in total) to identify the primary hazards affecting each Cable car line and determine the lines at the highest risk. The findings provide insights into the specific risks associated with each Cable car line. For Cable car lines 1a, 1b, and 2b, snow avalanches were found to contribute the most to the overall risk of Heritage Loss, whereas for Cable car lines 3, 5, 5-6, and 6, permafrost degradation emerged as the most prevalent hazard. In the case of Cable car line 2a, shallow landslides contributed the most to the overall risk of Heritage Loss. As an example, for the most hazardous Cable car line 1b, the contribution of the natural hazards to the total risk of Heritage Loss is shown in Figure 17.

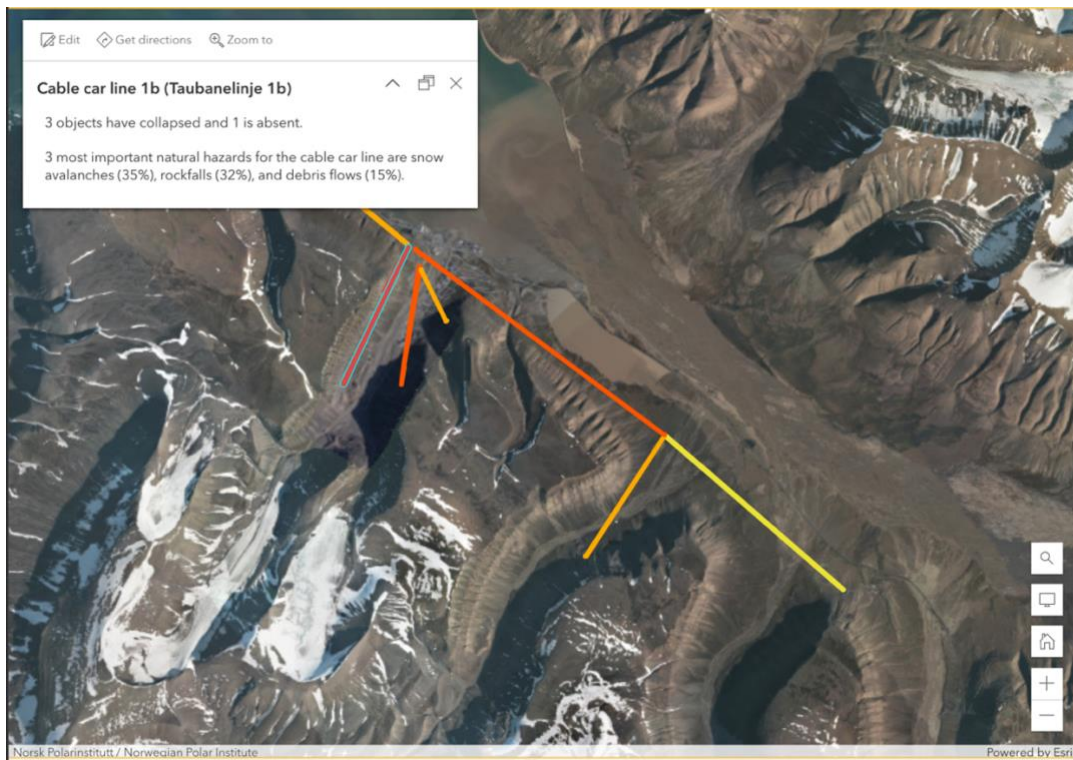
Figure 19. Pop-up window showing more information about each Cable car line.

The total scores and hazard distribution for each object were visualized in GIS. The map shows detailed hazard evaluation for each studied heritage object near Longyearbyen and Ny-Ålesund. The zoomed-out view shows overall hazard evaluation for each of the 8 Cable car lines in Longyearbyen, with red indicating highest risk and yellow lower risk (Figure 18). Clicking on a Cable car line opens a popup window with information on the Cable car line at question (Figure 19).

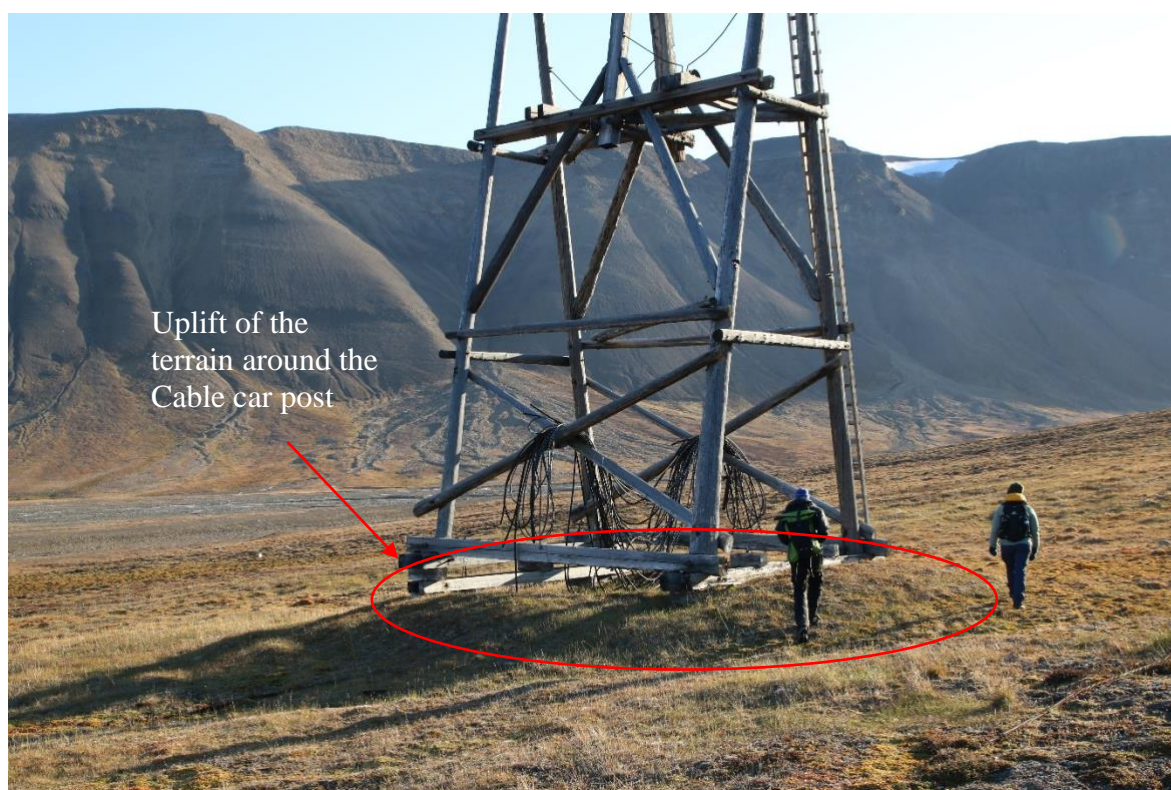
Figure 23. Post Nr. 6 at the Cable car line 5. This post is resting on a small bump/hill that is probably created as a result of frost heave, which is stimulated by absence of snow in winter, September 3, 2021. Photo by Anatoly Sinitsyn/SINTEF.

In general, in Adventdalen (Cable car lines 5-6 and 6), objects are catching more snow which leads to higher snow accumulation around the objects and thus increased permafrost degradation due to the insulating effect of snow. In Endalen (Cable car line 5), on the other hand, snow is not accumulated around the objects and thus the terrain around is not settling in those places. It even seems that terrain has some "uplift" there due to probable frost heave, that may be intensified by absence of insulation from the snow (Figure 23). Snow cover is a major source of water, and thus the correlation between snow depth and melt water around each object is assumed to be highly correlated.

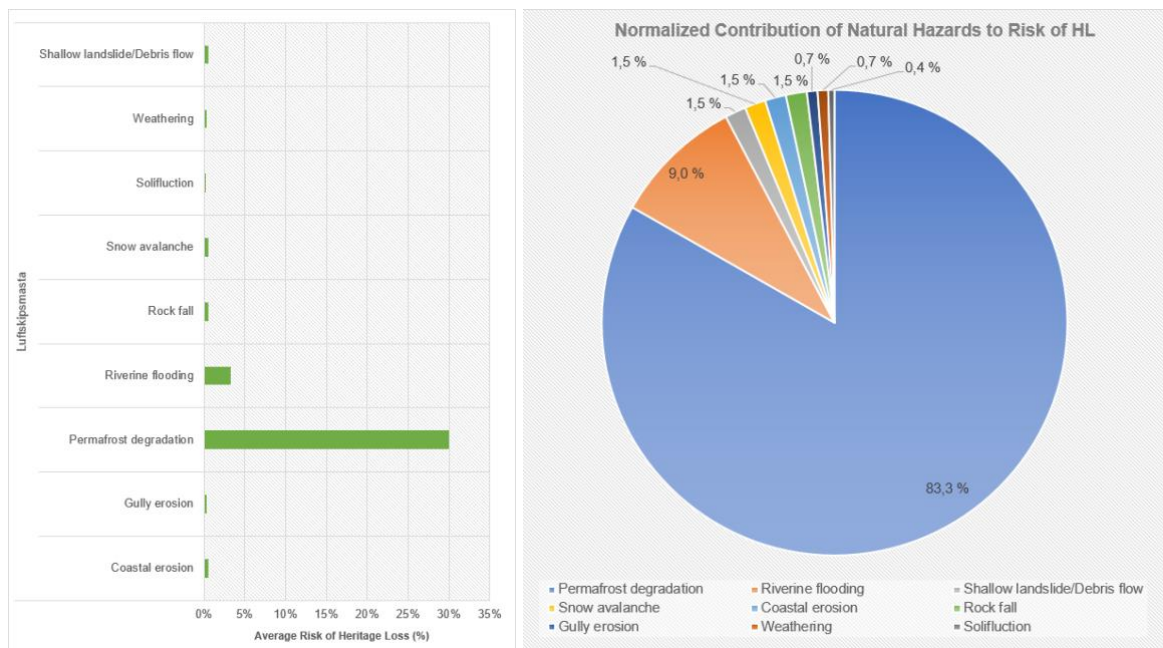
Figure 25. Contribution of different natural hazards to the risk of Heritage Loss for Luftskipsmasten (PCCH-Actic Risk Assessment Excel Tool).

The analysis highlights the significance of permafrost degradation as the primary natural hazard contributing to the risk of heritage objects in Ny-Ålesund (Figure 25). For the CH objects located at the coastal area, coastal erosion is considered as the second biggest contributor to the overall risk.

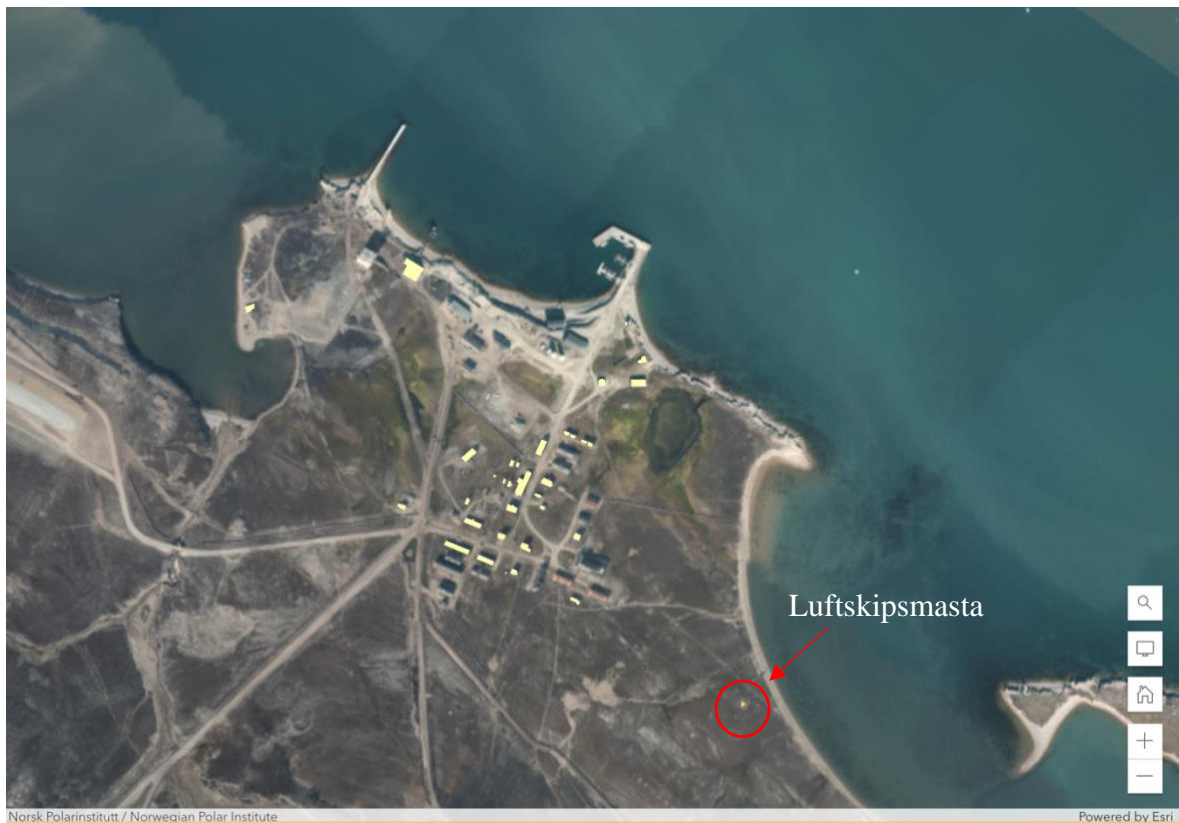
Figure 26. Overview of the CH objects in Ny-Ålesund. Yellow colour of CH objects indicates a total risk of Heritage Loss below 30%. Luftskipsmasta is coloured orange as it has a total risk of Heritage Loss of 36%.

As shown in Figure 25, all except one CH object has a total average risk of over 30%. Therefore, in the GIS map all CH objects in Ny-Ålesund are coloured yellow, except for the Luftskipsmasten that has an overall risk of 36% and is thus orange in colour (Figure 26).
