Piezoelectric Patch Transducers: Can alternative sensors enhance bearing failure prediction?

L. Schilling and P. Dalhoff

17.01.2019

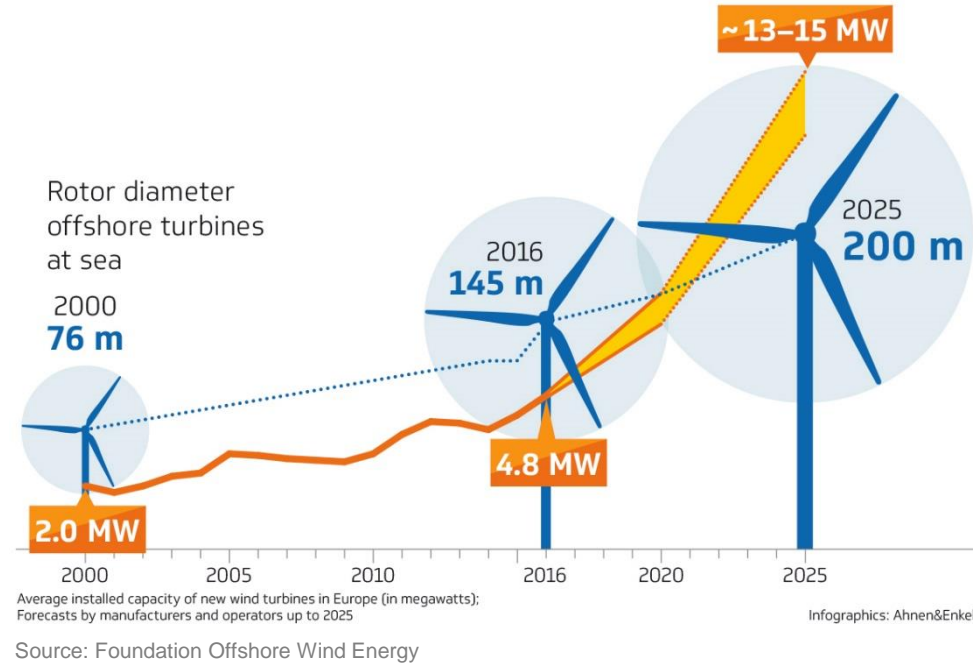
Correlation between turbine and gear growth

- ⇒ Increase of stiffness and damping
- ⇒ Incipient faults get more intricate to retrieve

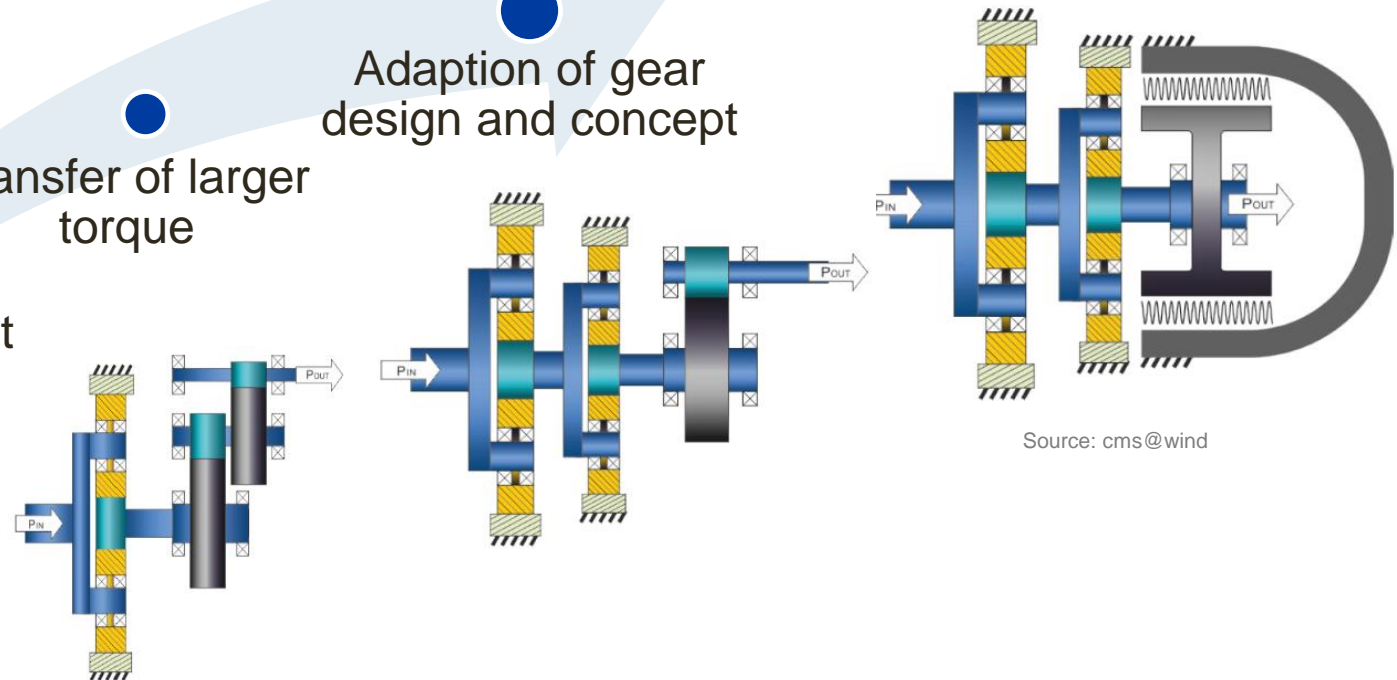
Growth of height and capacity

Transfer of larger torque

Adaption of gear design and concept

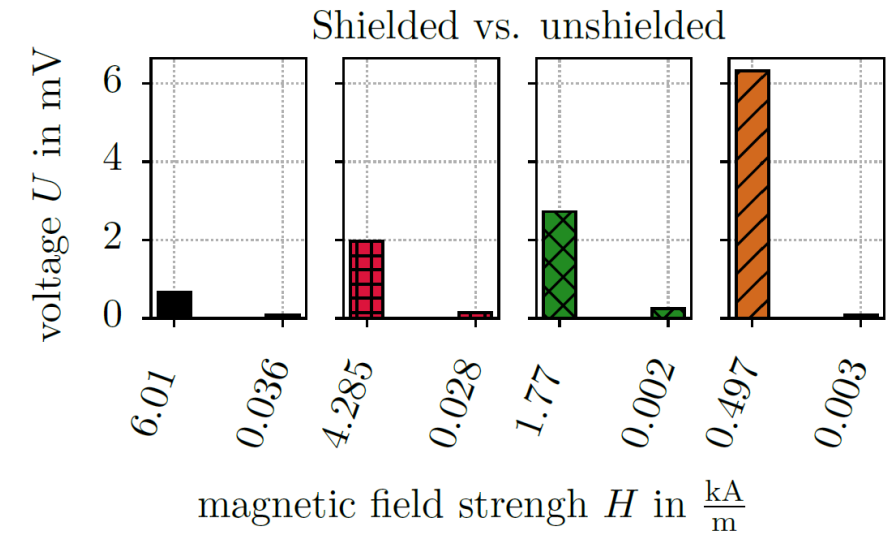
Shielding with a 1 mm mu-metal sheet:

Shielding is yet recommended to fully eliminate any unwanted interference

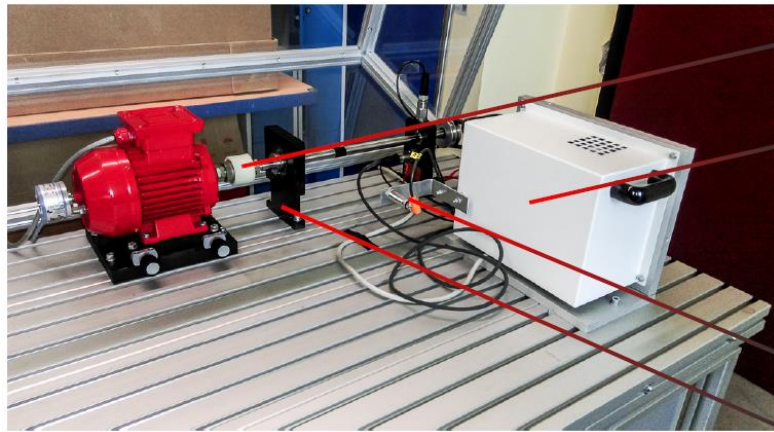
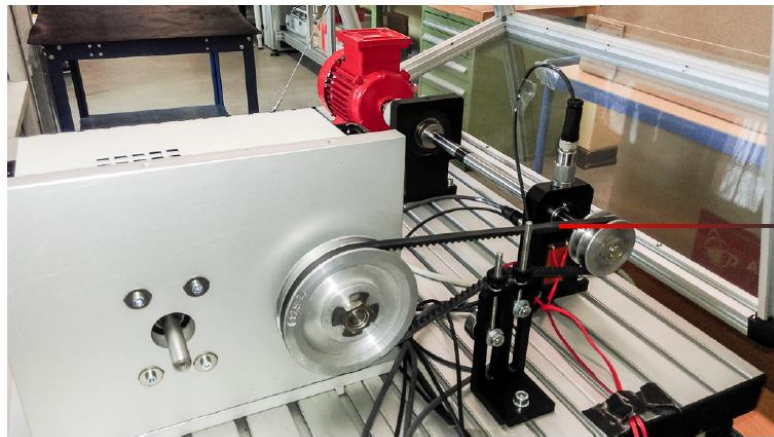
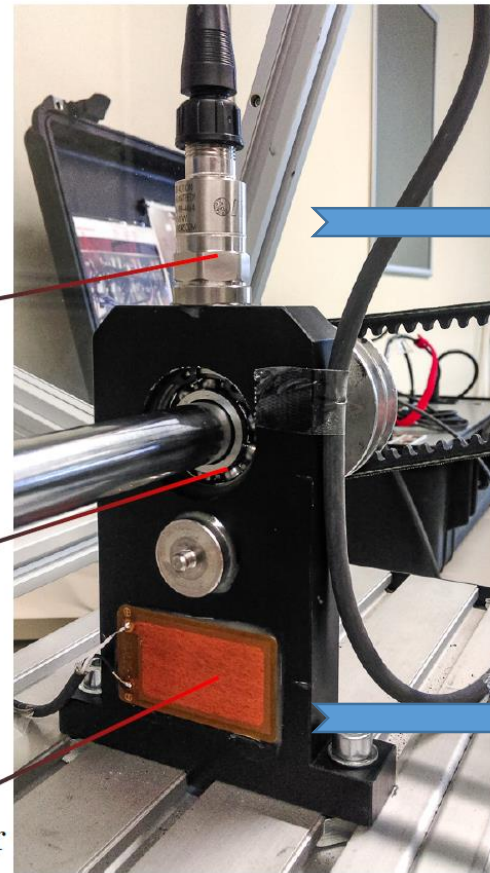
Damage detection – experimental setup and run-up plot

curved tooth
coupling
electromagnetic
powder brake

accelerometer
light barrier
fixed bearing
support
replaceable
bearing
V-belt
piezoelectric
patch transducer
