14th International  
Passive House  
Conference

Dresden,  
May 28,  
2010

# The first apartment house renovation with Passive House components in Norway

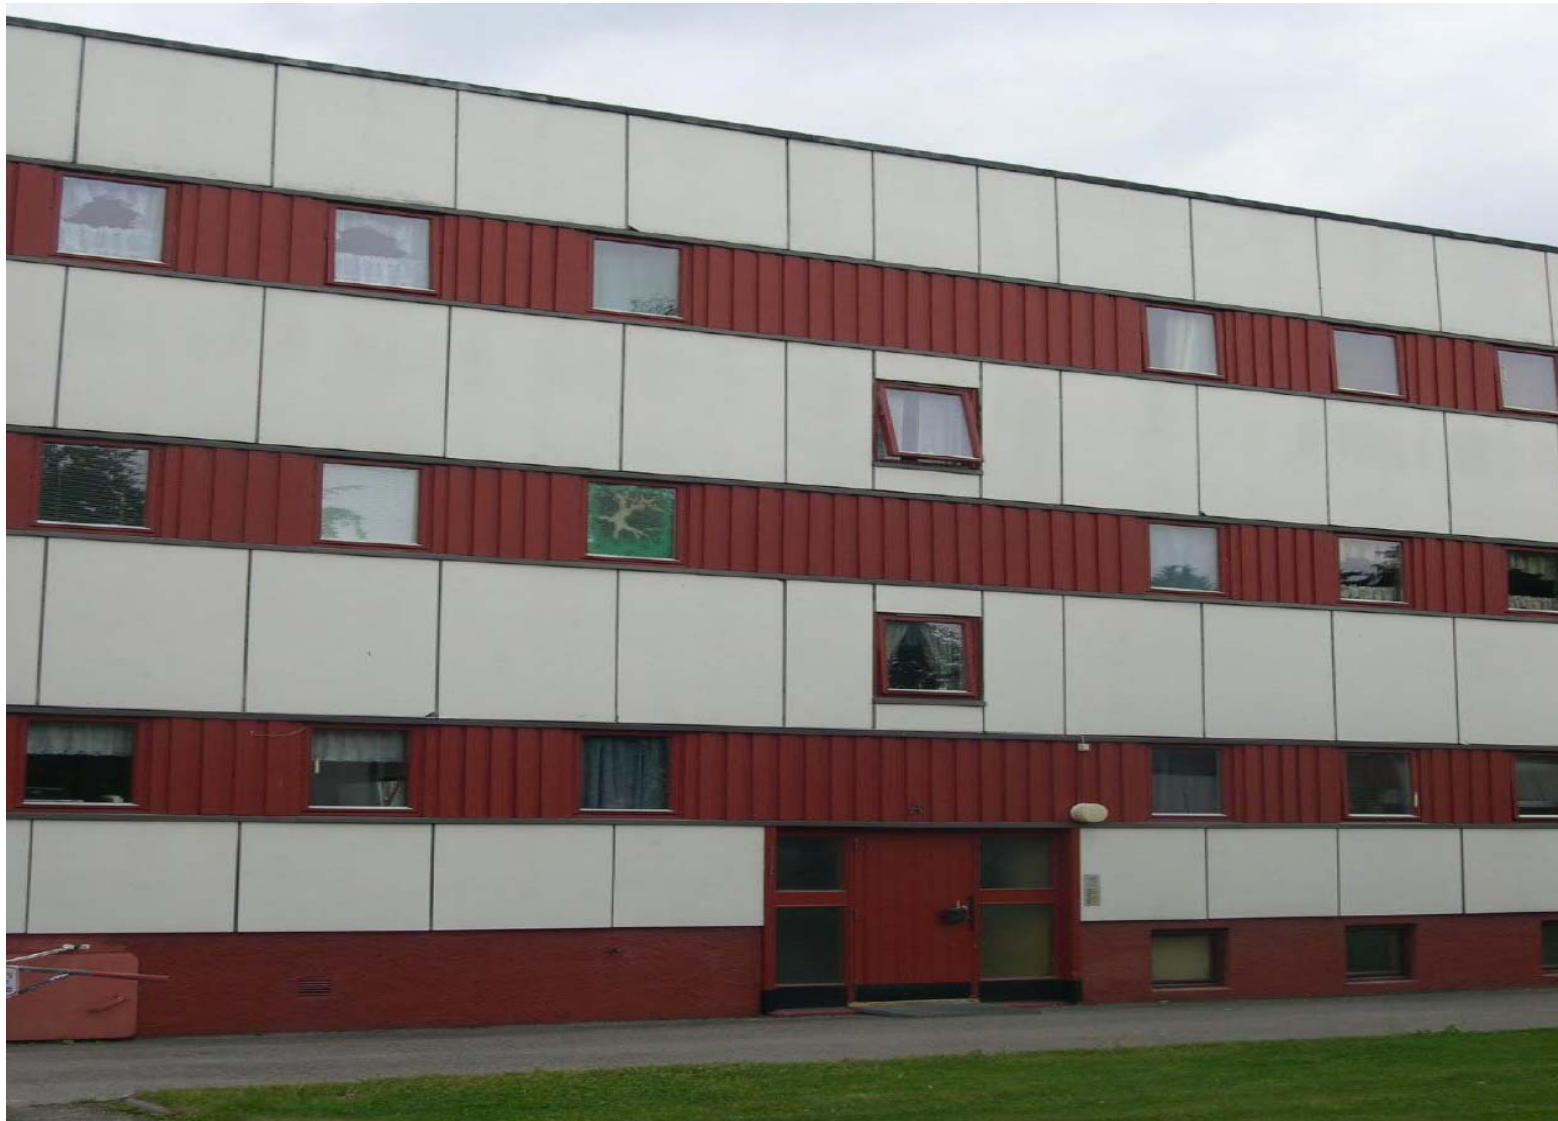
168  
flats,

one-  
bedrooms  
(55 m<sup>2</sup>)  
and

two-  
bedrooms  
(68 m<sup>2</sup>)

7 similar blocks, 3 storeys high with unheated cellar, built 1968-70

Myhrerenga housing cooperative at Skedsmokorset, 15 km north east of Oslo, nearly same climate with annual mean temperature around 6 °C

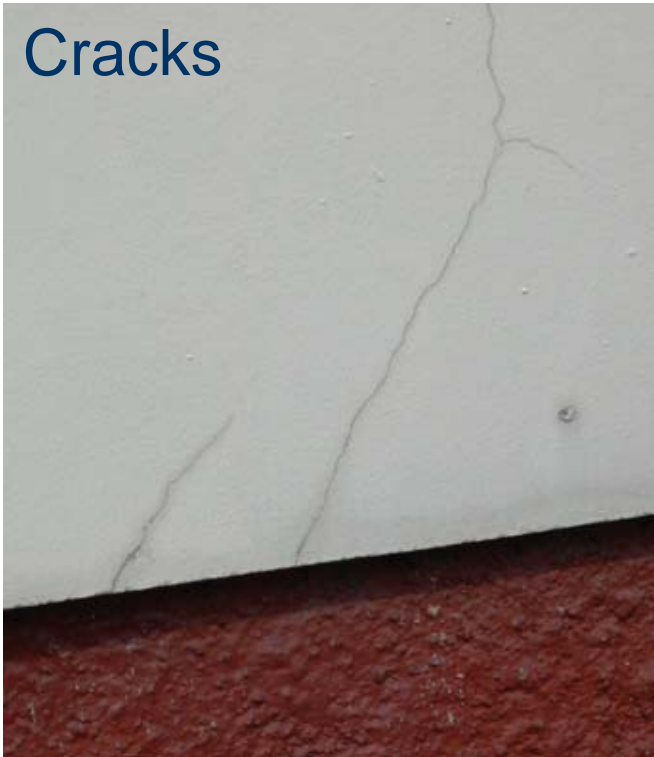
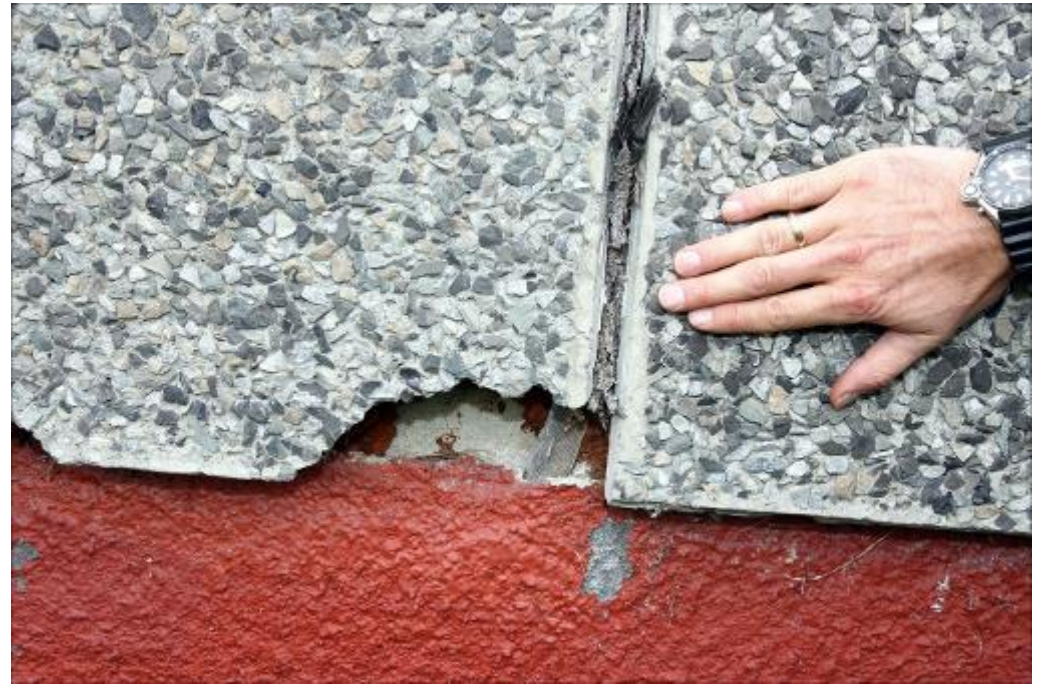
Many damages

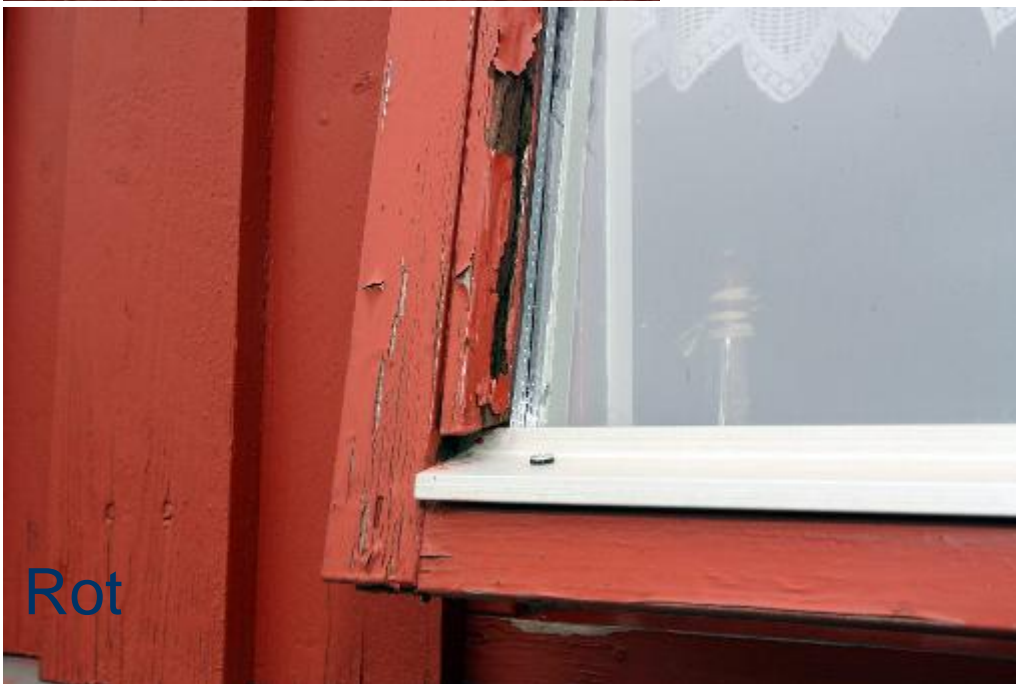
Rot

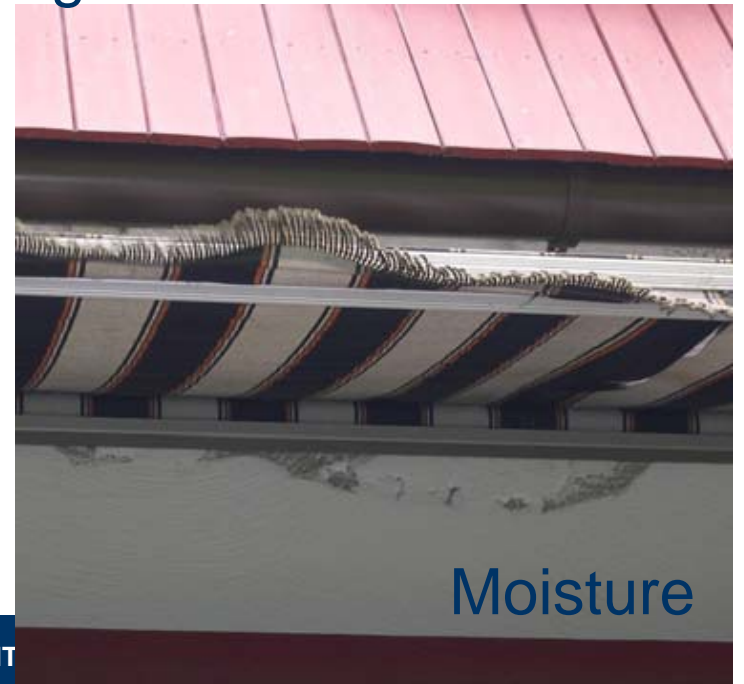
Moisture

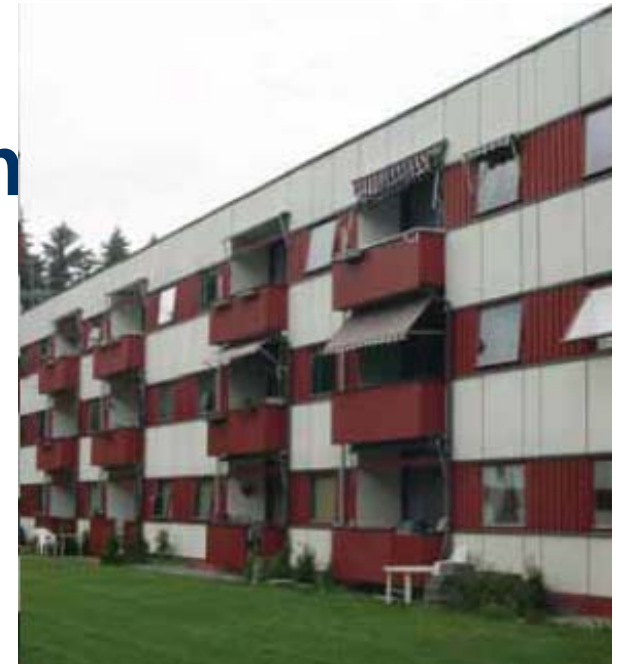
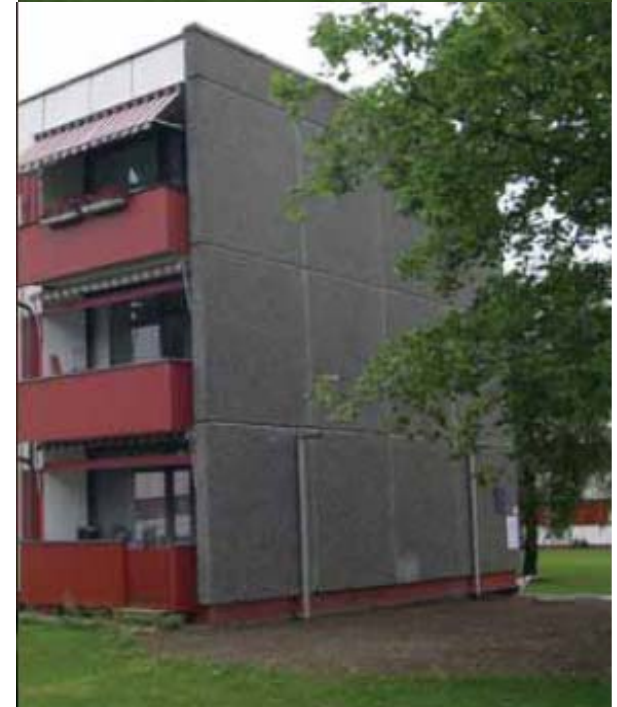
## Building fabric before renovation

- 5 – 10 cm insulation in floors towards cellar, walls and roof construction
- Poor air tightness
- Lot of thermal bridges

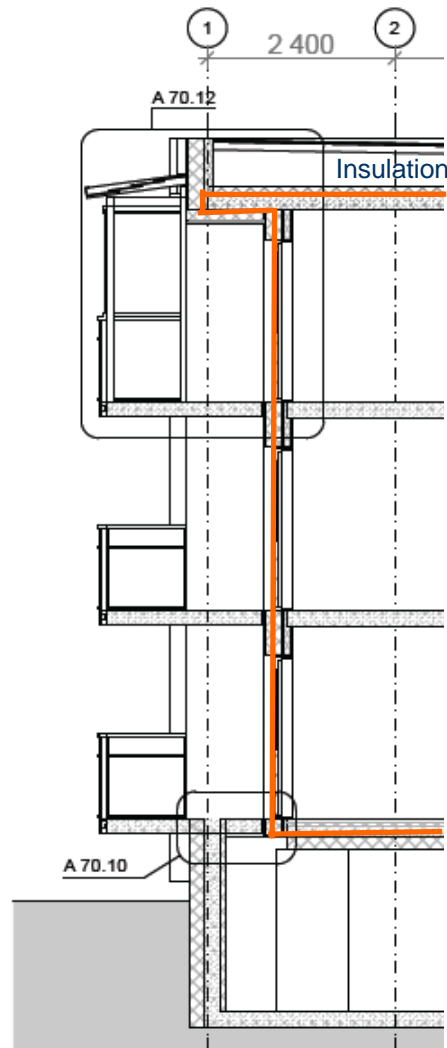
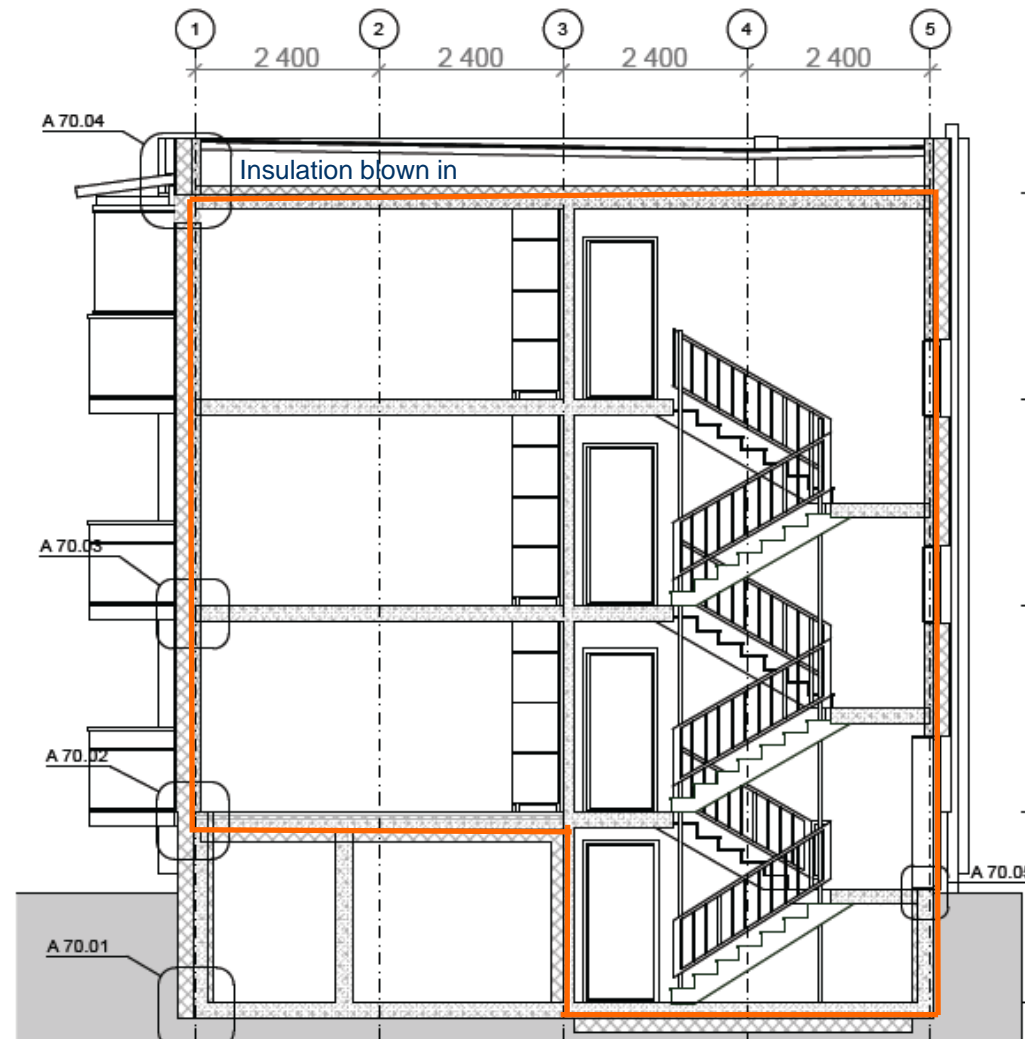
Airtight  
building  
envelope

including  
staircase in  
the cellar

No insulation below, but on wall

Air tightness:  
expanding  
foam caulking

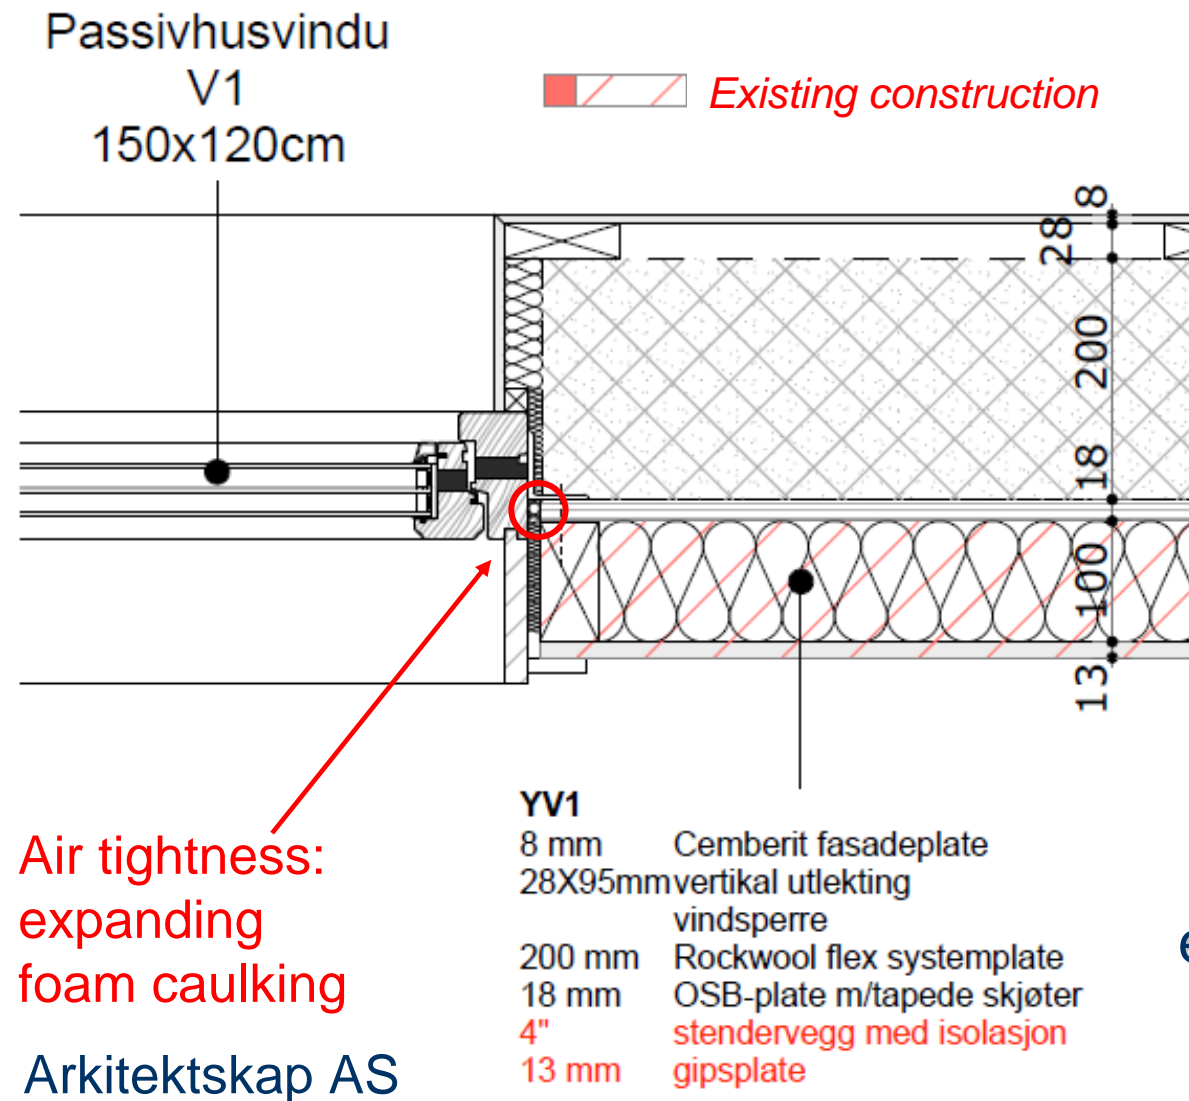
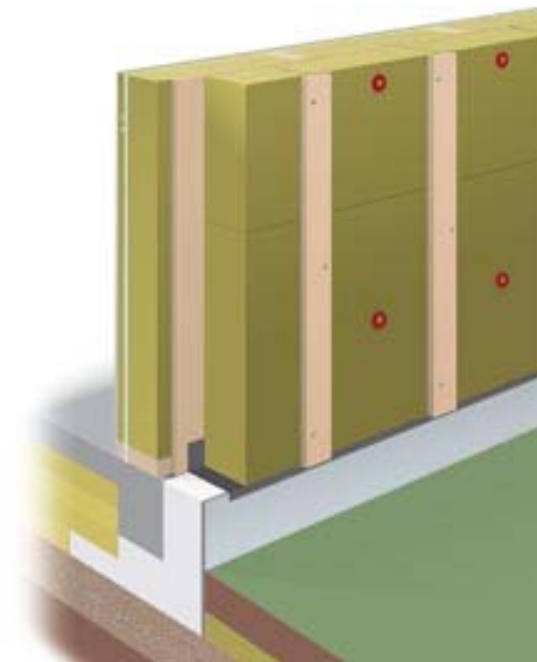
# PH-window and vapor permeable wall

OSB-boards and  
20 cm unbroken  
insulation on the  
existing 10 cm stud wall  
+ new facade lining

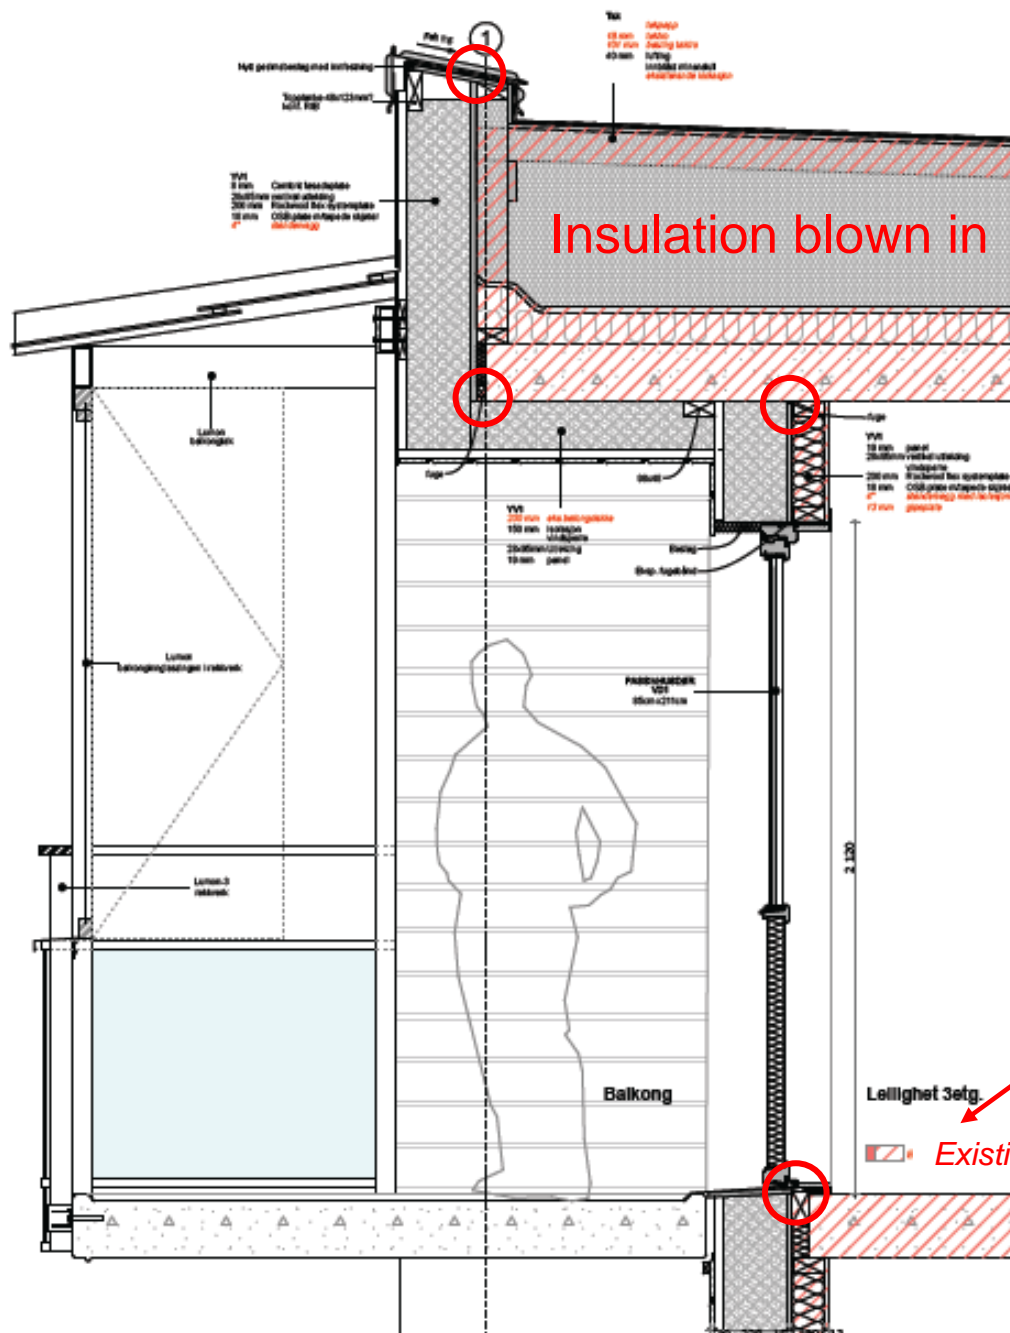
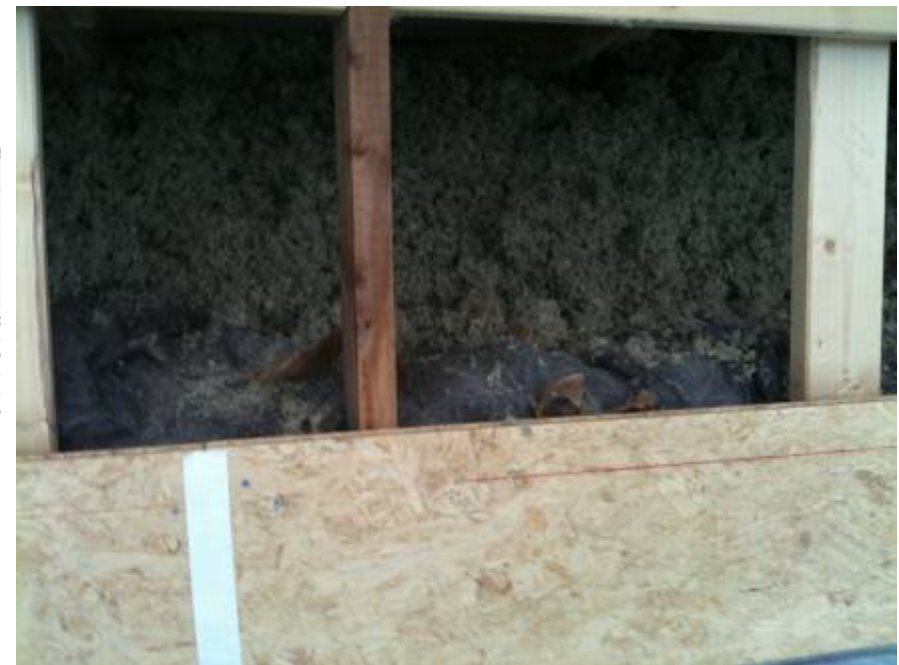
## Airtight window/wall solution after discussion on-site

Air tightness measures: ○

Air tightening OSB – frame and between stories

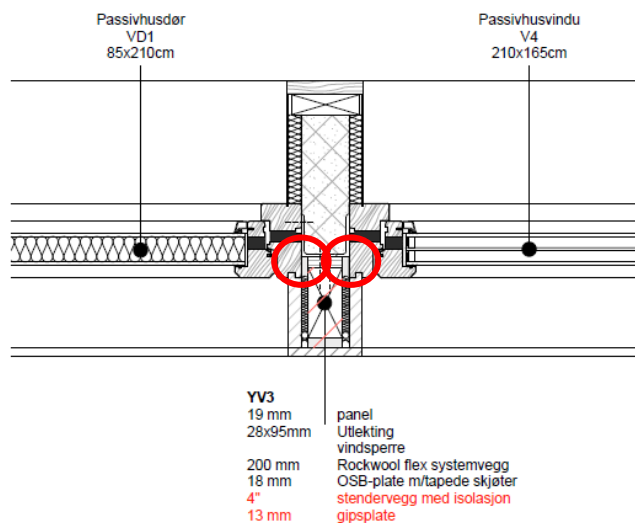
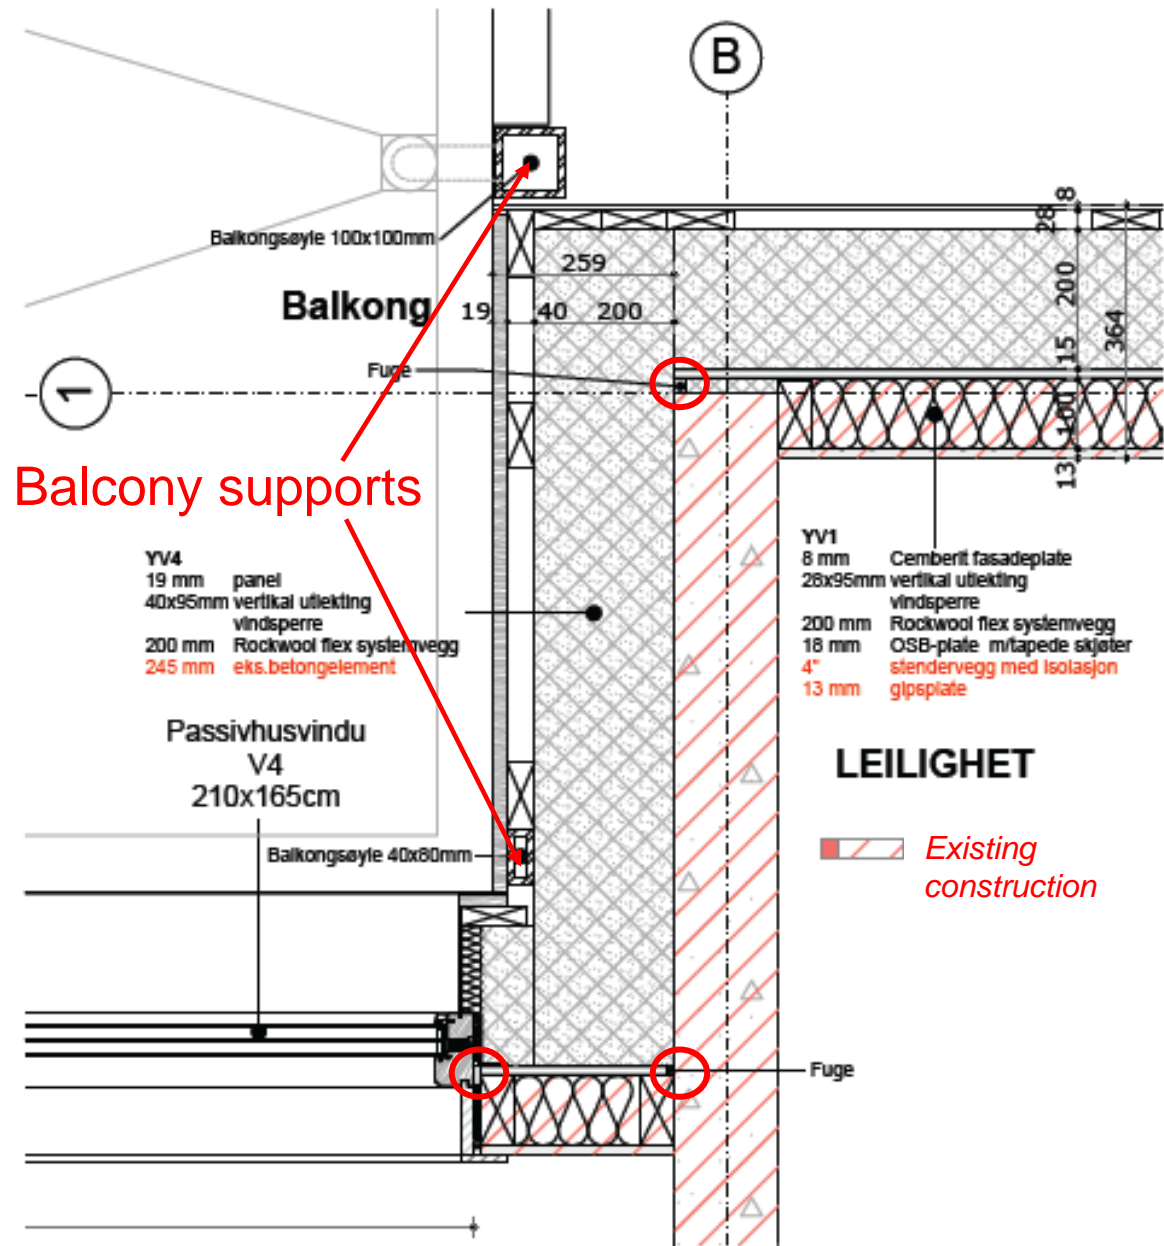
# Balcony and window/door

Air tightness measures: ○

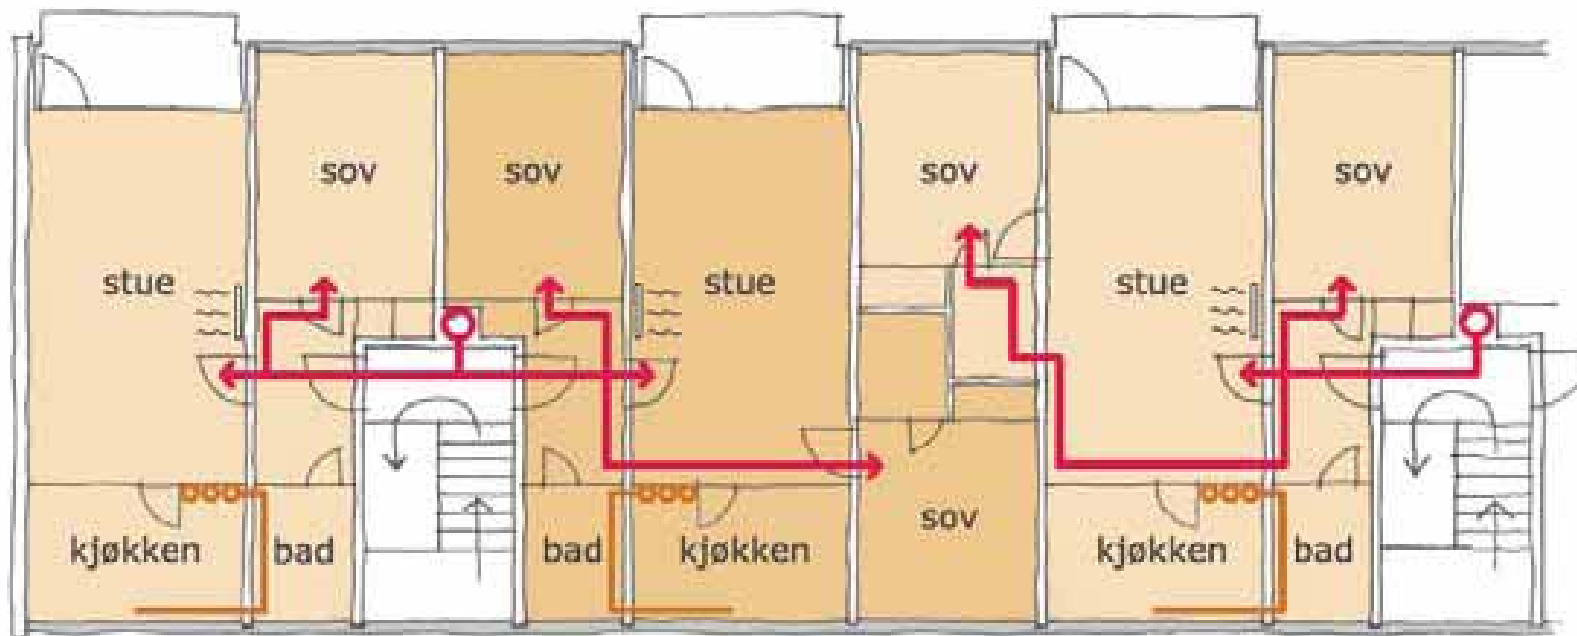
## Balanced ventilation

- One central air handling unit per block, placed in the cellar
- Double cross flow heat exchanger (probably) with high efficient heat recovery
  - ( $\eta > 80 \%$ ,  $SFP < 1,5 \text{ kW/m}^3/\text{s}$ )
- Air supply through old garbage chute
- Air extract through existing extract shaft
- >> limited interior work

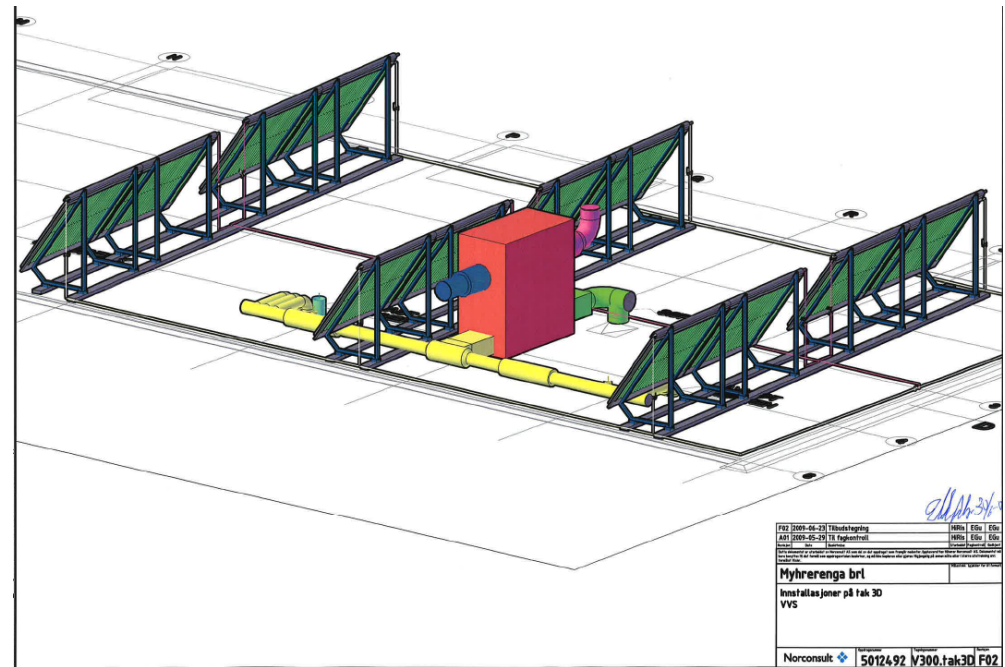
# Energy supply

- Only one radiator in the living room (1-1,5 kW) + existing radiator in the bath room
- Individual energy accounting (heat and electricity)
- Renovated boiler house:
  - 3 air-to-water heat pumps (25 kW each, run in cascade)
  - 44 vacuum solar collectors on the nearest block roof
  - 1 electric boiler kept (peak load)
- Reuse of existing heat distribution system
