Development and verification of NDT for detecting voids in tendon ducts

Validation through mock-up specimens for post-tensioned concrete structures

Report no.: 2025:01222

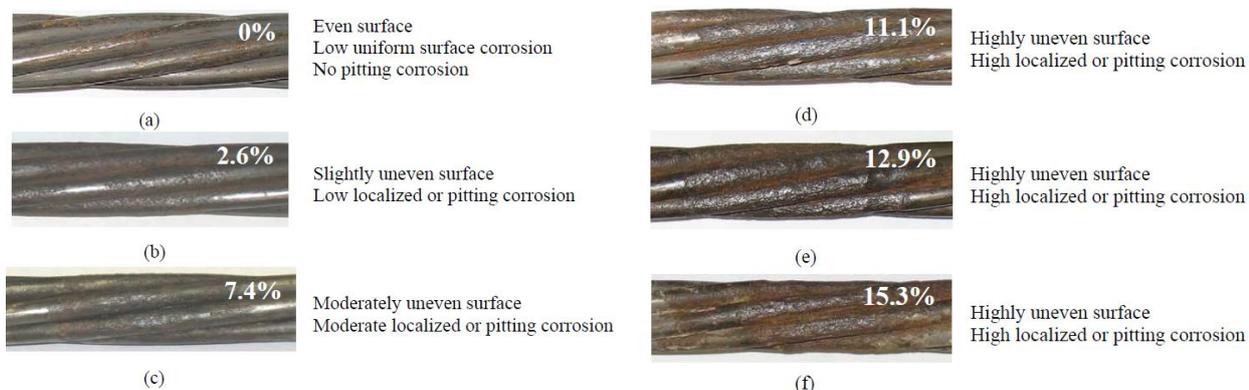
Figure 1. Photographs showing corrosion level and surface characteristics of strands. (Trejo et al., 2009)

The corrosion that initiates in these regions often leads to severe pitting and localized section loss in the steel strands. Because this type of degradation progresses internally and without surface indicators, it often goes undetected until a sudden and brittle rupture occurs. When a single strand fails in an ungrouted region, force redistribution becomes highly unreliable, potentially triggering progressive failure of neighboring tendons. This mode of failure has been observed in structures as early as 10–20 years into service – far earlier than the intended design life – demonstrating the severe durability risks posed by ungrouted voids. Characteristics of strand corrosion are provided in Figure 1.

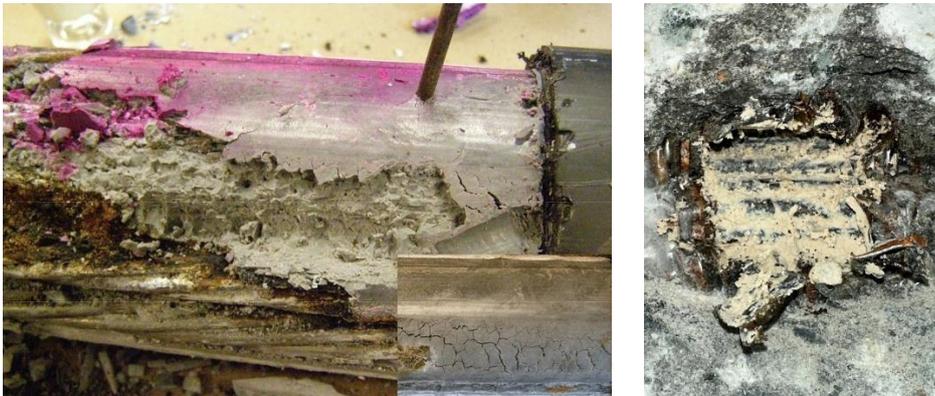
Wet segregated plastic grout (Lau et al., 2013)

Soft and wet grout (Popescu et al., 2024)

Figure 2. Examples of segregated and defective grout observed in post-tensioned tendon ducts

This phenomenon is characterized by the appearance of a white, soft, unhardened paste – an exudation product that separates from the intended grout mix. Such exudate is highly enriched in water and sulfates and exhibits an extremely high pH, often between 13 and 14 (Carsana & Bertolini, 2015). Though cementitious, this segregated material fails to protect the strands and instead becomes an aggressive corrosive medium. Laboratory and field investigations have shown that strands in direct contact with this material suffer from localized corrosion, particularly pitting (Bore et al., 2010; Carsana & Bertolini,

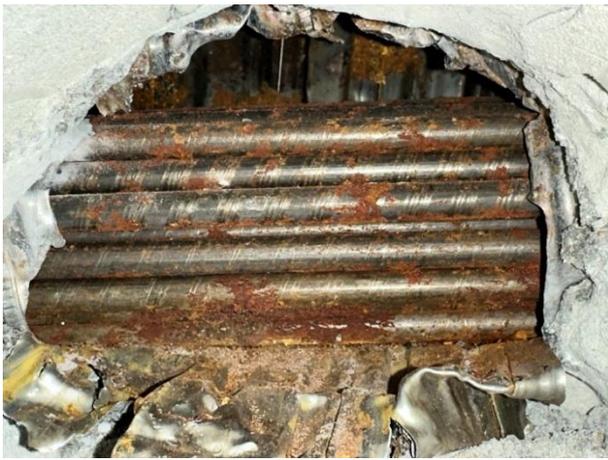
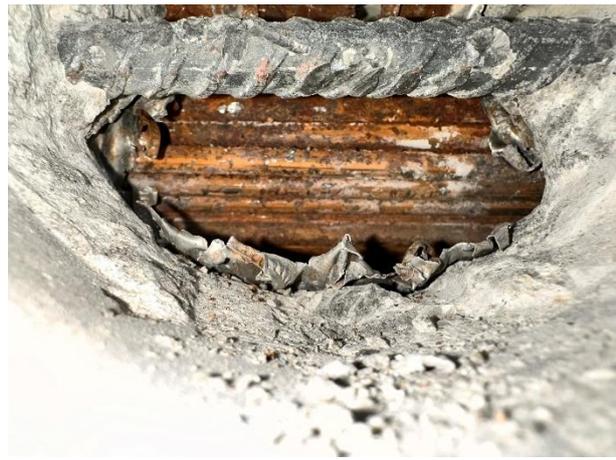
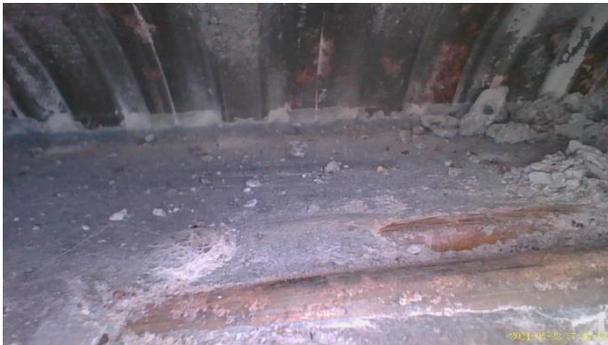
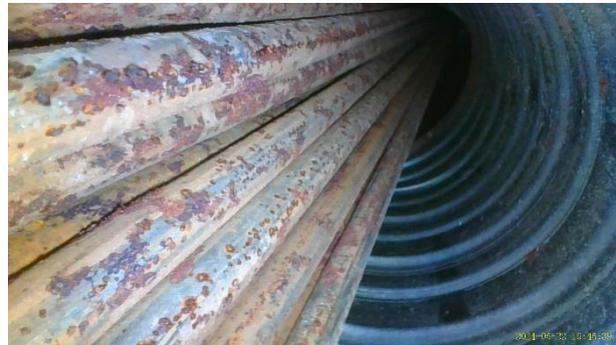
Void inside tendon duct and corrosion on the strands (Popescu et al., 2024)

Void inside tendon duct and corrosion on the strands (Holmqvist et al., 2024)

Partially filled duct (Holmqvist et al., 2024)

Empty duct (Holmqvist et al., 2024)

Figure 3. Examples of voids and missing grout in post-tensioned tendon ducts

The second, and more prominent, cause of corrosion in post-tensioned tendons is the presence of voids in the grout. These voids can form due to several issues such as entrapped air pockets, grout bleeding, or improper grouting procedures (Im & Hurlbaas, 2012). Air voids may be trapped if the grouting vents are closed too early – before the ducts are completely filled – or as a result of air naturally migrating toward the high points in the tendon duct system, often located near anchorages (Cavell & Waldron, 2001). Additionally, grout bleeding allows water to separate from the grout mixture. This water can move along the interface between wire strands and eventually accumulate near anchorages where it may evaporate, leading to increased risk of corrosion (Hansen, 2007).

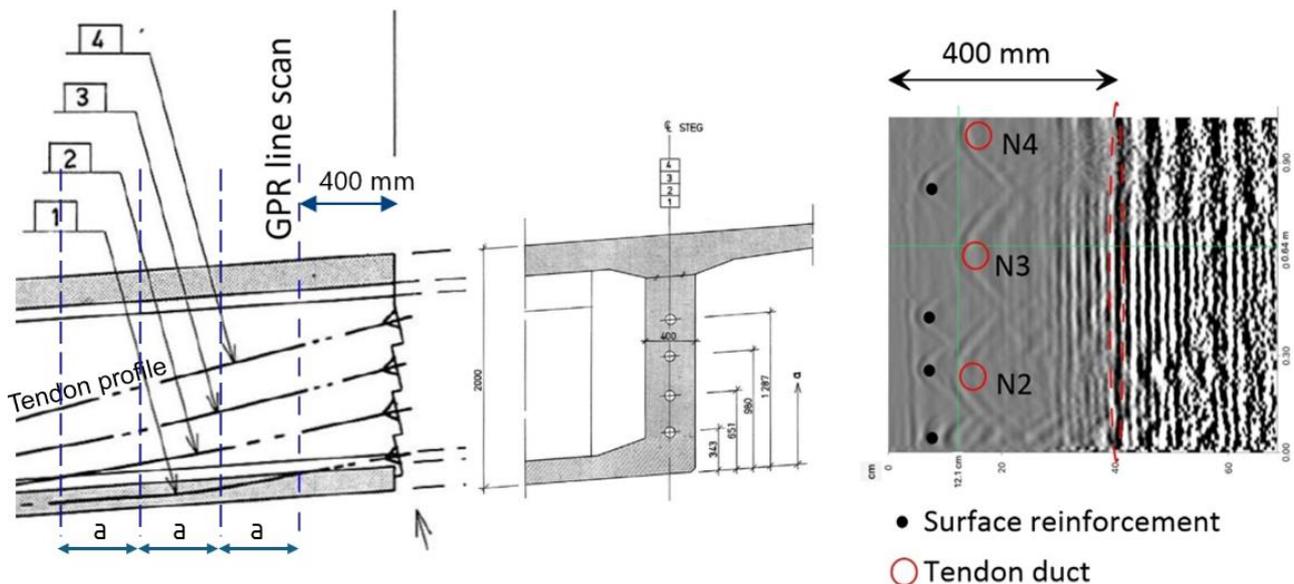
Figure 4. Example of GPR scan slices spaced (a) used to reconstruct curved tendon profiles

Interpreting these results demands experience and careful alignment of signal reflections across several scan slices or views. However, accurate reconstruction of the tendon profile requires more than just correlating signal patterns across multiple scans. Reflections detected by GPR may correspond to either tendon ducts or conventional reinforcement (see Figure 4), and distinguishing between the two can be complicated.

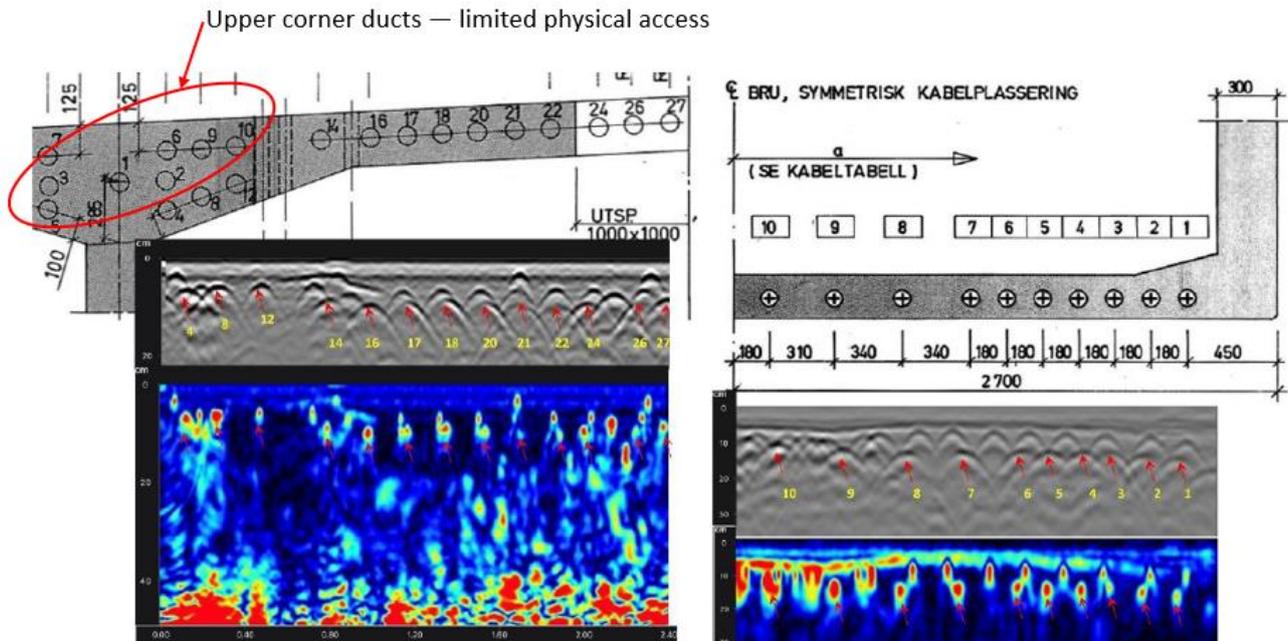
Figure 5. Cross-section of a post-tensioned box girder segment (top) with corresponding GPR scan results (bottom)

As illustrated in Figure 5, the left side shows ducts embedded in the upper deck slab – the traffic-bearing surface – while the right side shows ducts in the bottom slab, which is accessible from inside the box girder. Typically, inspectors have physical access only from the inside of the box-girder, unless external scaffolding or lifting platforms are used.

Access to the upper tendon zones, especially those placed near the deck-web intersection (corners of the box girder), is severely constrained. These areas are covered by asphalt surfacing, which limit physical access. Ducts positioned near the deck–web intersection are inaccessible from within the box girder and typically cannot be inspected from above without traffic disruption, making them effectively uninspectable without major intervention.

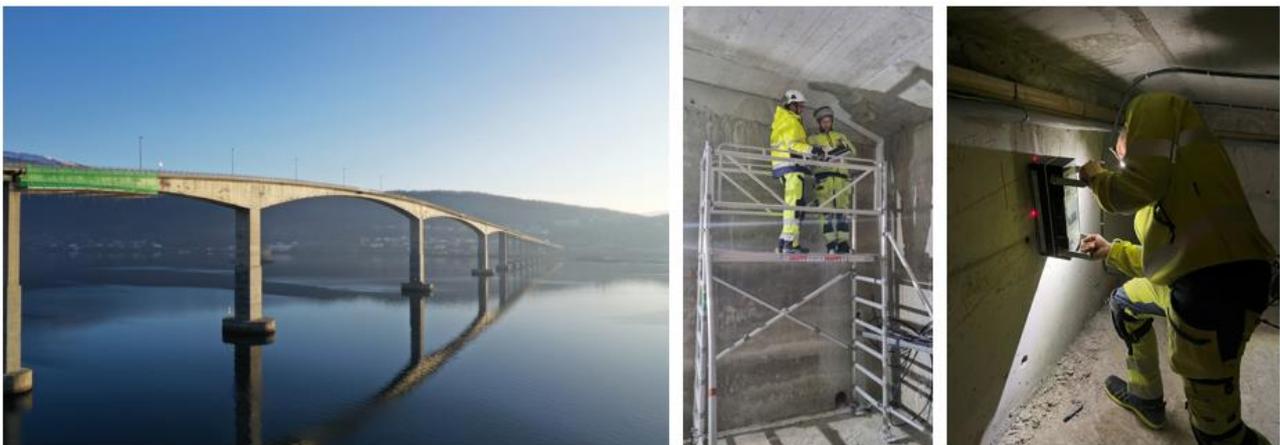
Figure 6. Practical challenges during NDT inspections of post-tensioned bridges, including access via scaffolding above water, confined interior spaces, and overhead scanning in constrained positions

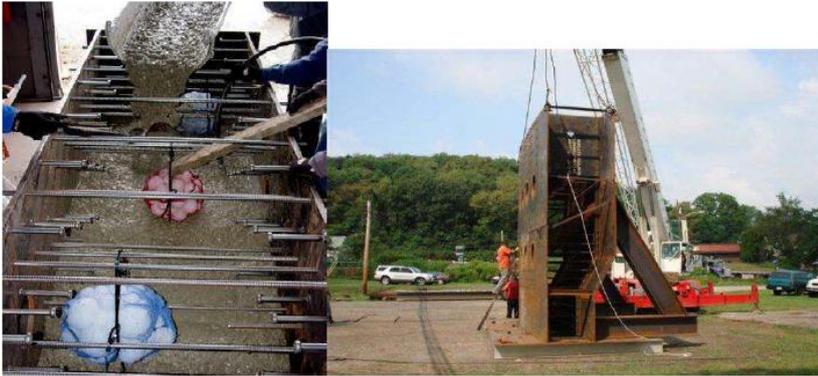
Figure 7 Fabrication of mock up specimens (from (Wiggenhauser et al., 2015))

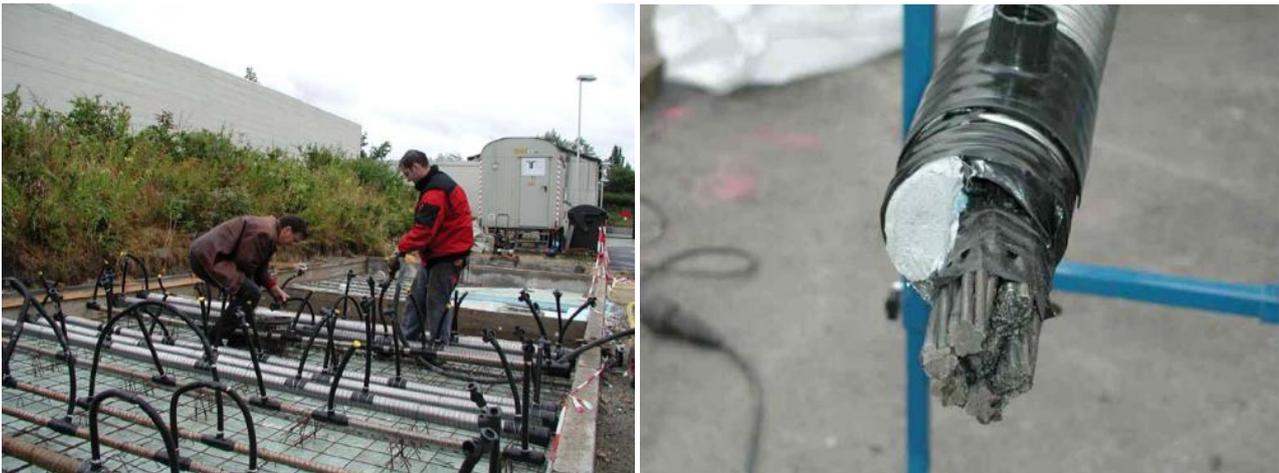
Figure 8 Left: Tendons being installed in the Large Concrete Slab (LCS) prior to grouting. Right: Close-up of a tendon duct containing prestressing strands with an intentionally created artificial void, prepared before placement in the slab.

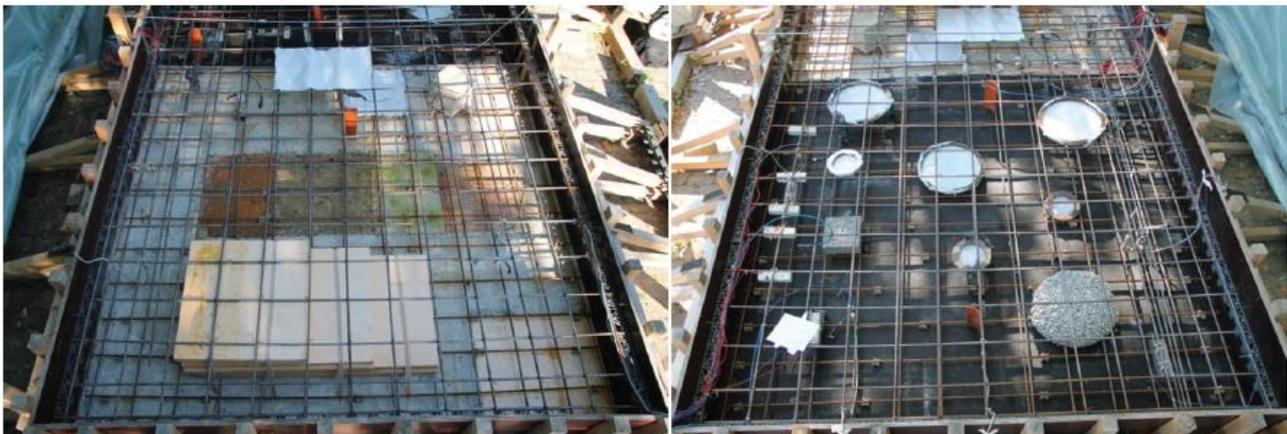
Figure 9 Photos of the mock-up before concreting

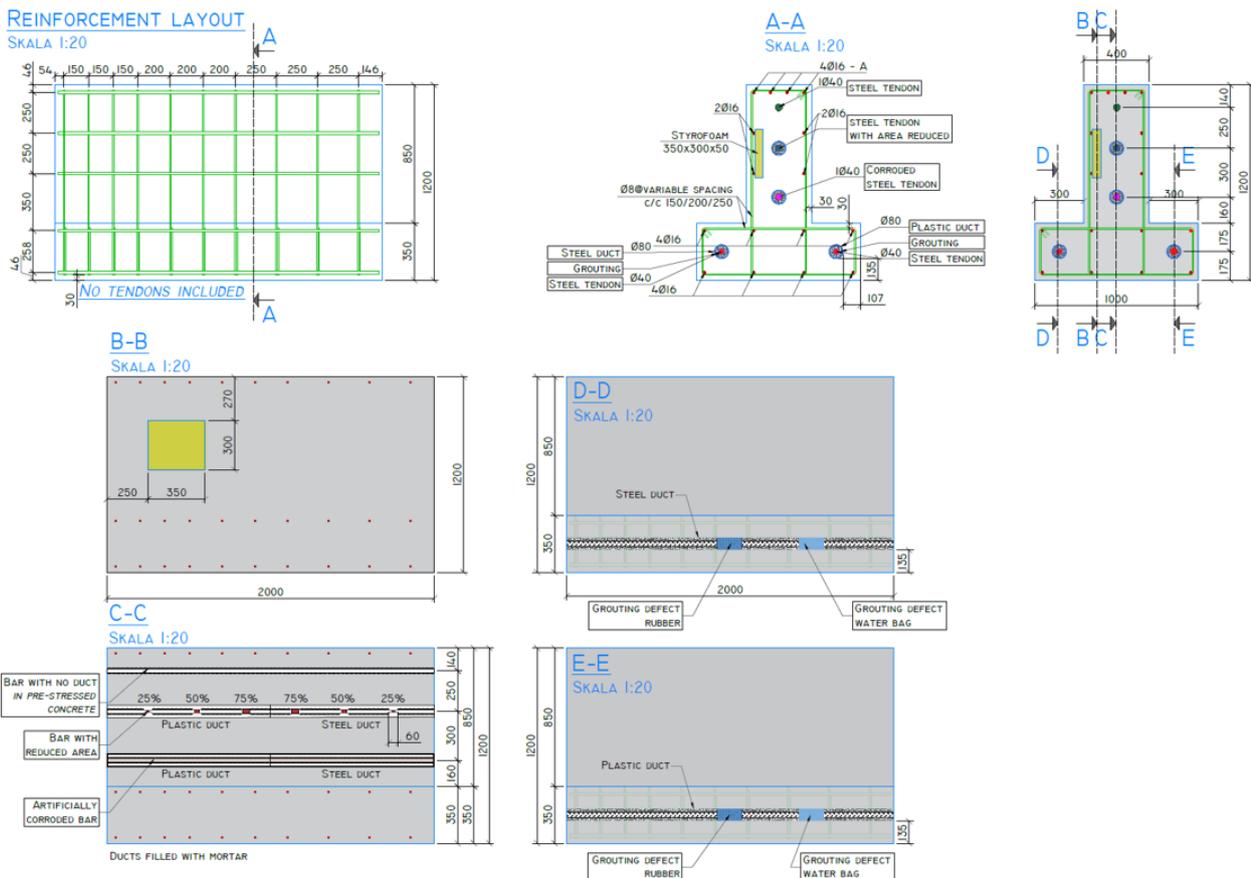
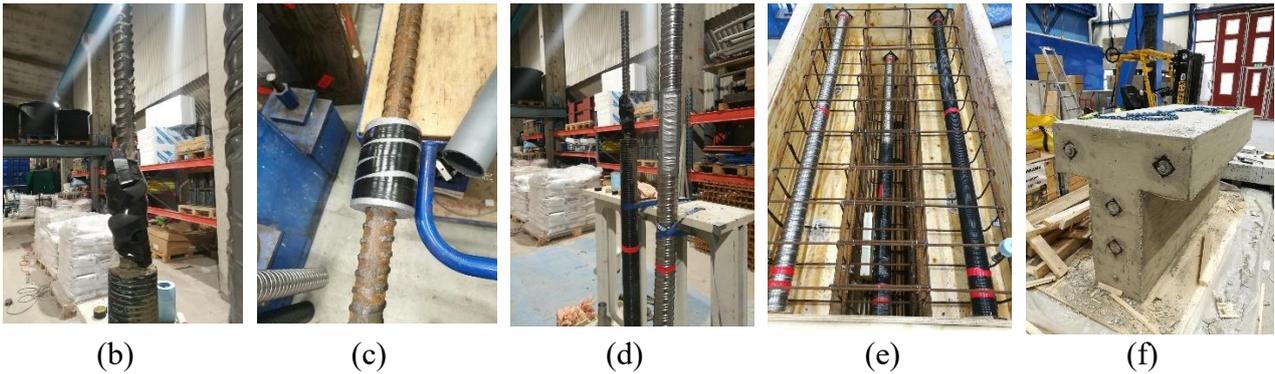
Figure 10 Design (a) and fabrication process: (b–c) Water bags and rubber inserts simulating water ingress and grouting defects inside tendon ducts; (d) grouting of the ducts; (e) placement of all ducts, reinforcement, and artificial defects before concreting; (f) completed mock-up specimen.

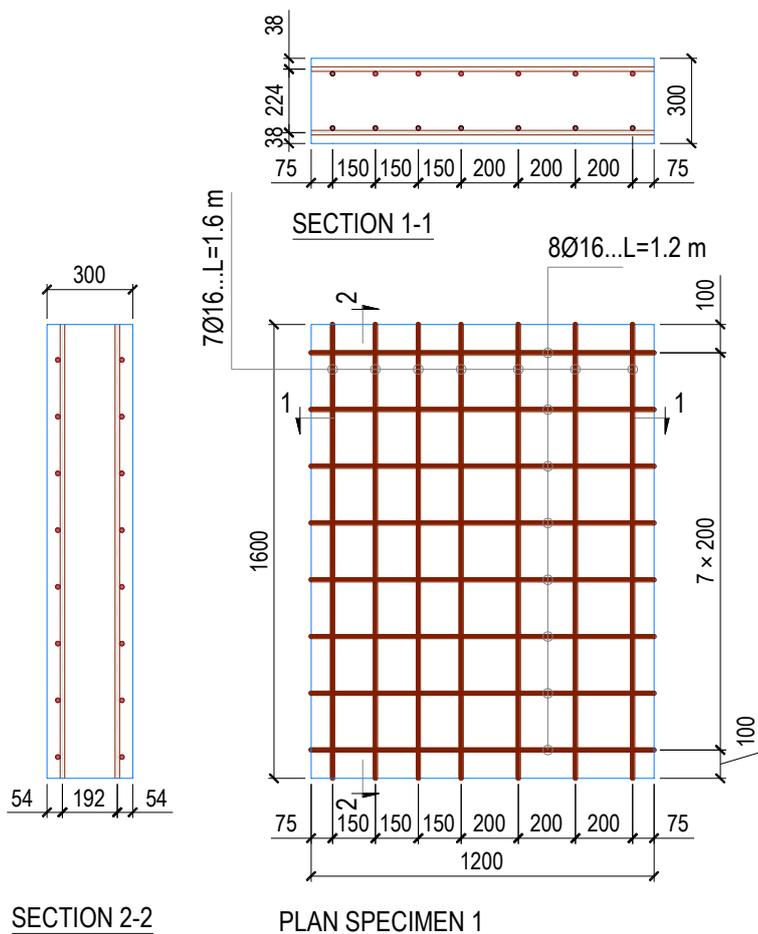
Figure 11 Design of specimen 1

The specimen measures 1600 × 1200 × 300 mm and is reinforced with Ø16 mm bars placed in both the top and bottom layers. The reinforcement spacing is 100 mm and 200 mm center-to-center, arranged in orthogonal directions. The clear cover to the rebar is approximately 35 mm. No ducts or embedded defects were introduced in this specimen.

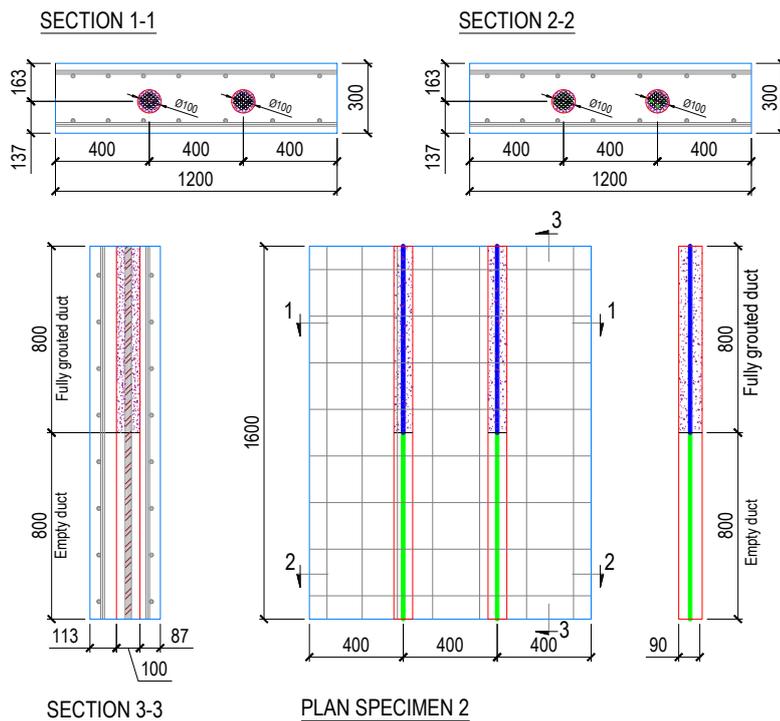
Figure 12 Design of specimen 2

This configuration supports training and method validation focused on locating ducts, estimating grouting extent, and understanding how tendon visibility is influenced by rebar congestion. However, unlike more intricate configurations, the relatively simple layout ensures that each feature can be clearly linked to the corresponding response in the NDT data—supporting both clarity in results and transferability to field conditions.

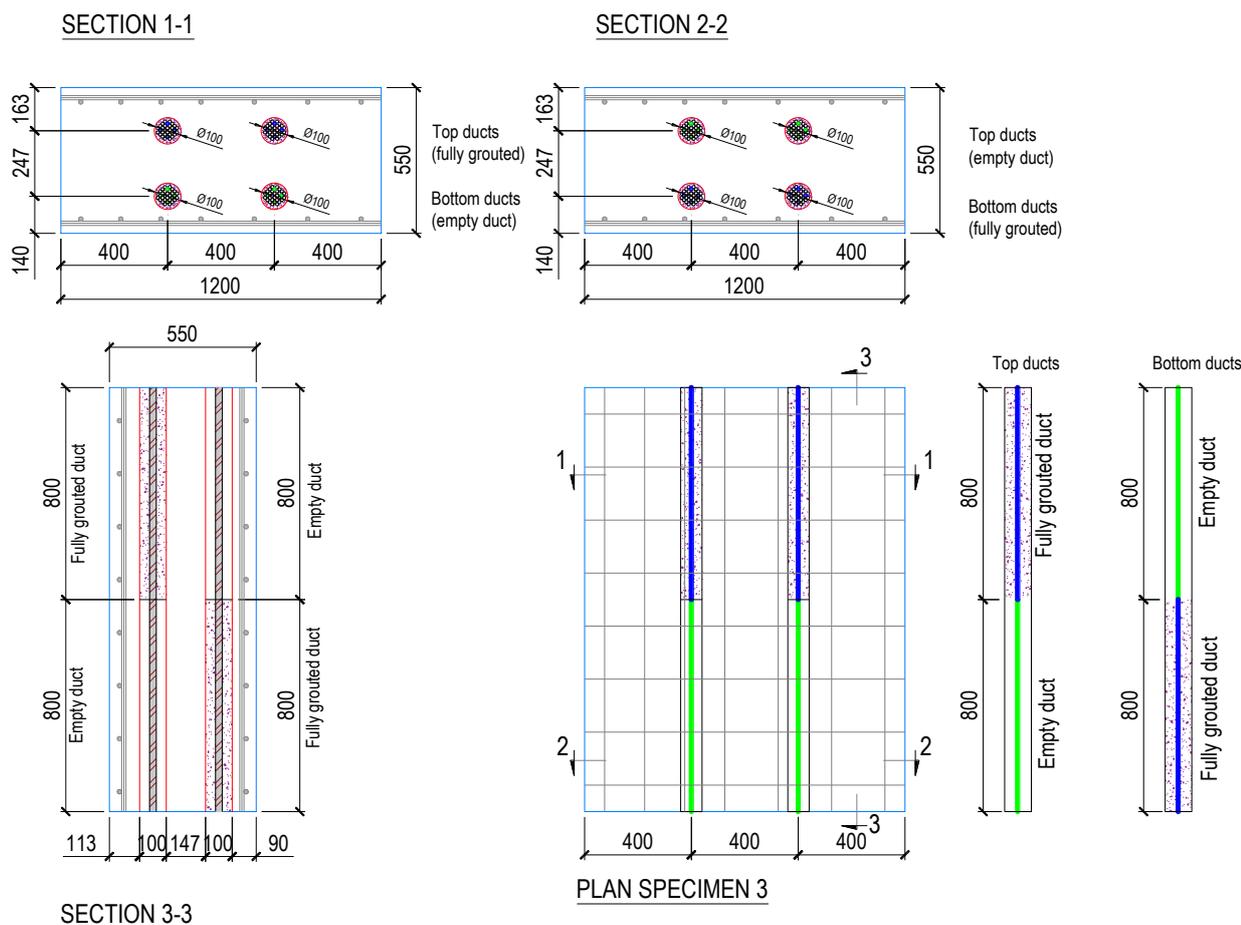
Figure 13 Design of specimen 3

Bottom layer: Two ducts, also alternating between grouted and empty segments, with the inverse pattern of the top layer to simulate alternating defect depth.

- Locate tendons in both shallow and deep positions.
- Distinguish between fully grouted and voided segments within the same duct.
- Assess the influence of tendon depth and grouting pattern on NDT results.
- Investigate signal interference due to alternating voids across depth layers—an artificial but instructive complexity.

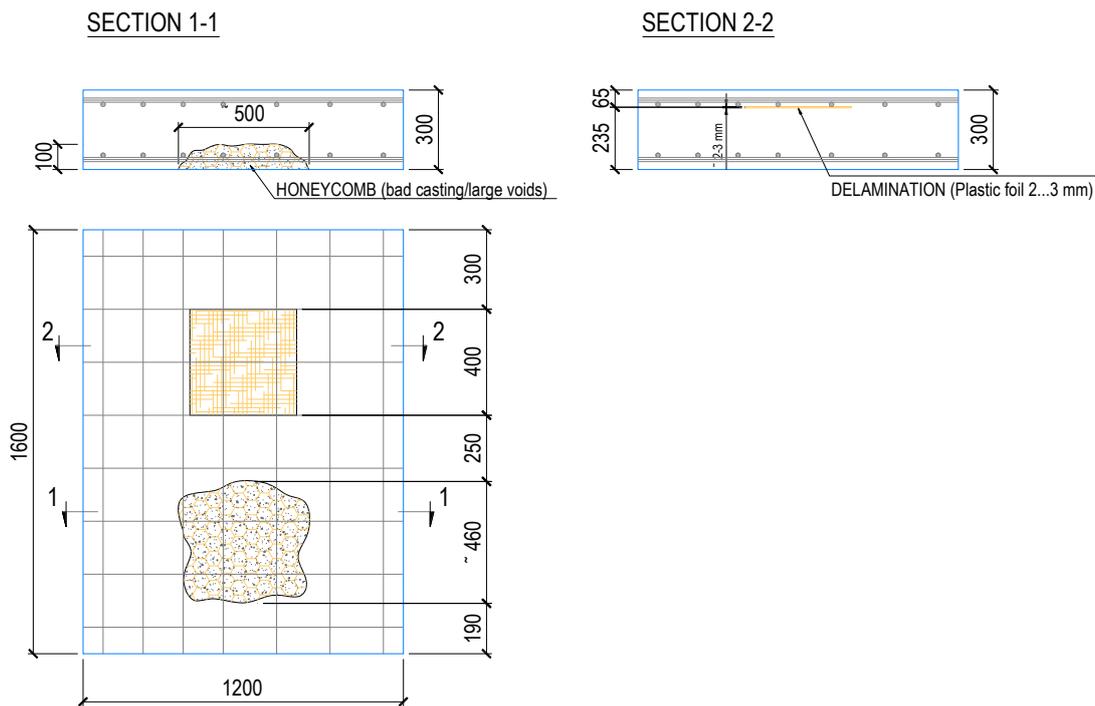
Figure 14 Design of specimen 4

The purpose of this specimen was to evaluate how well NDT techniques can detect and differentiate between delaminations and volumetric defects such as honeycombs, particularly when they occur at different depths. It also served to challenge both the capabilities of the inspection equipment and the interpretative skills of operators.

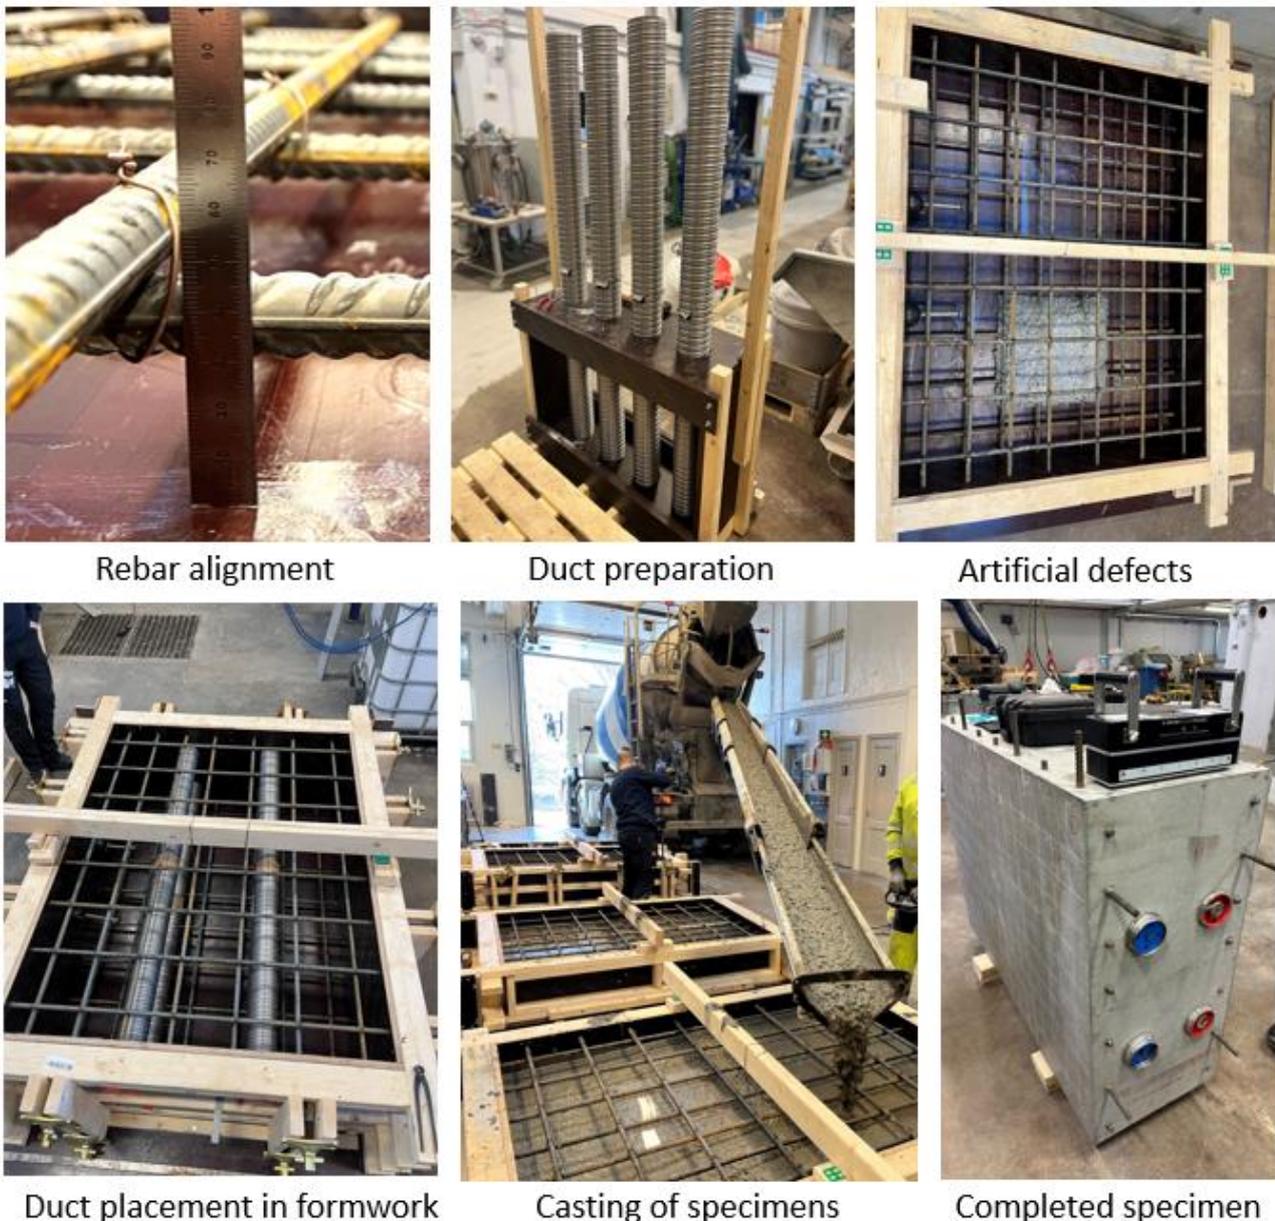
Figure 15 Fabrication process

1. Pre-fabrication of artificial defects separately from the specimens.
2. Grouting of ducts (where applicable) before placing them into the formwork.
3. Installation of surface reinforcement and tendon ducts into the prepared formwork, using alignment guides and fixed spacers to maintain correct positioning.
4. Concrete casting, carried out after a final inspection of all embedded components to confirm compliance with the drawings and defect layout.

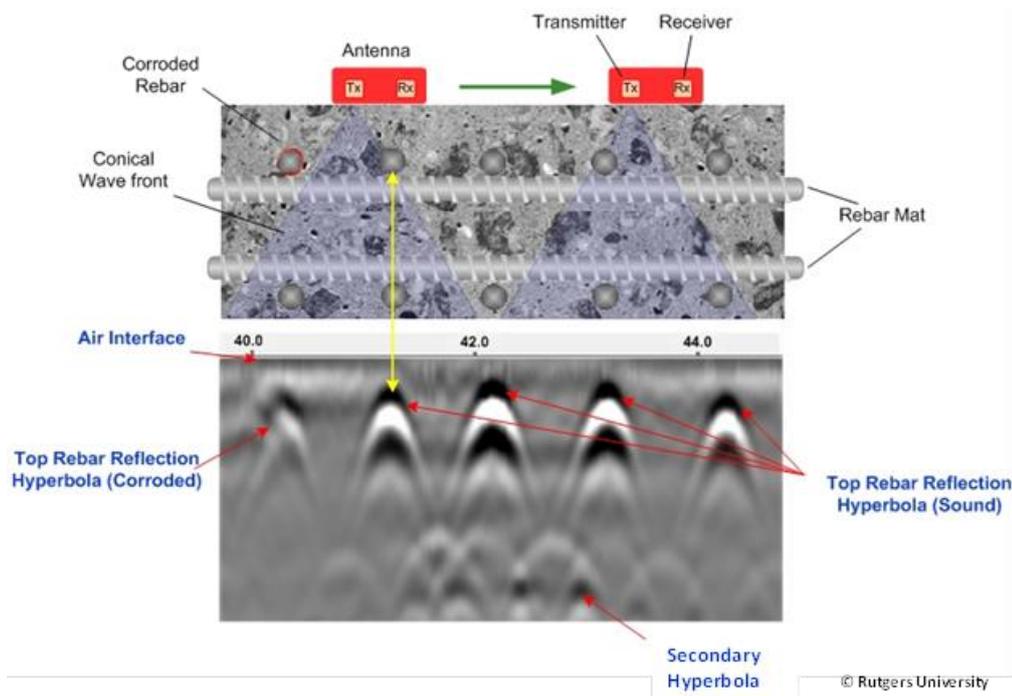
Figure 16: Ground-penetrating radar (GPR) (<https://fhwaapps.fhwa.dot.gov>)

Figure 16 provides an example of GPR usage. The evaluation of results heavily relies on existing algorithms and user interfaces. The possibilities and limitations of GPR inspection technology are discussed in Table 10, outlining GPR's capabilities and constraints.

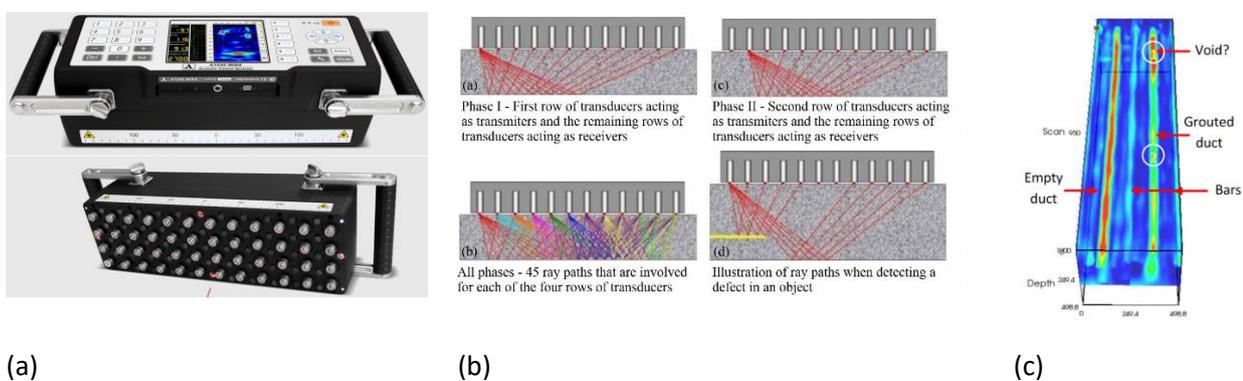
Figure 17: Shear wave tomography: (a) MIRA equipment; (b) working principle; and (c) MIRA 3D image grouted vs un-grouted tendon ducts (<https://www.germanninstruments.com>)

If there is a sufficiently large interface between concrete and air (a defect) inside the element, a portion of the emitted wave will be reflected by the defect, as illustrated in Figure 17c). MIRA equipment system consists of a phase-controlled antenna system, a portable computer with MIRA software (the software is based on SAFT - Synthetic Aperture Focusing Technique), and a power unit. To perform a scan, the user lays out a series of parallel scan lines on the surface to be examined. The signals captured by the antenna are automatically transferred to the computer, where the SAFT algorithm is used to reconstruct a 3D model of the concrete's internal structure.

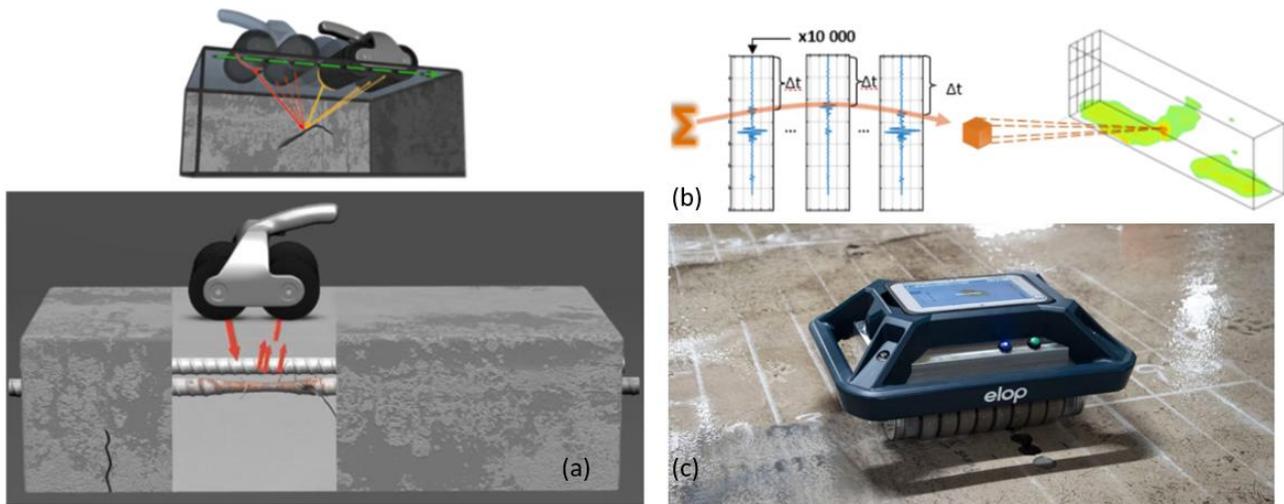
Figure 18: Elop Insight: (a) Ultrasonic signals sent and echoes received as the scanner moves; (b) SAFT delay-and-sum process; and (c) Elop Insight instrument (source: [SAFT \(Synthetic Aperture Focusing Technique\) for 3D image reconstruction and noise reduction in Elop Insight Ultrasonic Scanner - Elop](#))

high-speed mode, the scanner can be moved at speeds of up to approximately 1 m/s, equivalent to a normal walking pace.

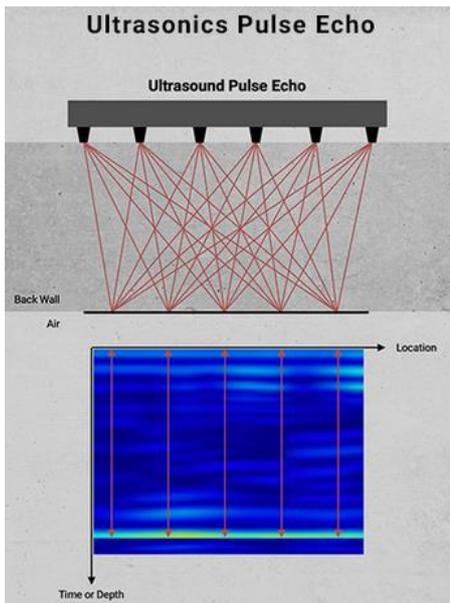
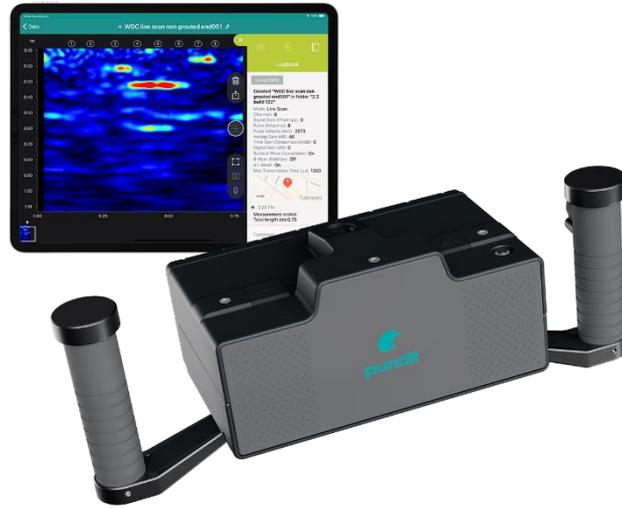
Figure 19: Ultrasonic Pulse Echo working principle and Proceq PD8000
<https://www.screeningeagle.com/en/products/pundit-pd8050>

The Ultrasonic Pulse Echo (UPE) equipment (Proceq PD8000 - Figure 19) is designed for non-destructive testing of concrete. The working principle is based on the reflection of ultrasonic waves within the material to detect internal features like voids, delamination, honeycombing, and thickness. An array of dry-point contact transducers (usually operating at ~50–100 kHz) generates a short, high-frequency ultrasonic pulse that enters the concrete surface. These are shear wave (S-wave) transducers, which are more sensitive to defects and propagate slower than pressure waves (P-waves), making interpretation easier in dense materials like concrete. The ultrasonic pulse travels through the concrete and reflects back when it encounters internal features like voids, delamination, or interfaces with different acoustic properties. These echoes are then captured by the receiver array, and the time it takes for the pulse to return is analyzed to determine the depth and location of the reflecting object. Advanced signal processing techniques convert this time-of-flight data into detailed 2D or 3D images, revealing the internal structure of the material.

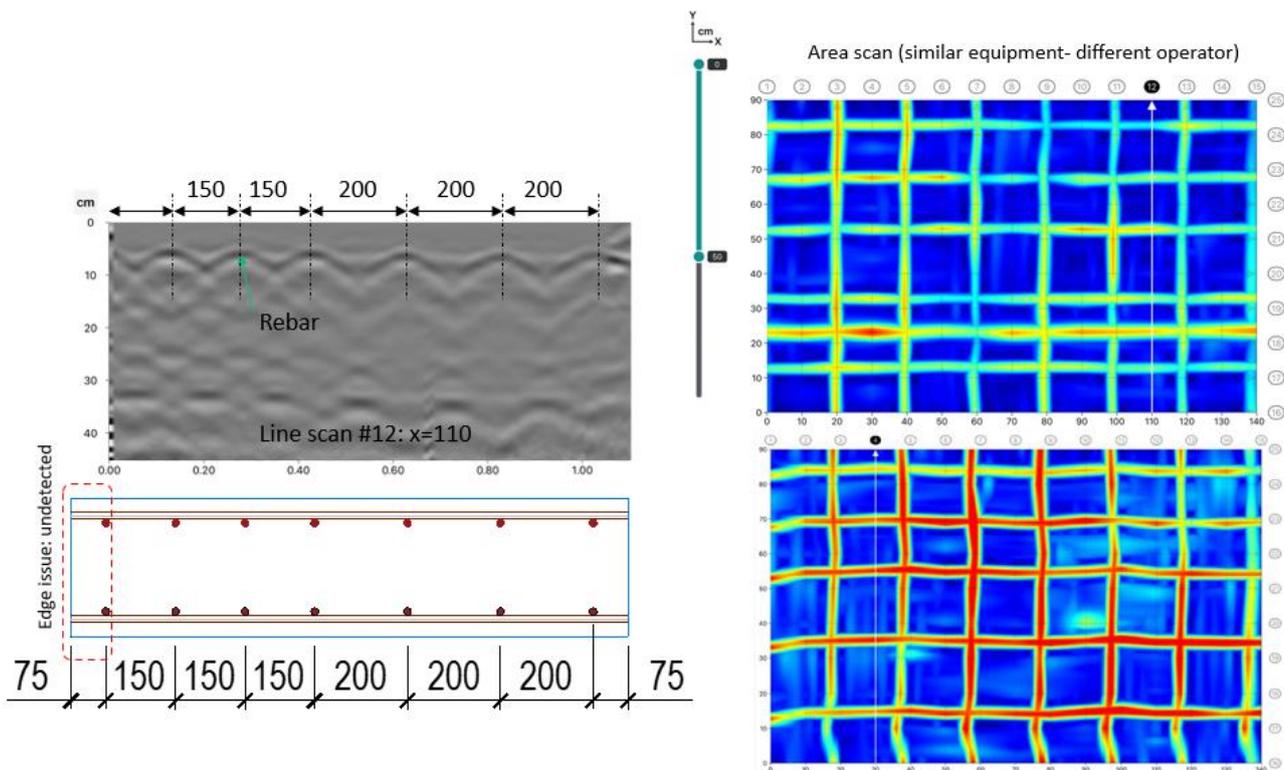
Figure 20. Surface reinforcement detection using the Proceq GP8000 GPR by two independent teams

Two teams employed the Proceq GP8000 GPR system independently but used similar scanning approaches. Despite slight variations in scan quality – possibly due to operator technique or post-processing – both produced clear and reliable results (Figure 20). The mesh of longitudinal and transverse bars was consistently visible, confirming that GPR was effective and user-friendly for mapping surface reinforcement across all specimens.

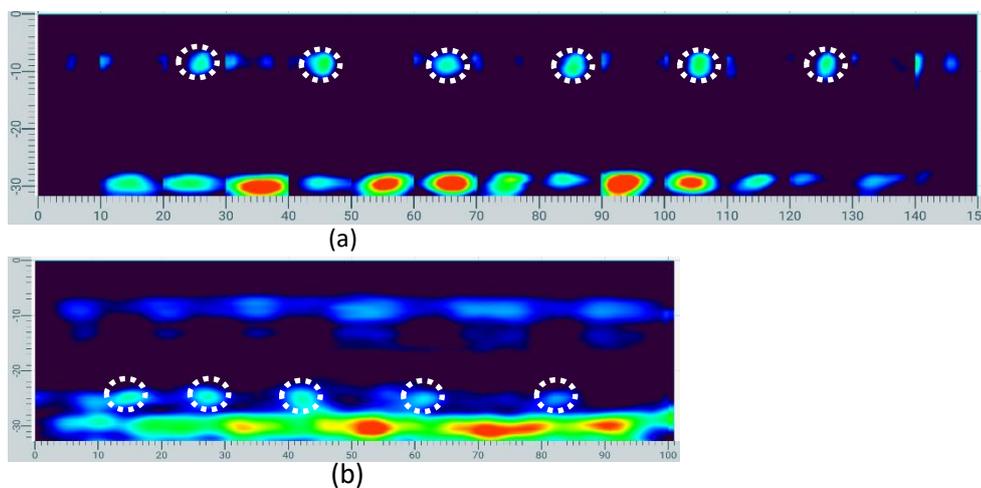
Figure 21. (a) B-scan showing reflections from the top transverse rebars, along with backwall echo at 30 cm depth. (b) D-scan showing weaker reflections from the bottom longitudinal rebars.

Overall, the ultrasonic approach demonstrated some potential to detect surface reinforcement, particularly with advanced post-processing. However, the results (Figure 21 and Figure 22) were weaker and less consistent compared to GPR-based scans, especially for shallow and small-diameter rebars.

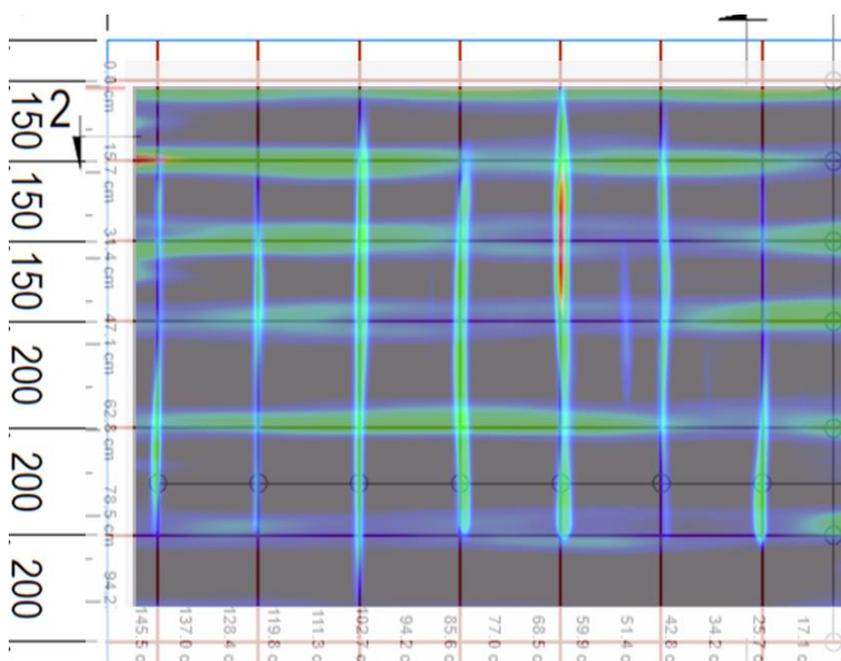
Figure 22. C-scans from the first reinforcement layer superimposed on the drawing for specimen 1.

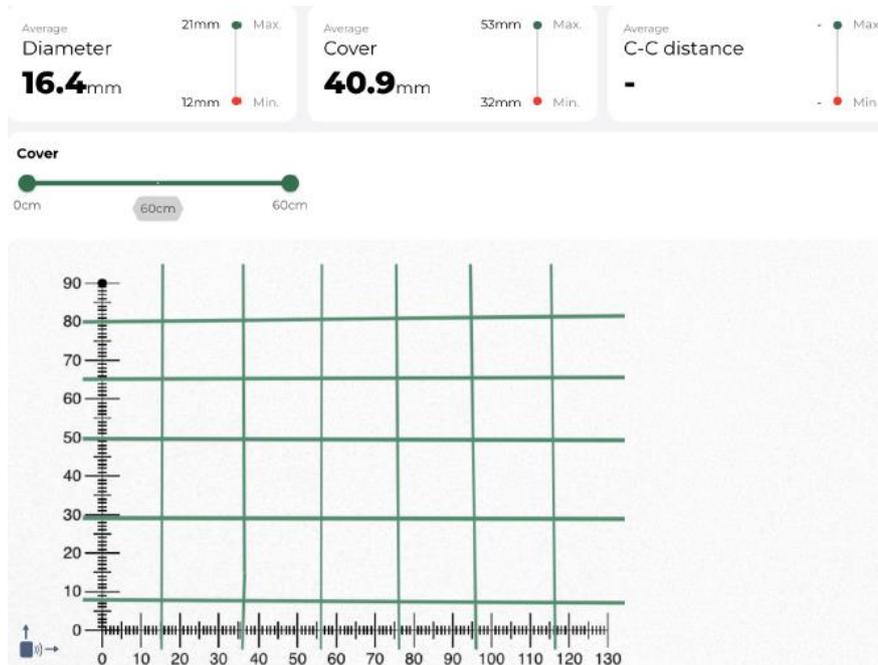
Figure 23. Automatically reconstructed rebar mesh based on GPR data processed with advanced signal interpretation algorithms

The rebar layout was mapped across the entire scanned area, with estimated spacings of 150 mm and 205 mm aligning well with the actual values of 150 mm and 200 mm – showing a maximum deviation of only +5 mm (Figure 23).

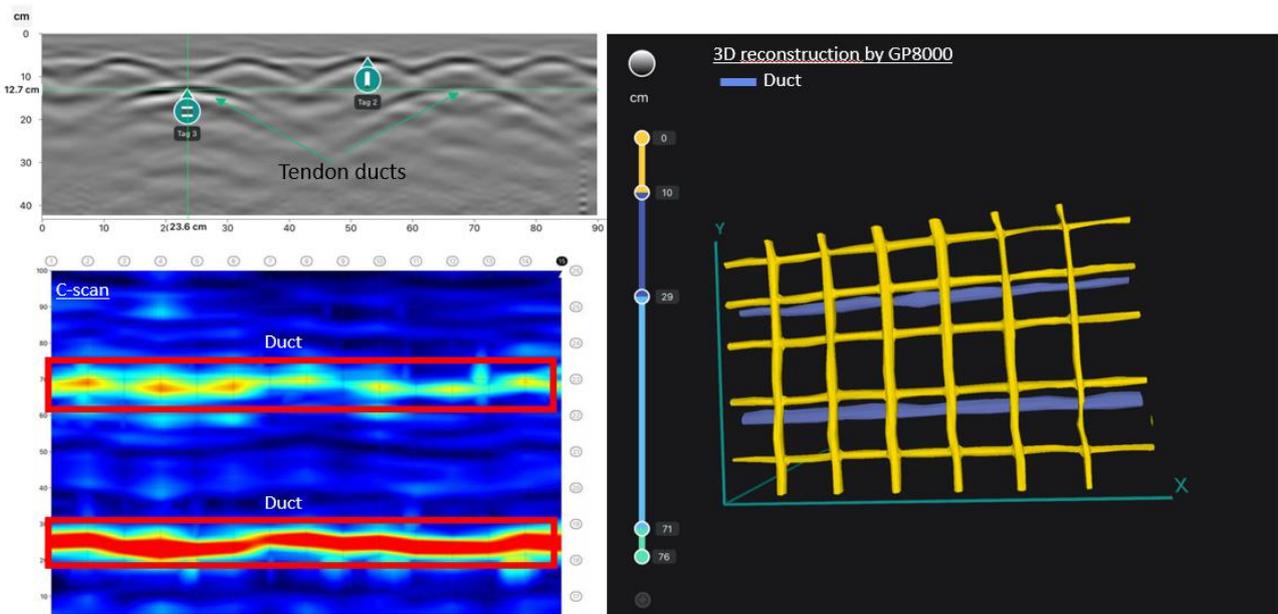
Figure 24. First layer duct detection (specimen 3) using the Proceq GP8000 GPR by two independent teams

Importantly, when assessing the presence of a second layer of ducts – deeper and closer to the backwall – the results were more ambiguous. In the 2D scans, reflections from the second layer were weak and difficult to distinguish confidently from background noise or signal interference.

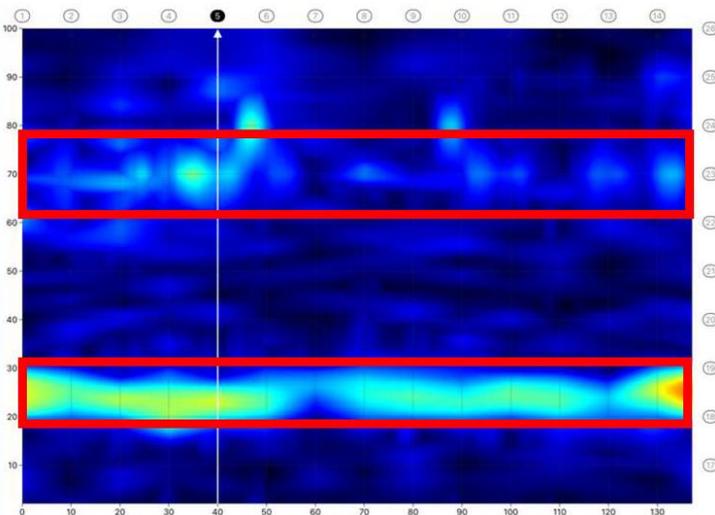
Figure 25. Attempt to detect the second layer of ducts in Specimen 3 using a C-scan from the GP8000.

Team 2 was able to indicate possible traces of this deeper layer in their C-scans, as highlighted in boxed regions, but the signal was faint and fragmented (Figure 25). This reduced clarity is not primarily due to the depth itself – since 360 mm is within the effective range of GPR – but rather the result of the duct geometry and alignment. The large duct diameters, combined with their vertical stacking and limited separation, created a shadowing effect where reflections from the upper layer obscured or interfered with signals from the lower ducts, making the second layer more difficult to interpret with confidence.

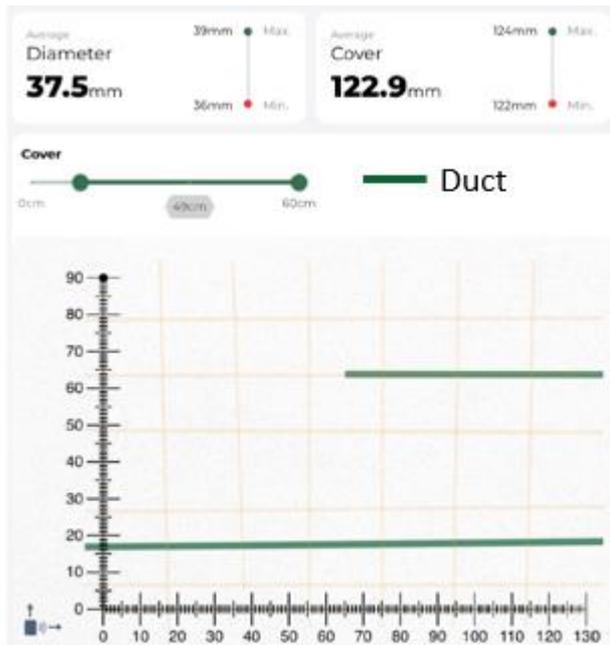
Reinforcement mesh + ducts: GP8800+ML

The final team employed the GP8800 GPR system enhanced with machine learning algorithms show successful detection and visualization of the first layer of tendon ducts (Figure 26). However, the second layer of tendon ducts was not identified in the output.
