Development and verification of NDT for detecting voids in tendon ducts

Validation through mock-up specimens for post-tensioned concrete structures

Report no.: 2025:01222

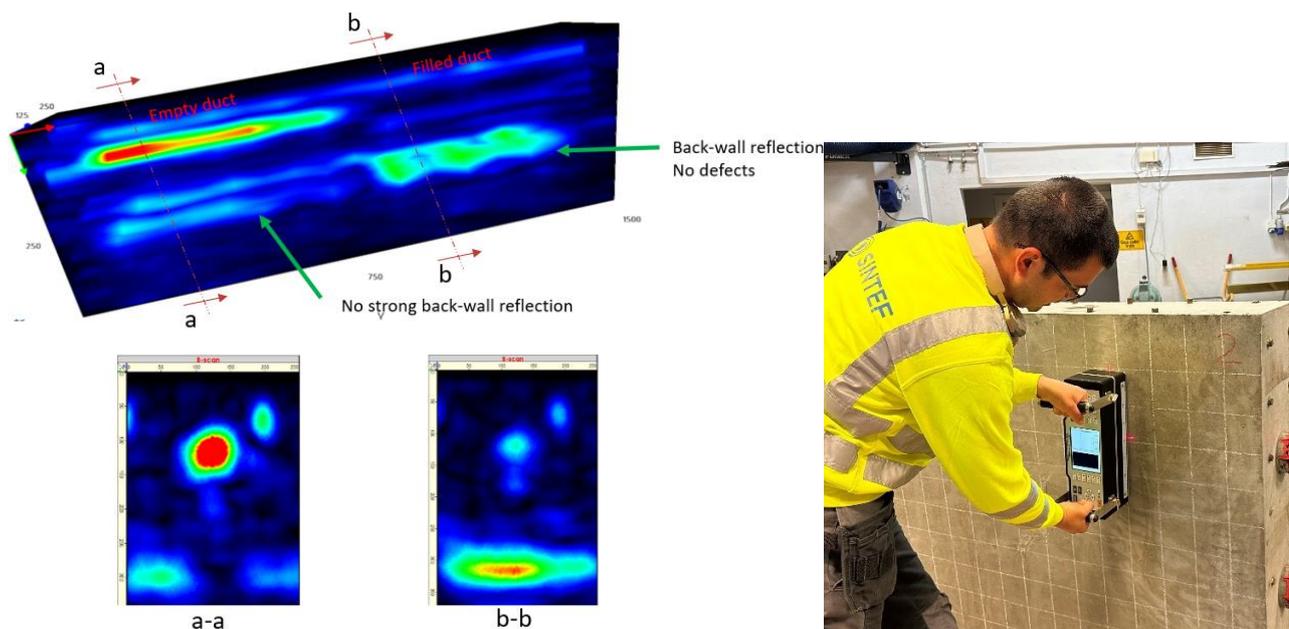
Figure 27. Mira scanning along tendon duct showing void vs grouted duct.

One team employed the Mira device, a synthetic aperture ultrasonic tomography system, to evaluate grouting condition inside the tendon ducts (Figure 27). Following duct path identification using GPR and physical marking on the concrete surface, Mira scans were conducted at intervals of 10 cm along each tendon. The recorded B-scans were post-processed to construct a 3D C-scan volume, allowing clear interpretation at the duct depth. In the resulting image, filled and empty duct segments are distinctly identifiable based on the intensity distribution at the duct level and, more importantly, the presence or absence of a back-wall reflection at 300 mm depth (i.e., the specimen thickness).

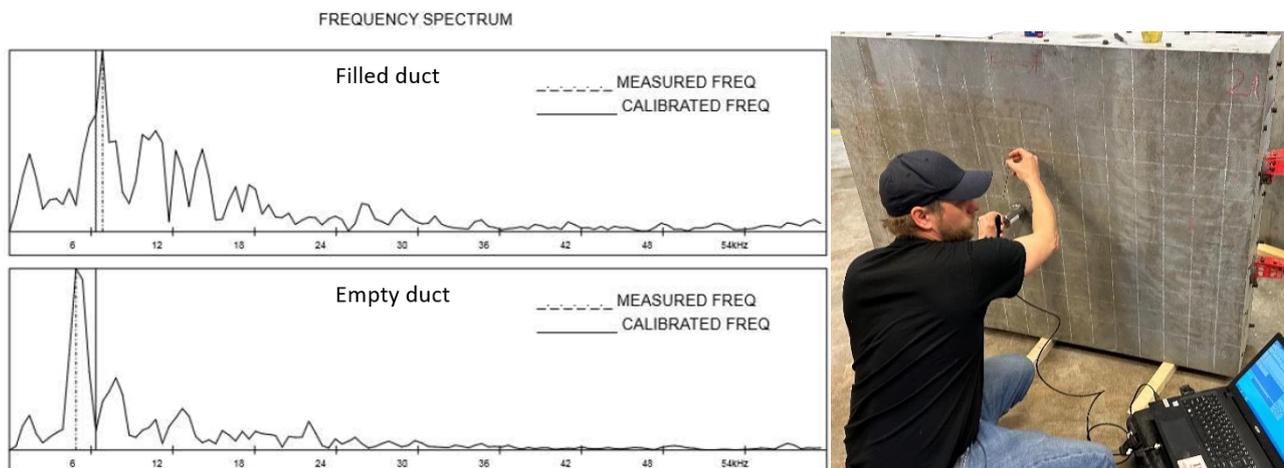
Figure 28. Impact-Echo frequency spectra showing a clear peak for the filled duct and a damped response for the empty duct, indicating internal void presence

This contrast between the two conditions is evident in the comparison of the measured and calibrated frequency spectra: the filled duct spectrum shows well-defined resonant peaks, while the empty duct spectrum appears damped and irregular.

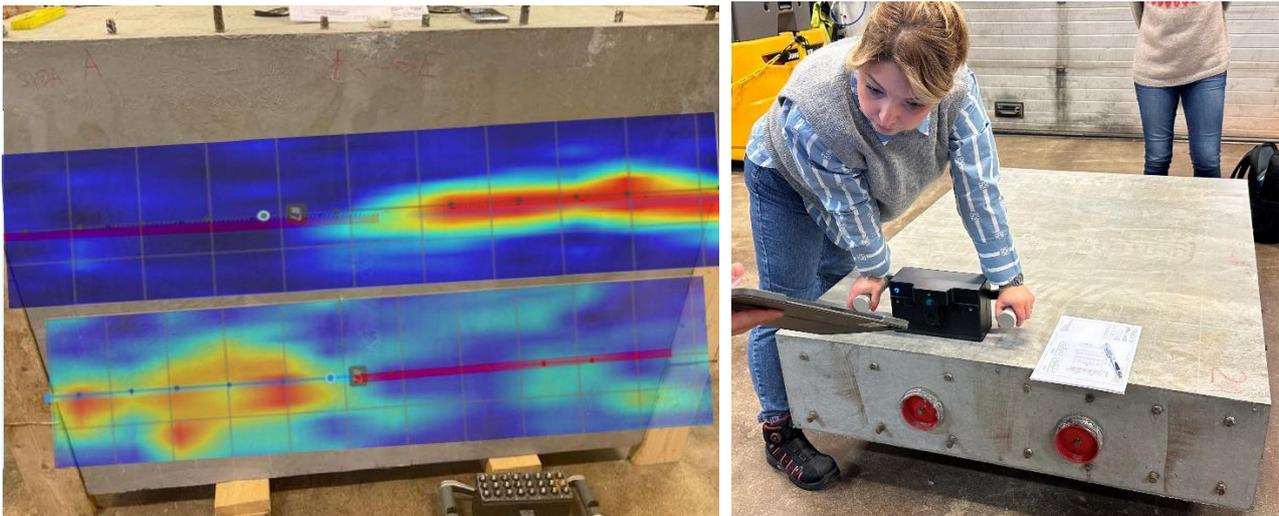
Figure 29. Pulse Echo (Proceq) scan on the side face of the specimen

Pulse Echo device (Proceq) was used to scan the side face of a concrete element known to contain two tendon ducts (the first layer). The resulting image (Figure 29) overlays a color map onto the physical surface of the specimen, where the intensity of colors corresponds to the amplitude of reflected ultrasonic signals. The goal was to evaluate whether differences in duct grouting condition (filled vs. ungrouted) could be inferred from the color distribution alone. While both ducts are visible in the scan, the reflections appear diffuse and lack sharp contrast, making it difficult to confidently differentiate between filled and empty ducts based solely on the visual intensity pattern. Although, in theory, ungrouted ducts should generate stronger reflections due to impedance contrast, in practice, interpretation remains challenging without prior knowledge or confirmation from another method. Thus, distinguishing between filled and unfilled ducts using only the Pulse Echo color map would require either strong operator experience or additional supporting data, underscoring the need for multi-method approaches or validation through techniques like Impact Echo or ultrasonic tomography.

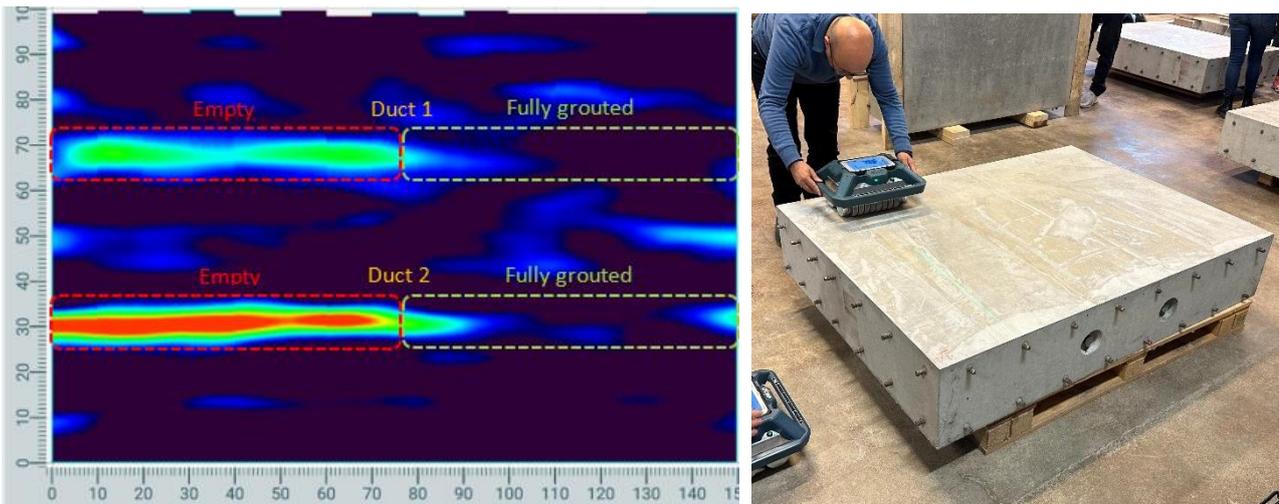
Figure 30. Elop Inshight - Method 1, area scan crossing the ducts

Finally, the Elop Insight team employed a roller-based ultrasonic system to inspect the ducts for voids (Figure 30). Three scanning approaches were tested: (1) area scan crossing the ducts, (2) area scan parallel to the ducts, and (3) single-line scan along the duct path. All methods successfully identified the empty portions of the ducts, which produced significantly stronger direct reflections in the C-scan images. In contrast, the grouted sections typically resulted in lower signal amplitudes, often falling below the amplitude threshold and thus appearing faint or absent in the scans. The results also demonstrated that voids could be inferred through changes in the backwall reflection. Specifically, the empty segments of the ducts created shadow zones at the backwall due to nearly complete signal reflection at the concrete–air interface. Conversely, the grouted portions allowed partial transmission through the duct material, preserving the visibility of the backwall echo. Among the three scanning strategies, all showed comparable results in terms of void detectability. However, method 2 (parallel scan - Figure 31) appeared slightly clearer in image quality, while method 1 (cross-scan - Figure 30) offered strong signal-to-noise ratio and coverage. Method 3 (single-line scan - Figure 32) proved to be an efficient approach when duct positions were known in advance and accurately marked, offering high-quality results with improved time efficiency.

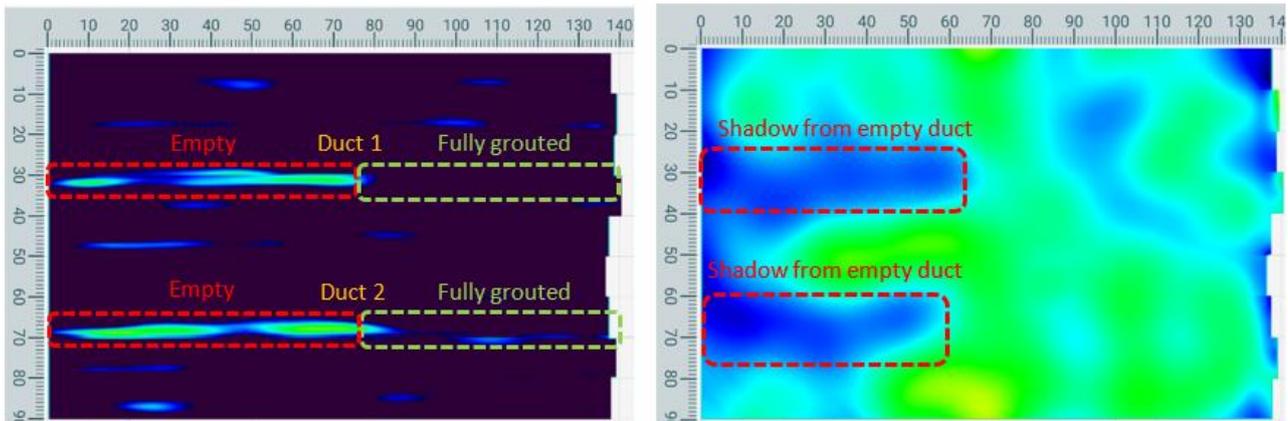
Figure 31. Elop Inshight - Method 2, area scan parallel to the ducts

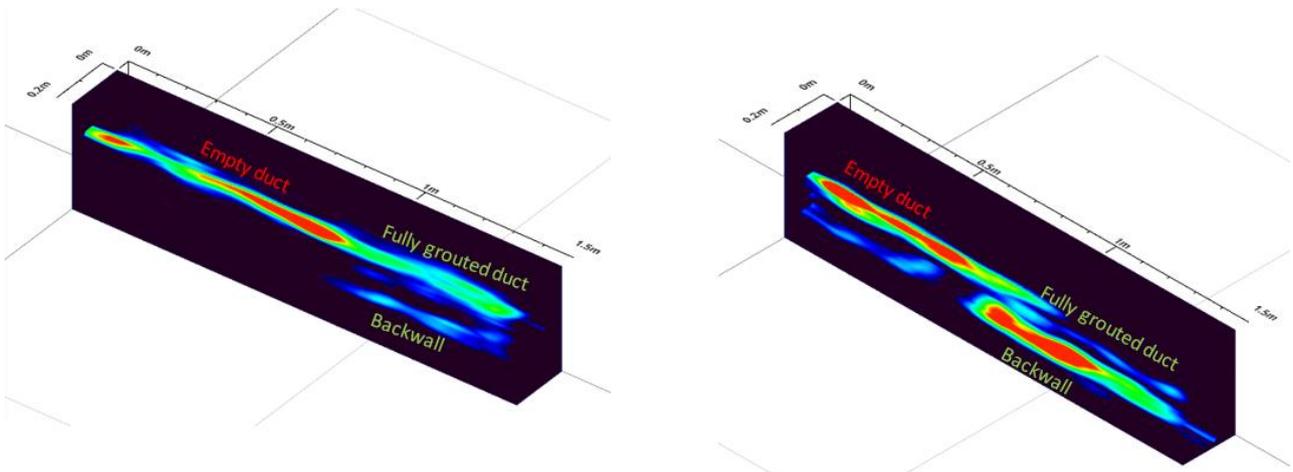
Figure 32. Elop Inshight - Method 3, single scan following the ducts

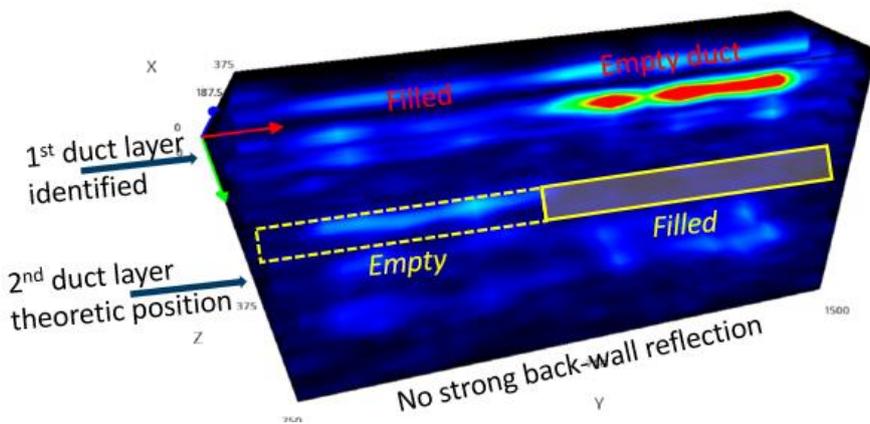
Figure 33. Mira scan performed along the duct axis in an attempt to detect voids within the second layer of tendon ducts

One team, using the MIRA ultrasonic tomography system, attempted to detect voids in the second duct layer positioned behind a full duct in the first layer. As shown in Figure 33, while the first (outermost) layer was successfully imaged – clearly distinguishing between filled and empty segments – there was no clear indication of voids in the second, deeper duct layer. The absence of strong reflections or back-wall signatures suggests that wave interference and shadowing from the first layer likely hindered detection. This highlights the limitations of current tomography approaches in resolving features behind complex or layered ducts.

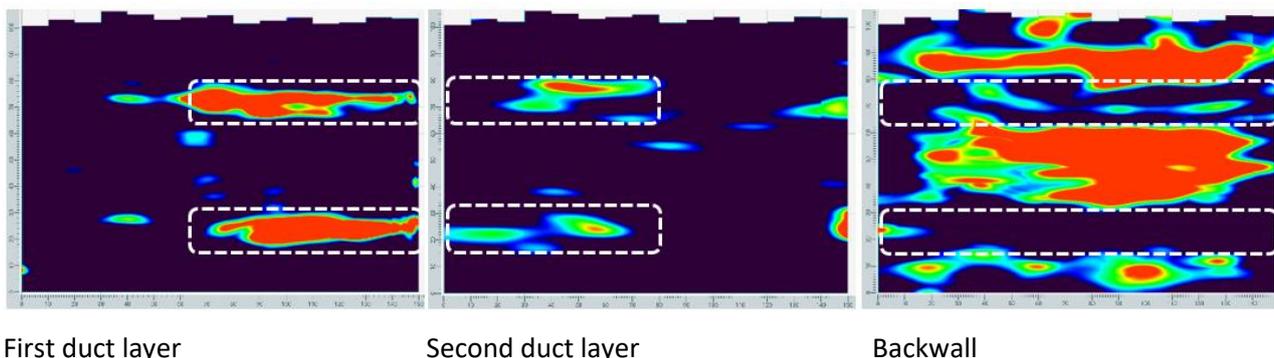
Figure 34. Elop insight C-scans from Specimen 3 frontside

The scanning was performed first from front side of the specimen (Figure 34). The team presented C-scan images at three depth intervals: the depth of the first (front) duct layer, the second (obstructed) duct layer, and the backwall of the specimen. For the first duct layer, the results were clear and consistent – the scanner was able to distinguish between the filled and empty sections, with the empty regions producing significantly higher amplitude reflections. This result was repeated and confirmed when scanning was performed from the backside of the specimen (Figure 35). At the depth of the second duct layer, which lies behind the first, the situation was more complex. The scanner was still able to capture some fragmented high-amplitude reflections in locations corresponding to the empty regions, suggesting that ultrasound waves did manage to partially penetrate the filled first layer and reflect off the voids behind it. However, these reflections were less clear. This made interpretation more uncertain and indicated the limits of detectability under such conditions. Finally, C-scans taken at the backwall depth showed clear shadowing effects across the length of the ducts. In particular, when voids were present in either duct layer, the ultrasonic signals were almost entirely blocked, resulting in a distinct absence of backwall reflection. This indirect evidence was used by the team to support the presence of voids, even when direct imaging was inconclusive (Figure 36). These results reflect both the potential and the current limitations of one-sided ultrasonic scanning in congested structural conditions.

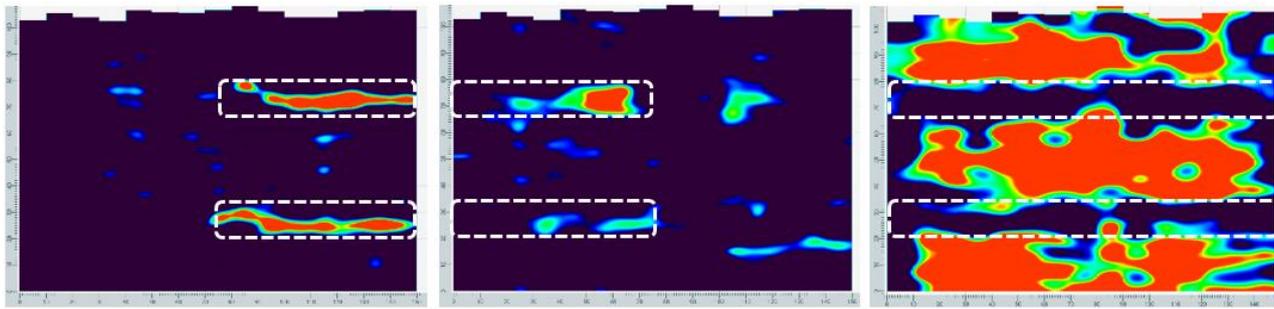
First duct layer

Figure 35. Elop insight C-scans from Specimen 3 backside

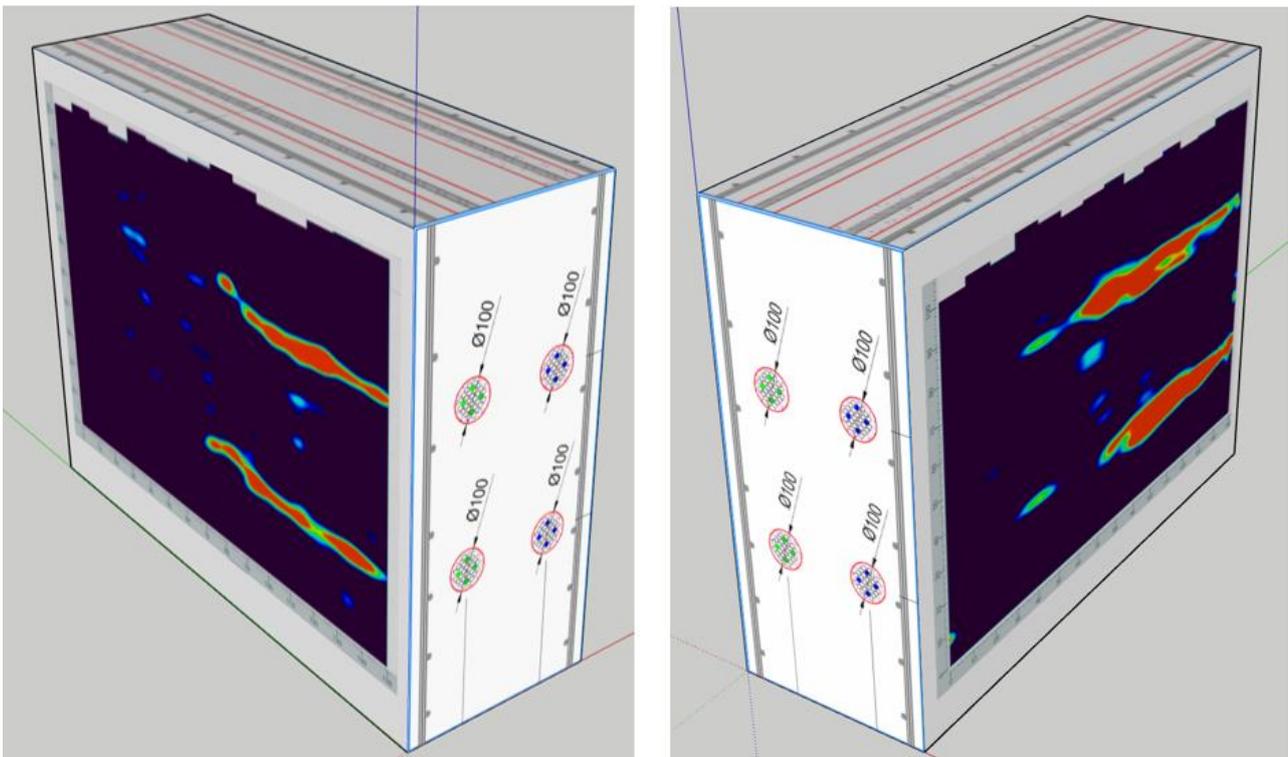
Figure 36. C-scans of the first layer of tendon ducts obtained from both faces of Specimen 3, superimposed on a rectangular block model along with the reference drawings

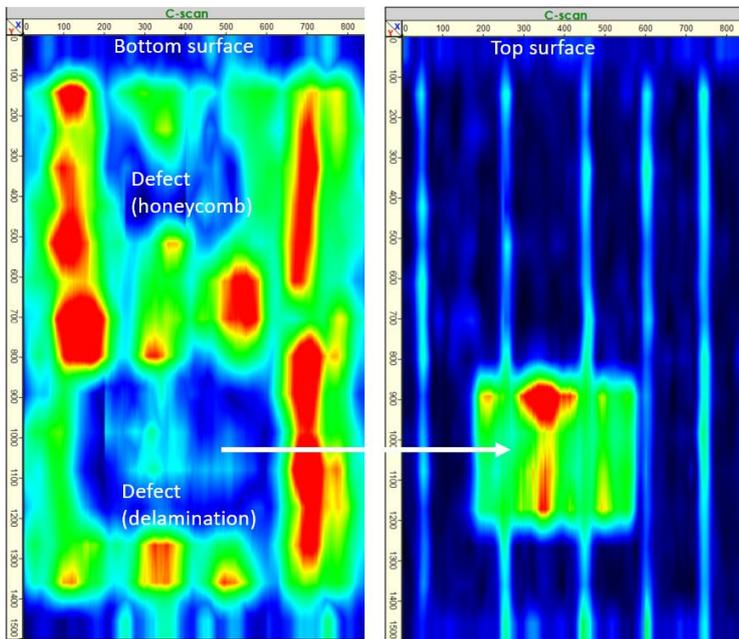
Figure 37. MIRA scans showing delamination/honeycombing inside Specimen 4

defects such as delaminations and honeycombing to be localized and distinguished based on their vertical position and signal amplitude.

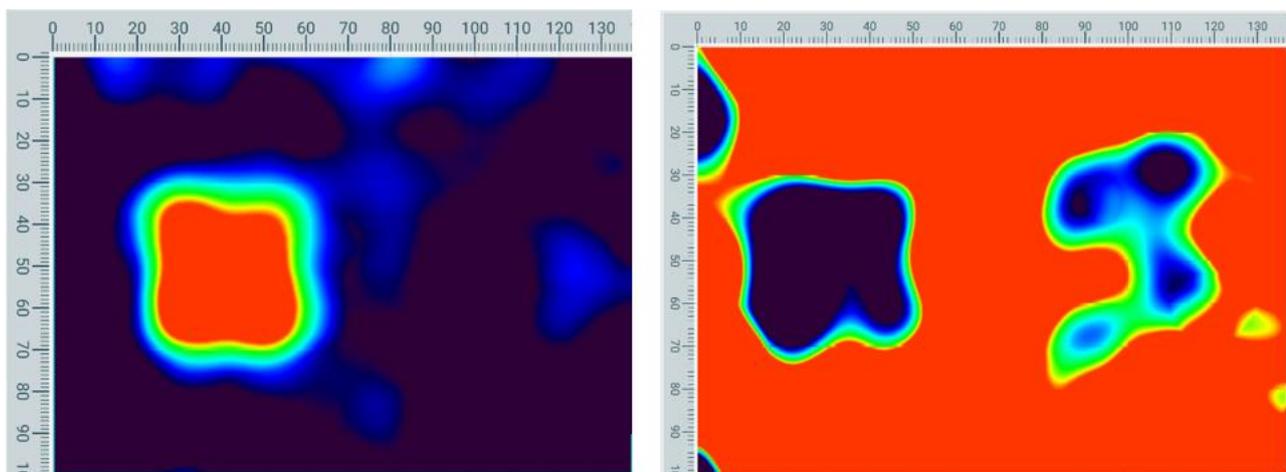
Figure 38. Elop Insight scans showing delamination/honeycombing inside Specimen 4

Based on the results presented in Figure 38, the ultrasonic roller successfully detected internal defects including delamination and honeycombing. A C-scan taken at a depth of 10–15 cm using a center frequency of 100 kHz revealed a clear and distinct reflection from a delaminated area approximately 40 × 40 cm, closely matching the known defect location. While honeycombing was not as clearly distinguishable through direct reflections – likely due to general scattering from large aggregates – it was nonetheless detected through characteristic shadowing observed in the backwall echo at 30 cm depth. This shadowing, visible even more distinctly in a scan using a higher 150 kHz frequency, aligns with both the delaminated and honeycombed regions. Thus, even when direct imaging is inconclusive, backwall shadowing can serve as a reliable indicator for evaluating the extent of internal damage such as delamination and honeycombing.
