# Lessons Learned from Offshore Wind (OSW)

# Data Background

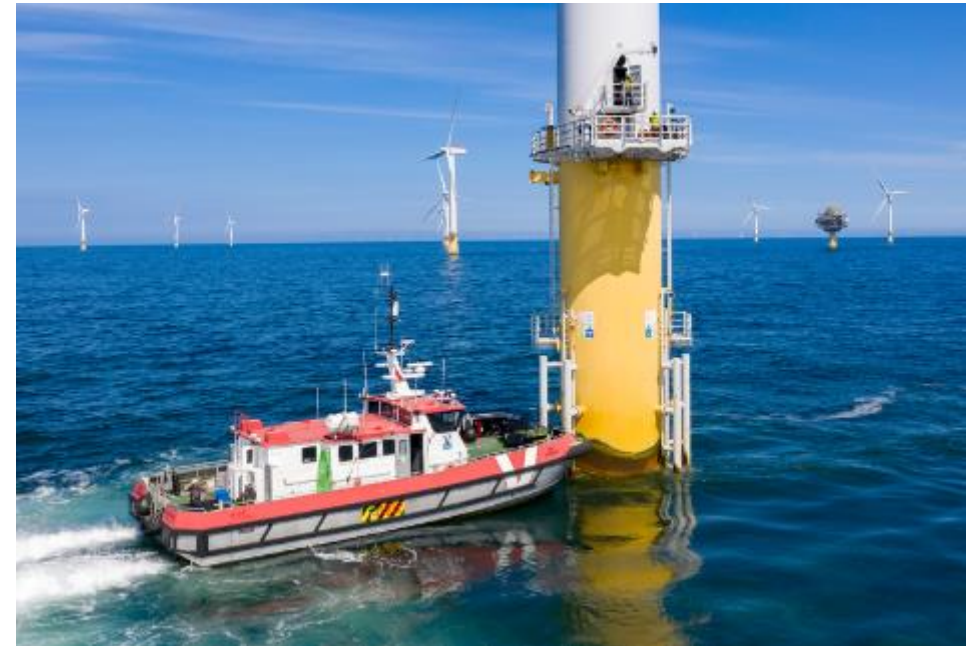
## OSW Incident area analysis: Crew Transport Vessels (CTVs)

CTVs are used to transfer personnel to and from offshore wind farms. Therefore, incidents involving CTVs can impact many individuals. In 2020, one incident involving a CTV caused three first aid injuries.

- Main incident area in 2020:
  - 79 incidents
  - 27% of the incidents were high potential
  - 37% of lost work day incidents – manual handling
- Improvement measures:
  - Constant overview on the bridge
  - Mandatory use of seatbelts
  - 2021 G+ CTV workstream focus on: fatigue, manning levels, vessel suitability and manual handling improvements

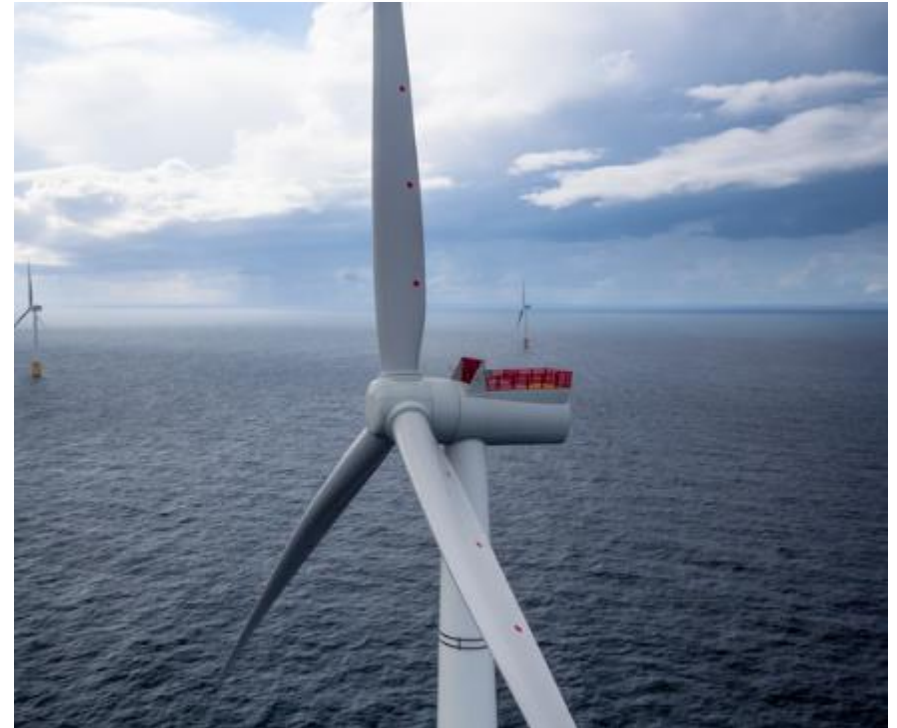
## OSW Incident area analysis: Nacelle

The nacelle is the housing at the top of a wind turbine which houses the generating components such as generator, gear box, and drivetrain. It is the area with the greatest number of accumulated historical incidents.

Most incidents within the nacelle occurred while undertaking routine maintenance tasks.

Lost workday injuries within nacelle increased by 33% as a result of manual handling incidents.

- Turbine design
- Maintenance practices to decrease exposure to hazards
- Standardization of procedures within the nacelle

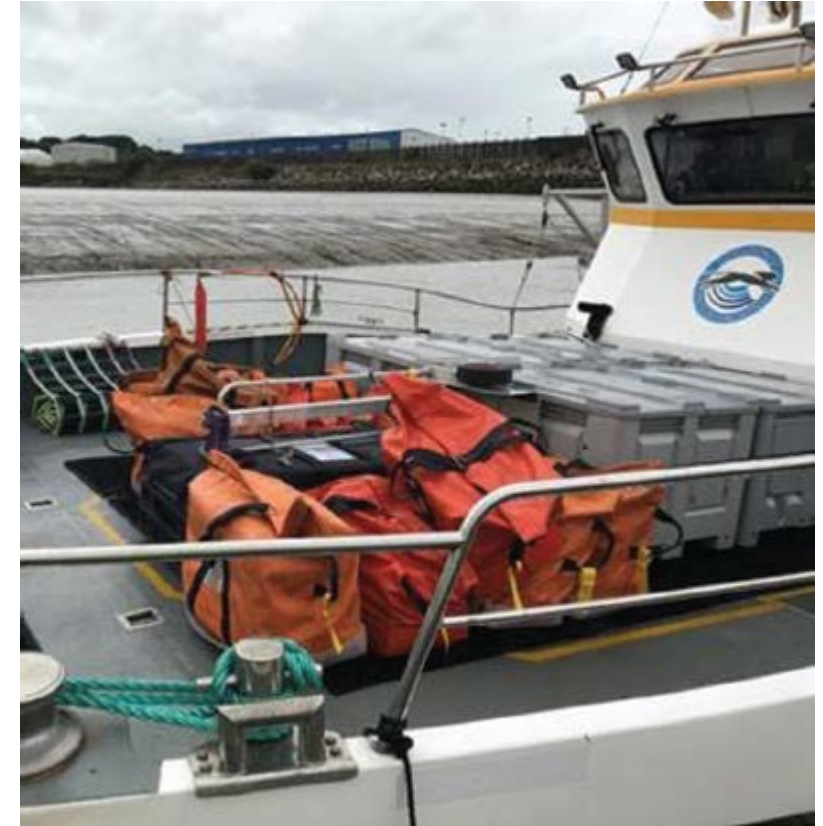
## OSW Case Study of Manual Handling: CTV

**Moving items around on CTV:** technician strained back while moving equipment around on deck.

- Common for a CTV to transfer number of teams to different assets
- Consequently, can be large number of bags on board
- Space limited so may be need to move and lift over other bags
- This 'double handling' increases frequency of lifts
- Movement of vessel throws people off balance
- Bags vary in weight, shape and size – unanticipated heavy load
- Time pressure may influence poor handling

- Avoid or limit use of CTVs with different levels in deck storage and lifting areas
- Create demarcated areas so items for one asset can be grouped easily

- Provide scissor lift or equivalent to help raise items to different level
- Provide slip ramps so items can be more easily moved up stairs

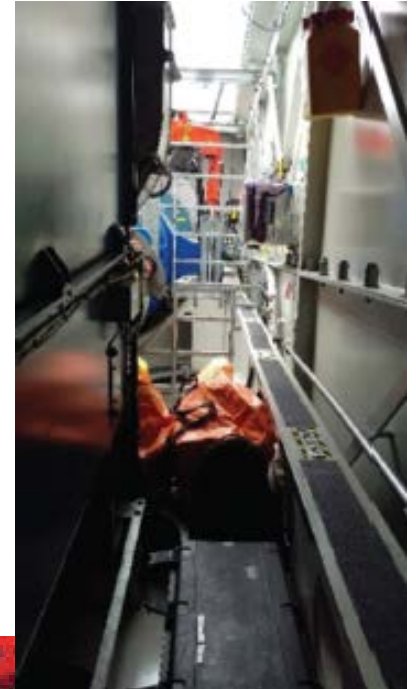
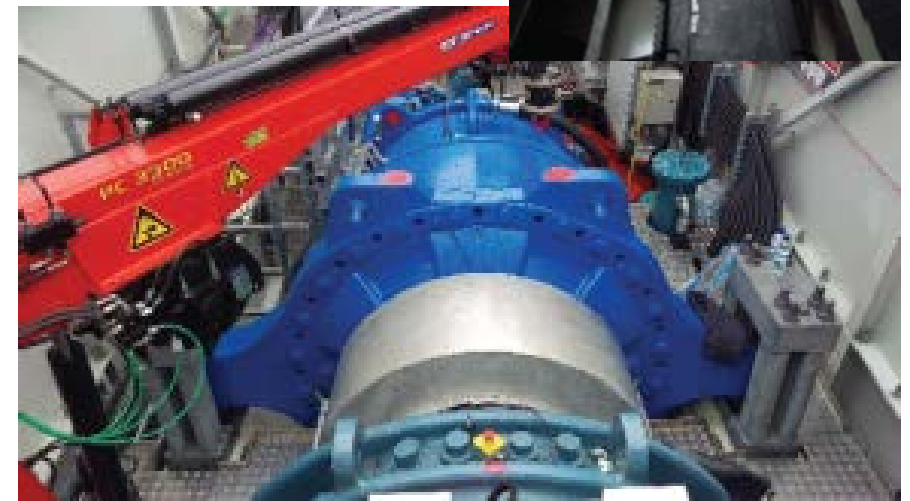
# OSW Case Study of Manual Handling: Nacelle

**Maintaining equipment in nacelle:** technician was working in nacelle unfastening bolts on brake calipers, the bolt released suddenly and the tech struck head against shaft cover.

**Working in nacelle:** operator tightening bracket down a shaft using long T bar with Allen key end. Small, tight area required arms extended upwards through gap. Report from operator of tingling sensation in hand.

- Majority of service/maintenance activity performed in nacelle
- Despite range of tasks, many similarities, such as:
  - Movement of tools, kit bags, consumables, parts and equipment, etc.
  - Preparation of work area
  - Clean up, pack away, transfer to next task
- Retrofitting equipment after installation can be difficult to complete
- Workspace generally limits
- Floors may not be level in some turbine nacelles
- Limited pace making tool use difficult
- Awkward body positioning – small spaces, tight angles, arms outstretched

- At design stage, sizing nacelle for sufficient people access
- Ensure known high failure/service items positioned and located for easier access

- Design for safe access for maintenance
- Develop custom tools/equipment – lighter, extendable
