WP8, Deliverable D25 End-user test report

**Computer Aided REhabilitation of Sewer networks.
Decision Support Tools for Sustainable Sewer Network Management**

**REPORT ON END-USER TEST RESULTS OF THE CARE-S
SOFTWARE**

Trondheim, November 2005

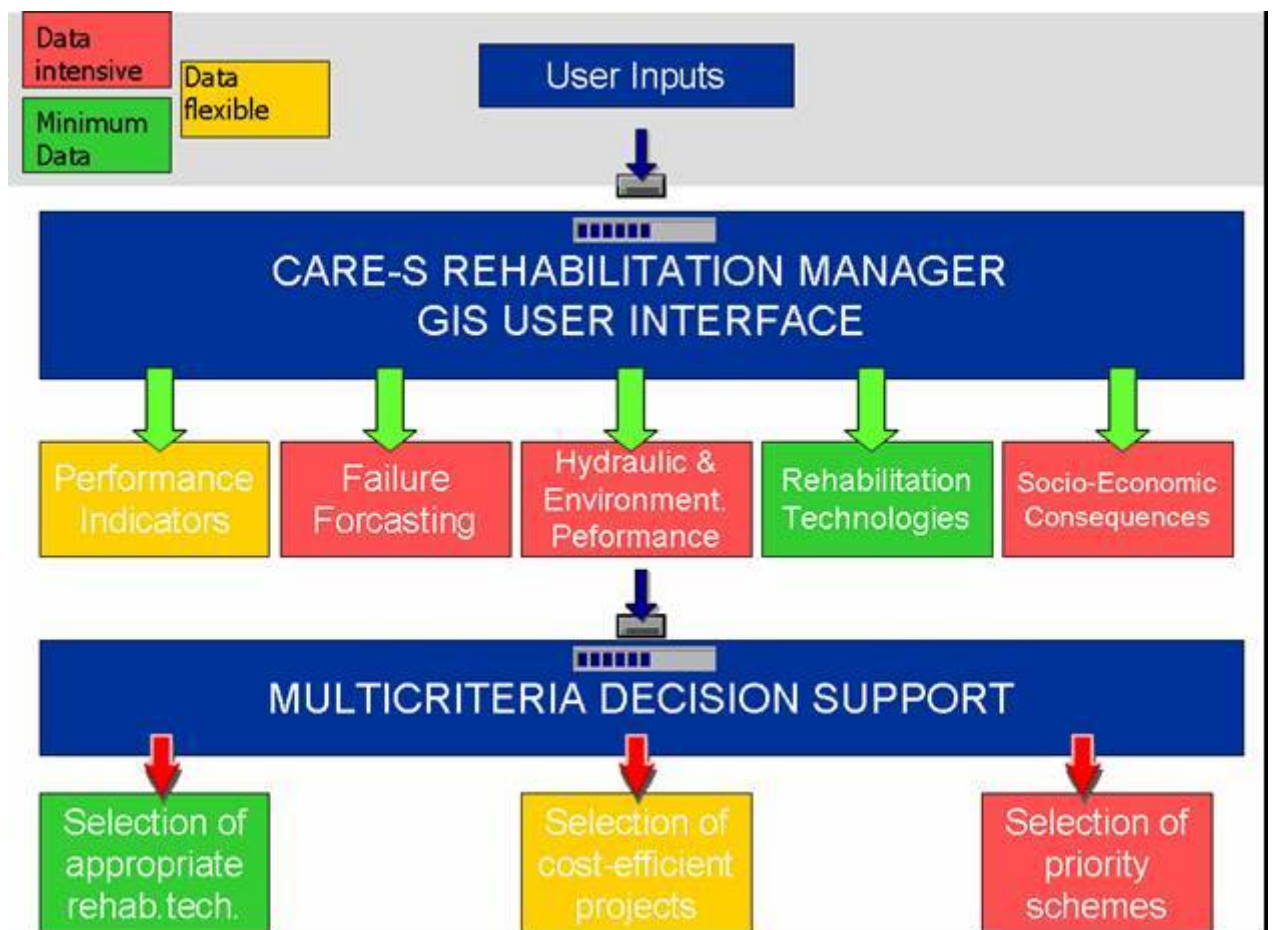
Figure 8: CARE-S flow chart and tools data demanding.

One of the objectives of *CARE-S* is for the software to be applicable to both data-rich and data-lean networks. Data availability influences the way the *CARE-S Rehab Manager* can be used. Some of the *CARE-S* modules are more data-consuming than others. The advanced user with updated GIS, digital maintenance records, calibrated hydraulic network simulation models, etc. can use all the functionality *CARE-S* provides. However, users with fewer data can also benefit, but will more than likely adopt a different path through the software (Figure 8). Exactly which tools to use should be decided case-by-case, based on an evaluation of availability and quality of data.

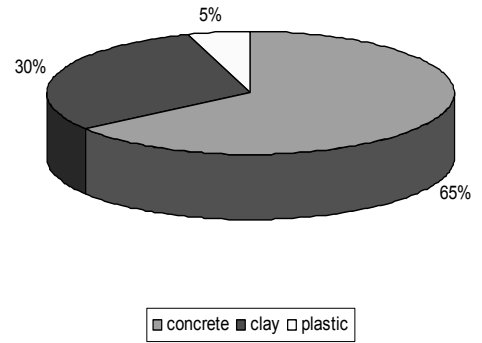
Figure 2 Material distribution

The sewer system has a total length of 26 km and it contains three main sewers A, B, C. The drainage system includes 732 pipes and 739 manholes, 8 weirs and 5 pumping stations. It is mainly combined sewer system, average impermeability coefficient is of 0,34, average pipe depth is 3 m below the ground level. Pipes cross section is of 96% circular, the rest is egg-shaped.

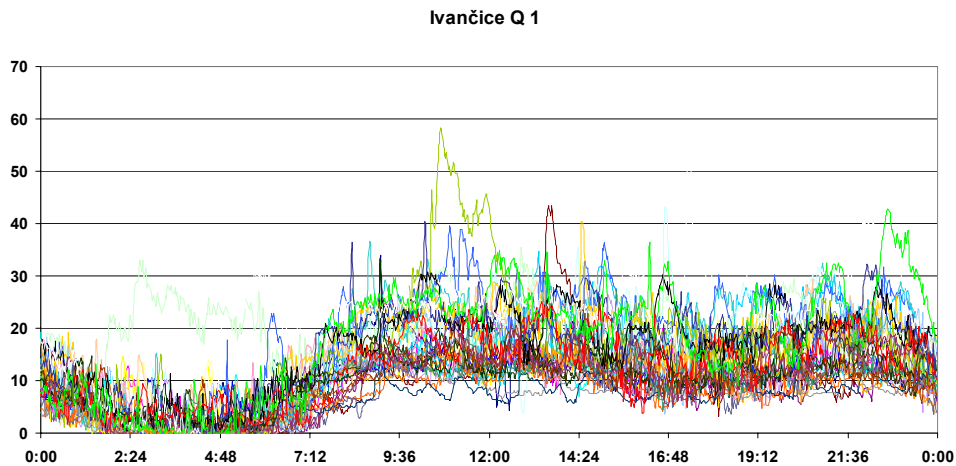
Figure 5 Monitoring campaign of DWF

A dry weather flow determination has a substantial effect on calculation accuracy of combined sewer overflow and consequently on pollution impact to the river. Q/H measurement was done during 06-08/2003. Figure 5 shows flow curves inside the last manhole in front of WWTP during monitoring campaign.

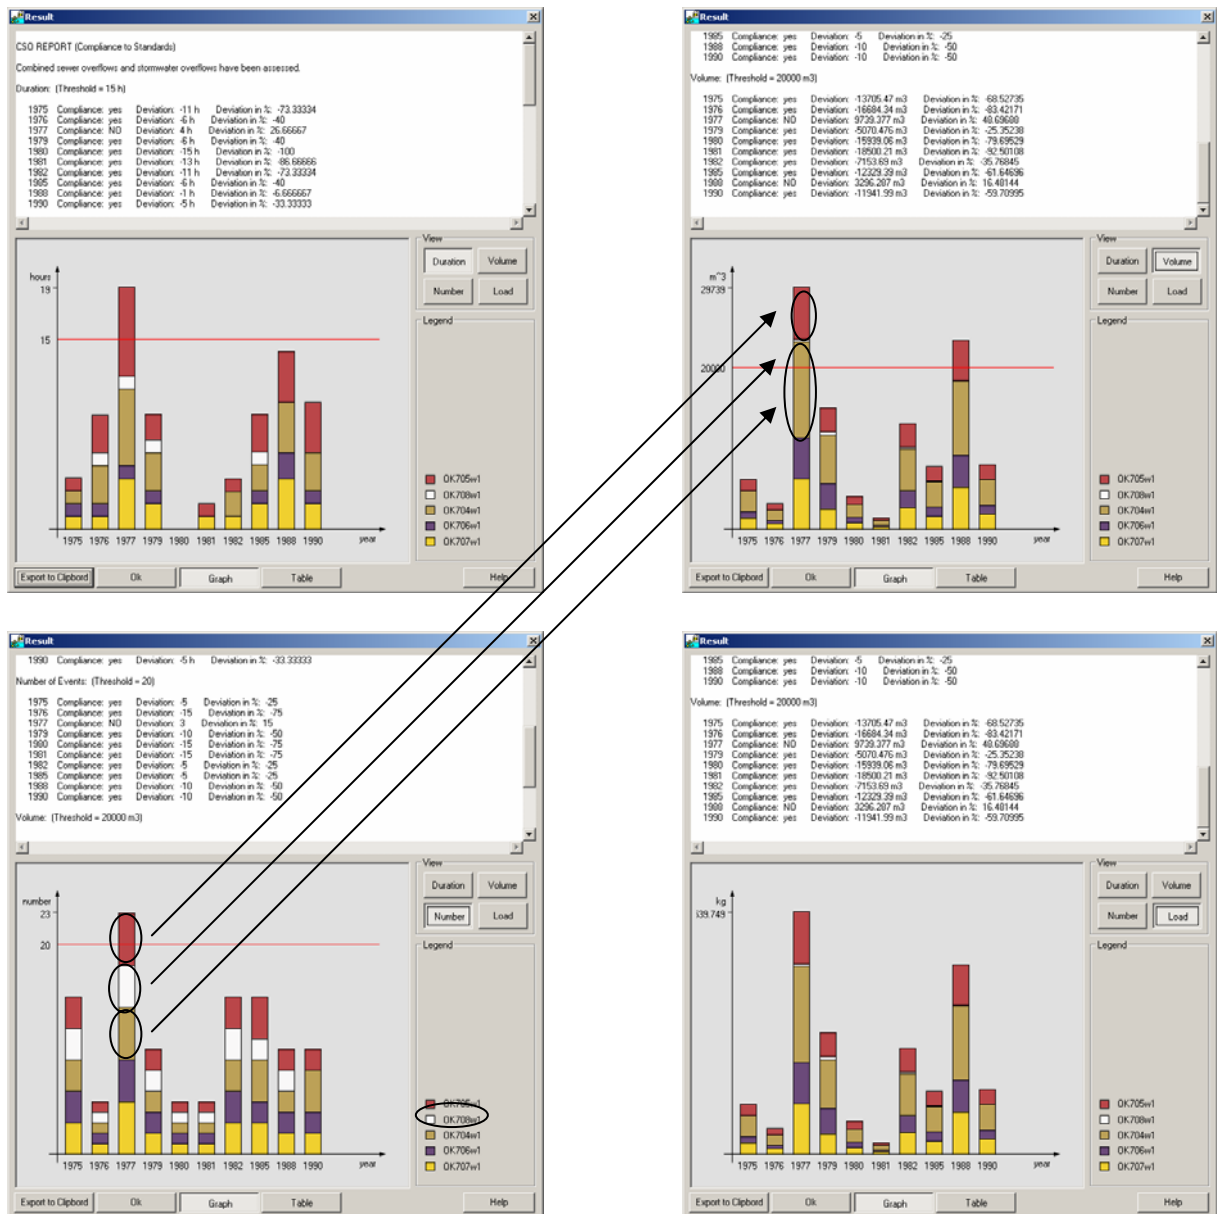
B-value: the river biocoenosis is probably adversely affected by the hydraulic impact of CSO.

Figure 25 CAT graphs (Duration, Volume, Number, Load)

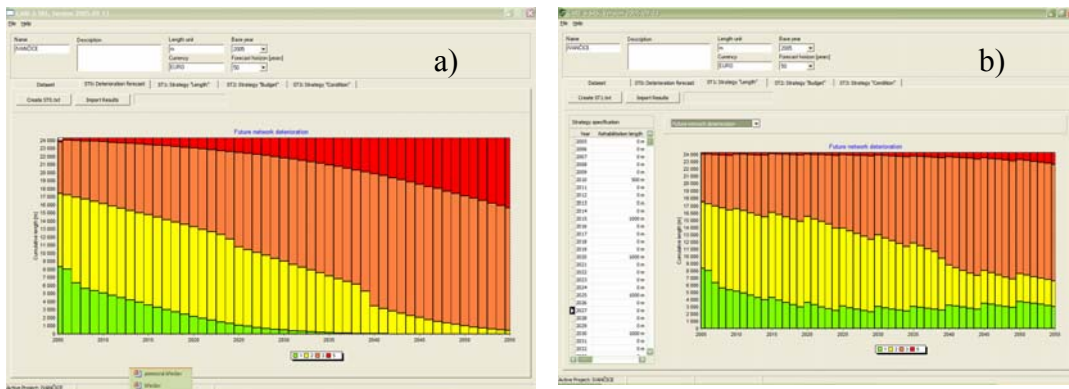
Figure 30 Future network deterioration:
 a) without any rehabilitation b) rehabilitation of 1000m every 5 years

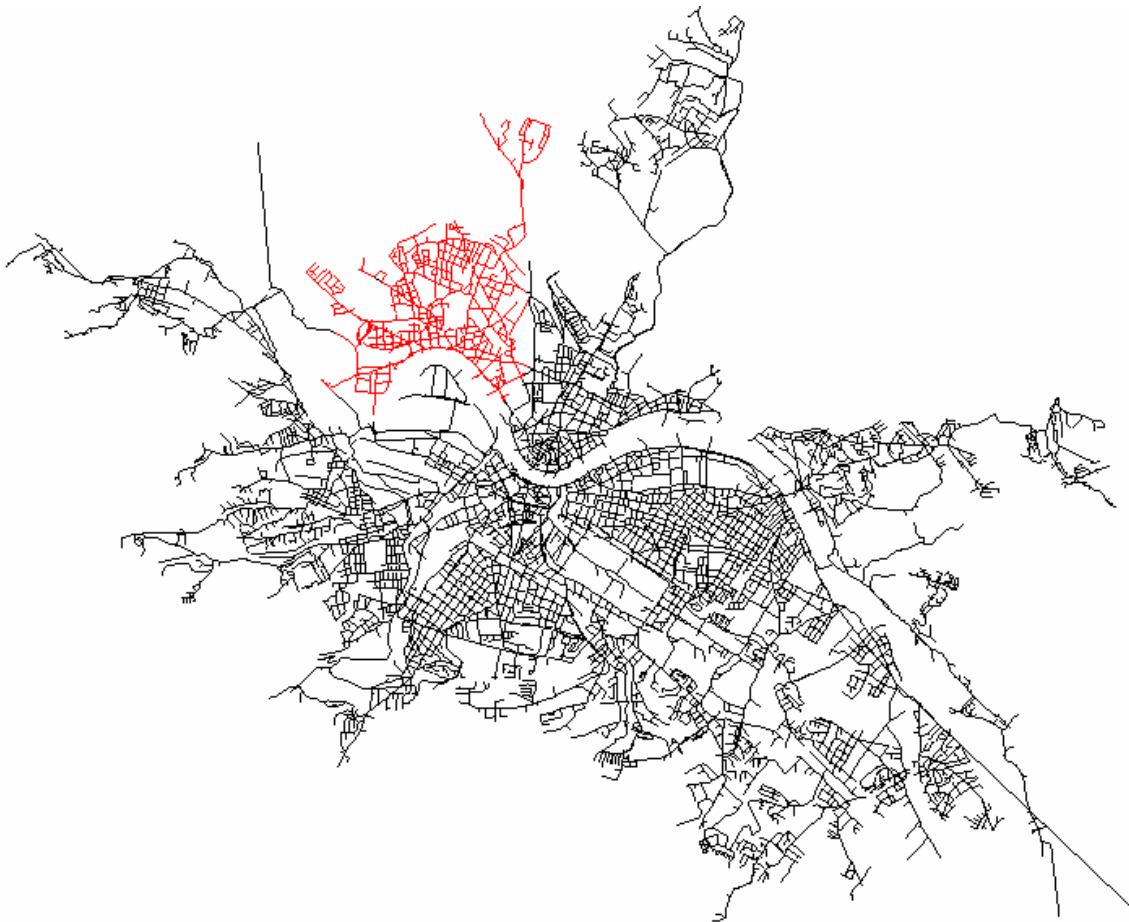
Figure 2: Scheme of the Dresden Sewer system indicated the Pieschen sub-network

With respect to the tools that require hydraulic simulation data it was decided to import the surrounding sub-network of Dresden-Neustadt additionally because this whole area drains into the network of Pieschen, especially into the main collector drain located along the river Elbe. That decision allows a hydraulic dissociation with a minimum number of system boundaries with unknown conditions (only two cut-offs) and it is assumed that the cut offs do not influence the hydraulic situation of the network.

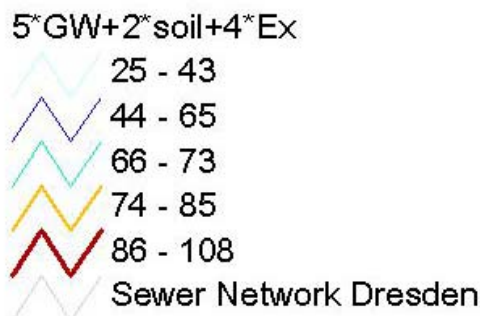
We tested the Groundwater Assessment Tool as stand alone version. The reason therefore is described under the chapter recommendations and requirements. Vulnerability values reach from 25 to 108 in the example (Figure 4).

Figure 4: Result of the groundwater vulnerability evaluation for Dresden

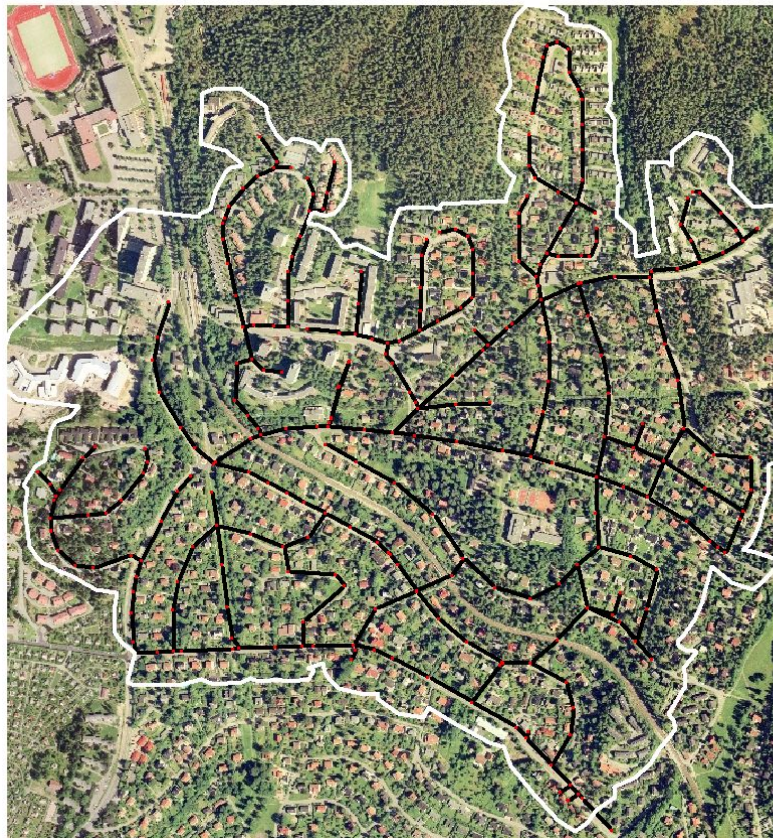
The Nordberg catchment (white line) and the network (black lines)

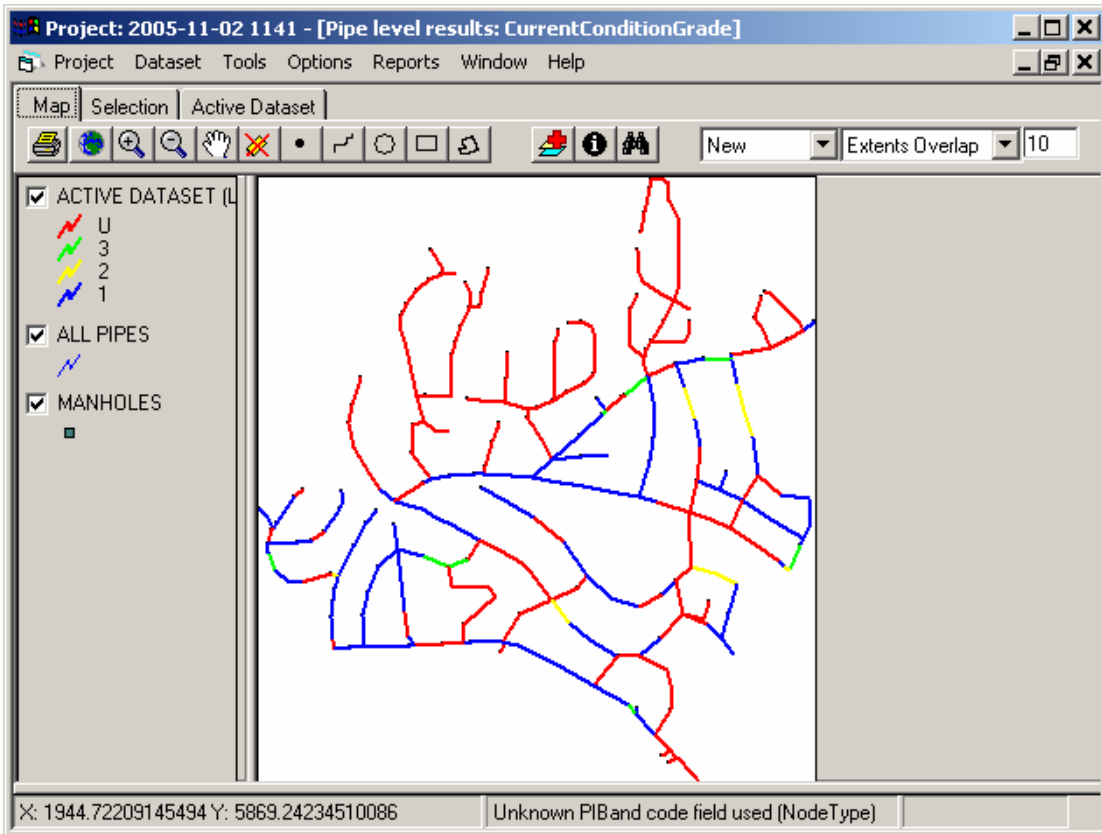
119 pipe inspections from Aug until Dec 2001 were imported. We had a problem with longitudinal cracks, since these are not exported today (this might be included in the next version of WinCan primo 2006). Oslo Municipality has their own system for "calculating" the condition grades. These values were imported to CareS.

Current Condition Grade

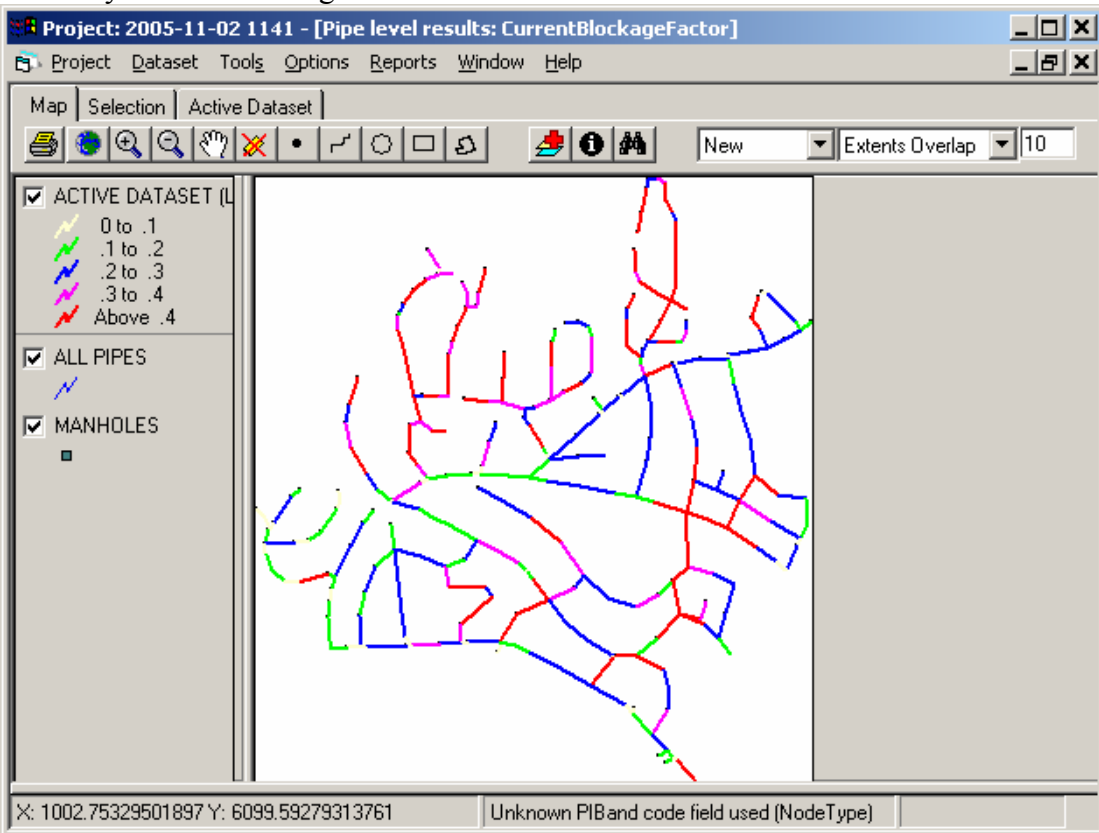
A history with 41 blockages were used.

Blockage Factors based on Material, Diameter, InstallationYear and ConditionGrades

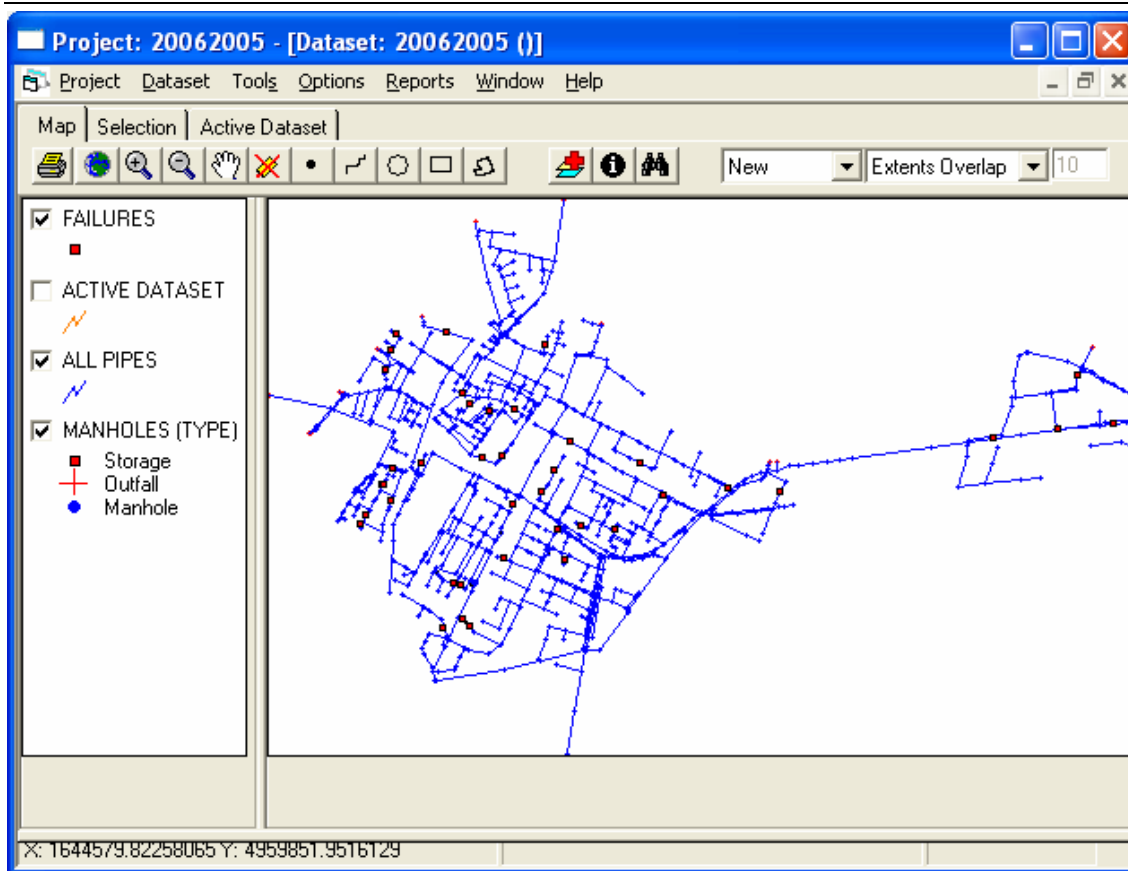
Figure 5. Blockages in Correggio network

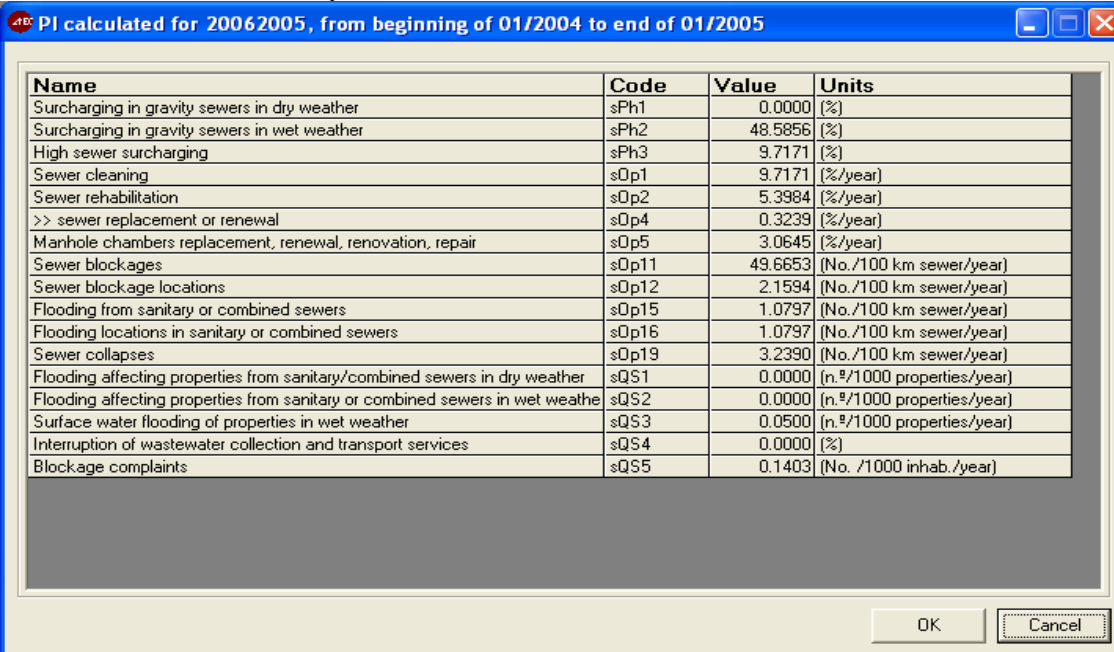
Some examples of PI calculated (Figure 7) are sPh3 (High sewer surcharging) expressed as percentual and with a value of 9.72%, sOP15 (Flooding from sanitary or combined sewers) expressed as number/100 km sewer/year and with a value of 1.08, sQS5 (Blockage complaints) expressed as number/1000 inhabitants/year and with a value of 0.14.

Name	Code	Value	Units
Surcharging in gravity sewers in dry weather	sPh1	0.0000	(%)
Surcharging in gravity sewers in wet weather	sPh2	48.5856	(%)
High sewer surcharging	sPh3	9.7171	(%)
Sewer cleaning	sOp1	9.7171	(%/year)
Sewer rehabilitation	sOp2	5.3984	(%/year)
>> sewer replacement or renewal	sOp4	0.3239	(%/year)
Manhole chambers replacement, renewal, renovation, repair	sOp5	3.0645	(%/year)
Sewer blockages	sOp11	49.6653	(No./100 km sewer/year)
Sewer blockage locations	sOp12	2.1594	(No./100 km sewer/year)
Flooding from sanitary or combined sewers	sOp15	1.0797	(No./100 km sewer/year)
Flooding locations in sanitary or combined sewers	sOp16	1.0797	(No./100 km sewer/year)
Sewer collapses	sOp19	3.2390	(No./100 km sewer/year)
Flooding affecting properties from sanitary/combined sewers in dry weather	sQS1	0.0000	(n./1000 properties/year)
Flooding affecting properties from sanitary or combined sewers in wet weather	sQS2	0.0000	(n./1000 properties/year)

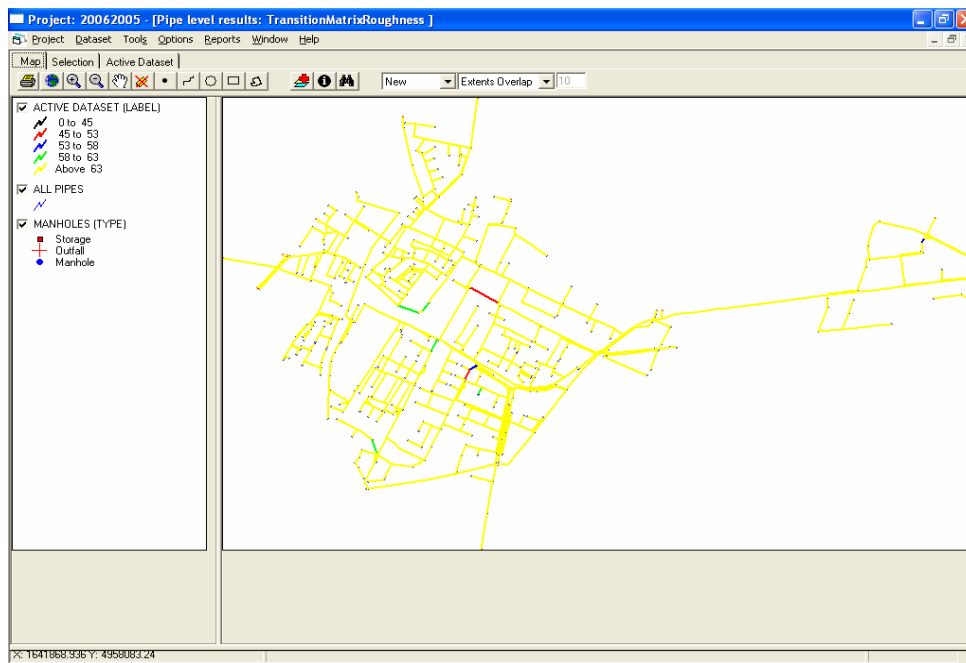
Degradation Tool produces a change of roughness only in inspected pipes; thus a new network can be simulated with Infoworks, MOUSE or SWMM code, and results imported again in the Rehab Manager central Database. The pipes inspected were ten, but a new roughness was calculated only for nine pipes, because the codes related to pipe number 416 did not imply a roughness change. The initial value of roughness for all the pipe is assumed to be 65 [m1/3/sec]; after Tool use, a new value has been found for pipes inspected; this value ranges from a minimum of 50,90 [m1/3/sec] for pipe 795 to a maximum value of 61,75 [m1/3/sec] for pipes 285 and 321. Five classes of roughness value were created to illustrate the results (Figure 22).

Figure 22. Transition Matrix Roughness

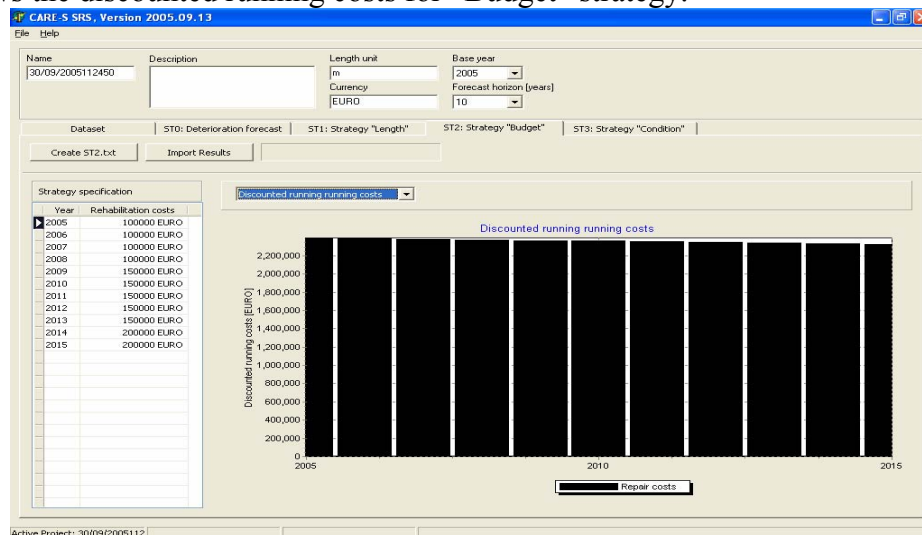
Figure 38 shows the discounted running costs for “Budget” strategy.

Figure 38. Strategy “Budget”: discounted running costs

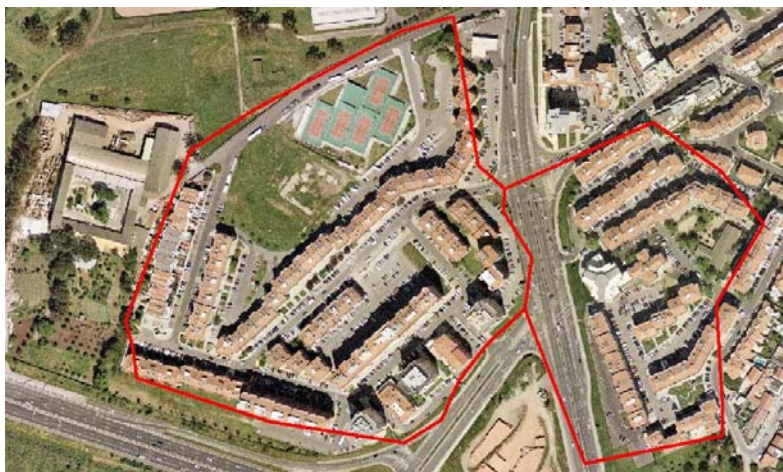
The catchment of Borel for the CARES testing is located in the Municipality of Amadora, near Lisbon, in Portugal. Borel has a separate sewer system built in 1981/1982, with a total catchment area of 13 ha, about 80% considered as impervious. Domestic sewers are circular with diameters from 200 mm to 300 mm, the pipe material is vitrified clay, concrete and polyvinyl chlorine and the total domestic sewer length is 1460.1 m. Storm sewers are also circular with diameters in the range 200 to 700 mm, the pipe material is reinforced concrete and polyvinyl chlorine and the total storm sewer length is 2208.7 m. The main problems detected are wrong connections, surcharging of sewers in wet weather, odours, structural defects and sediments in upstream reaches.

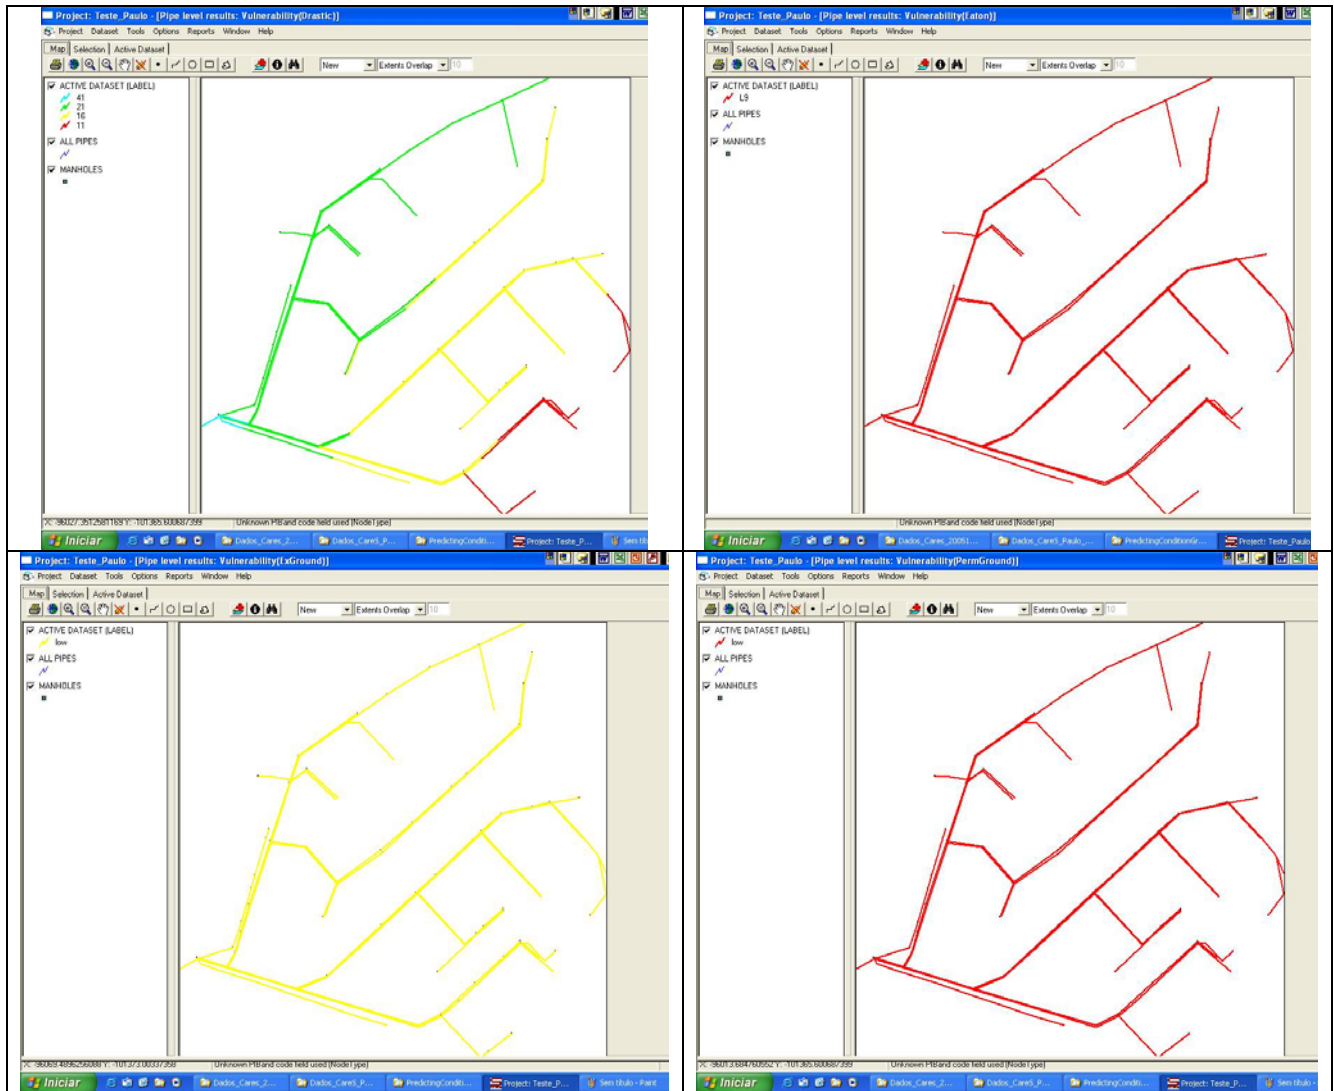
GAT

This Tool run without problems. All the four methods were used and results presented in GIS.

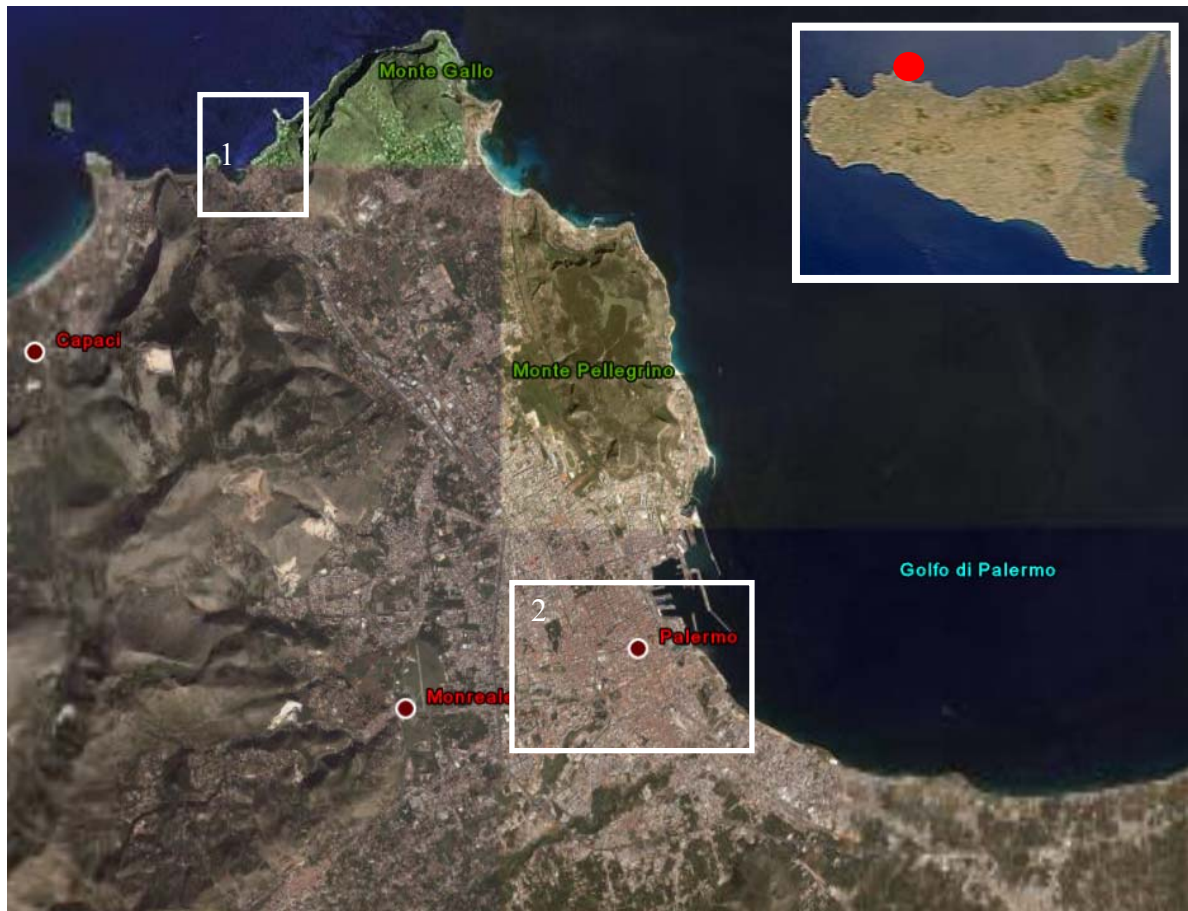
Figure 1 – Testing areas: Area 1 – Sferracavallo catchment; Area 2 – Palermo city centre

Sferracavallo is a small fisherman village that after the second world war was progressively adsorbed by the city of Palermo during the urban expansion of Sixties and Seventies. The catchment area is about 57 ha with a population of 12000 inhabitants. The network is combined and relatively new (being reconstructed in 1957 and progressively upgraded in recent times). The network length is around 80 km considering also private properties connections. Material used are concrete and polyethylene. Figure 1 represent principal sewers and connected areas: dark blue lines represent concrete egg-shaped pipes that have been installed before 1992; light blue lines represent polyethylene circular pipes that have been installed in recent times (since 1995).

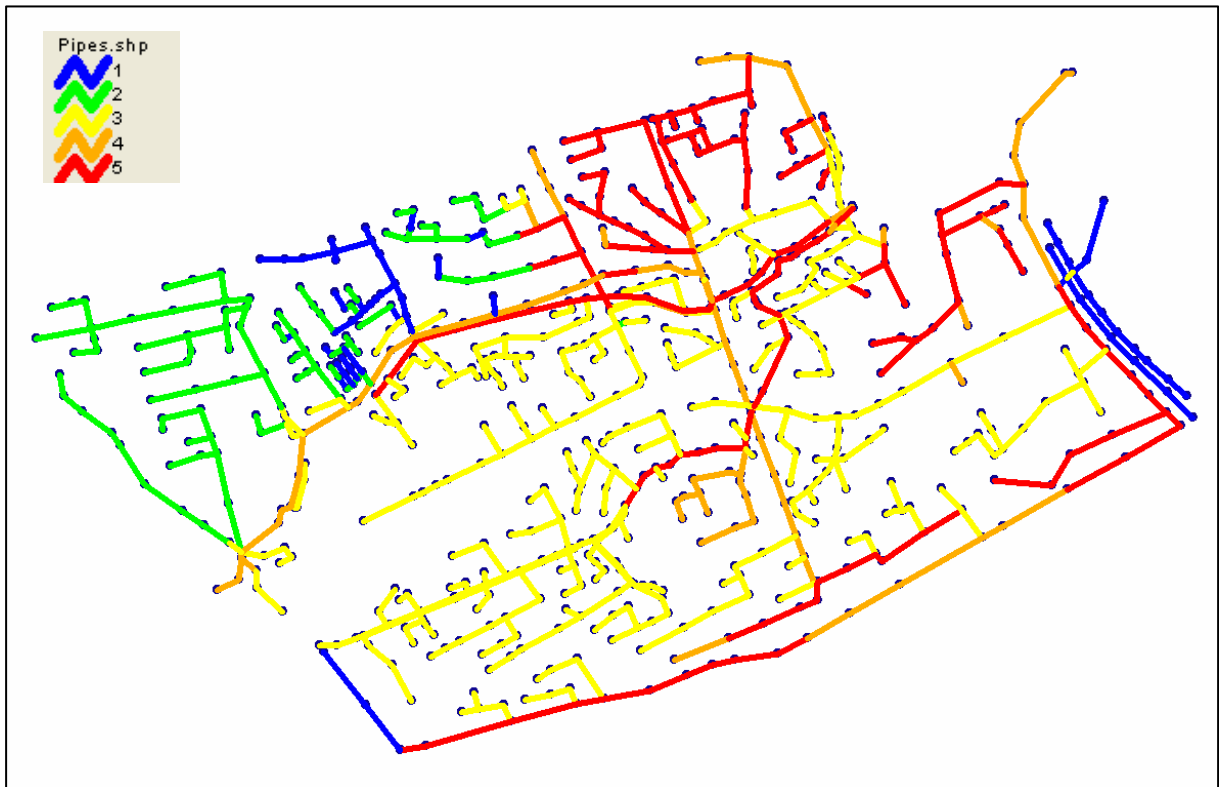
Figure 8: Pipe condition classes at the present time (CC1 corresponds to excellent condition; CC5 to failing pipes)

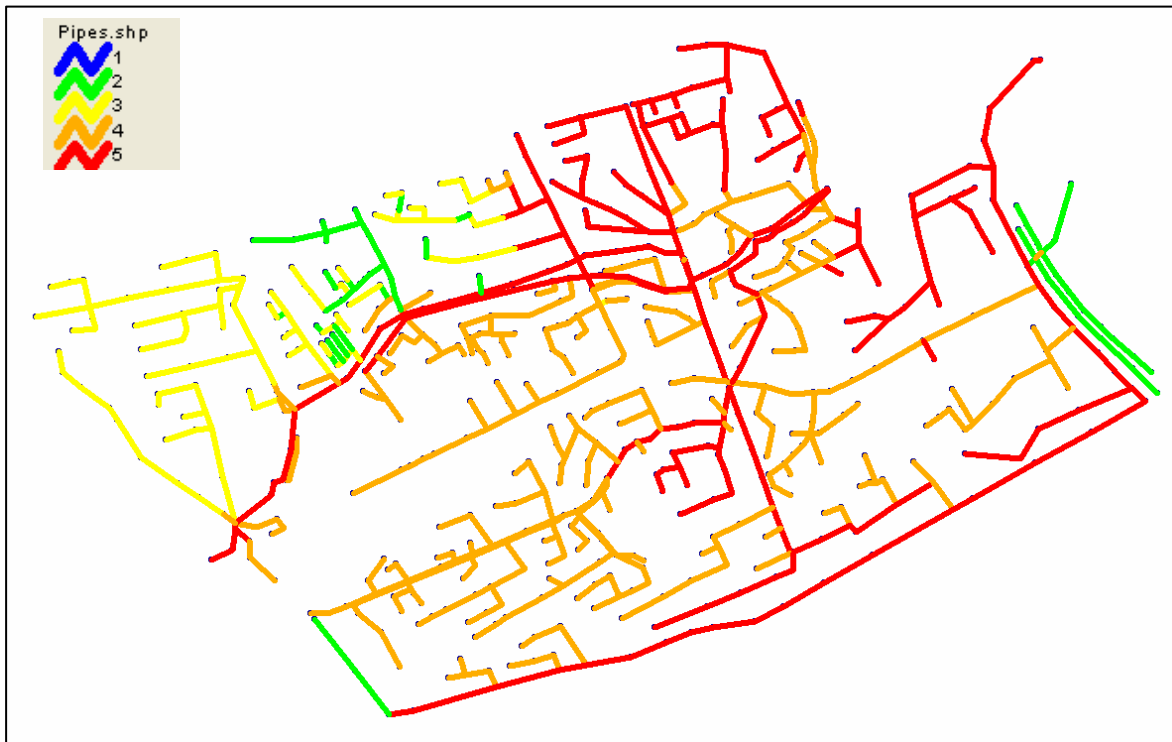
Figure 9: Pipe condition classes at 2050 (CC1 corresponds to excellent condition; CC5 to failing pipes)
