Presentation from WP1 Input in managing strategies

Anatoly O. Sinitsyn (SINTEF), Yared Bekele (SINTEF), Anni Vehola (LUT University and UNIS), Lena Rubensdotter (NGU and UNIS), Sebastian Westermann (UiO) and Juditha Aga (UiO)

Input in managing strategies – Report Nr. 6 – Draft version

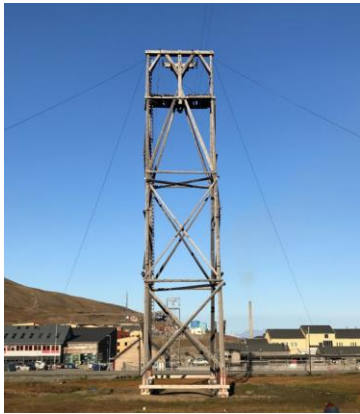
Figure 1. Cableway Post Nr. 6, Line 5-6, Longyearbyen.

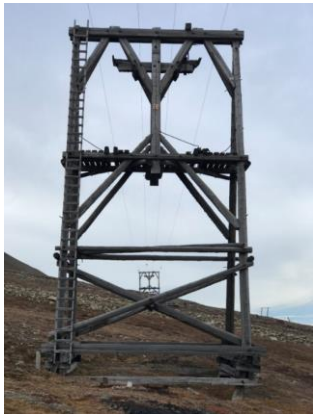
Figure 2. Cableway Post Nr. 34, Line 5-6, Longyearbyen.

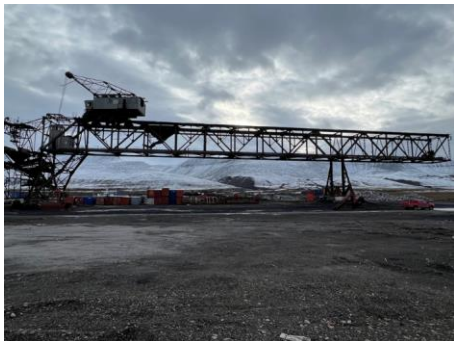
Figure 1. Titankrana, Longyearbyen.

*Taubanesentralen is presumed to involve a combination of shallow and deeper support elements, and Titankrana is presumed to have surface support elements. While detailed numerical settlement results were not obtained, the same warming trends as indicated by the thaw settlements presented above will influence both structures. Progressive deepening of active layer may augment potential differential settlement, and any deeper foundation elements may experience higher creep rates if subjected to sustained loads considering the gradual warming of permafrost as predicted (see figures above). **For both Taubanesentralen and Titankrana, routine ground-temperature measurements and active-layer monitoring are recommended to detect evolving permafrost conditions.***

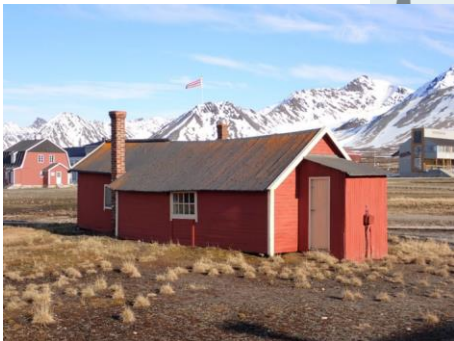
Figure 2. Green Harbour House, Ny-Ålesund.

Green Harbour House rests on a series of surface foundations (logs supporting a simple frame). By 2070, total settlement (Figure 26) begins to approach levels that, especially if uneven, might compromise the structure's alignment or functionality. Although these absolute values remain moderate, heritage structures in permafrost often have little tolerance for differential movement. Therefore, even a few centimeters of settlement can become problematic over time.

Shallow rock lying at approximately 3 m depth was discovered at Green Harbour House during PCCH-Arctic field work in Ny-Ålesund in spring 2024 ([18]). This suggests considering using pile foundations when restoring Green Harbour House. At the same time, as the load from the house is small and the object itself is quite compact it may be advised to keep the authentic foundation solution with introduction of minor modifications such as slightly deeper planks of the foundation "grill" (see Figure 15). The grill plate may also be made sufficiently rigid to allow its levelling by inserting new timber elements underneath when deemed.

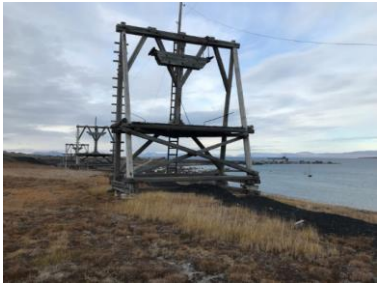
Figure 3. Cableway Post Nr. 32, Line 3, Longyearbyen.

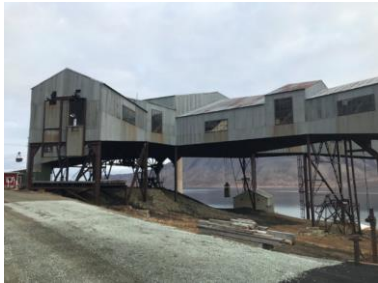
Figure 4. Taubanesentralen, Longyearbyen.

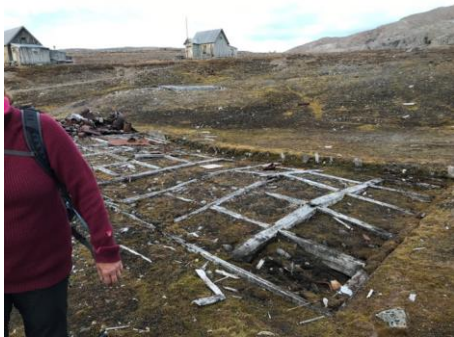
Figure 3. Foundation remains in Ny-London (2021), similar foundation type is believed to be used at Green Harbour House.

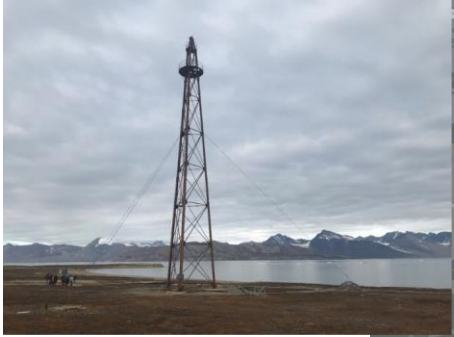
Figure 4. Luftskipsmasta, Ny-Ålesund.

***Luftskipsmasta** is supported by shallow foundations and bears an estimated total weight of approximately 14 tons. Although specific creep settlement calculations are not shown here, the thaw settlement projections in Figure 25 apply similarly to this structure, and the added creep component could further elevate total long-term deformation. These predictions correlate with settlements of terrain at Luftskipsmasta that were observed in 2022 (Figure 27). Given the historical and symbolic significance of Luftskipsmasta, installing temperature/settlement monitoring instrumentation – such as ground-embedded thermistors and surveying markers – could provide early warnings of foundation distress. In 2024 it became known that pile foundations installed in bedrock will be utilized when restoring Luftskipsmasta in 2025.*

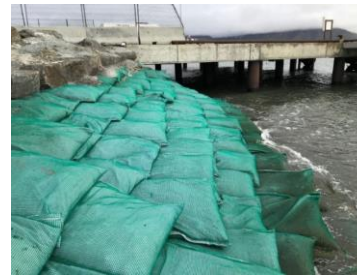
Figure 1. Example of revetment form geotextile bags (Svea, Svalbard).

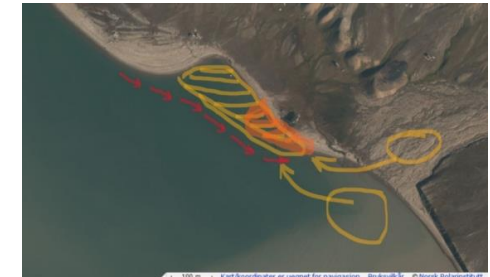
Figure 1. Principal scheme for artificial beach. Photo: © TopoSvalbard.

5. Artificial beach, fed by soil from alluvial fan of the Telegrafdalen . This might even enable longshore transport to the station. This solution is based on the already mentioned observations of Antonello [22] that a spit (accumulative landform locate in few hundred meters to the west) is drifting towards the station with estimated speed of approximately 5 m per year. By creating artificial beach, one will introduce the landform that may appear in this location in some 50 years in the future. Such approach can be then classified as truly nature-based. It will also restore the original outline of the coastline, that will comply with antiquarian value. Groin may be a part of such solution.
