# Report 6

## Input in managing strategies

Recommendations for the objects managed by the user partners in PCCH-Arctic

This report presents input for managing strategies of selected objects of technical-industrial cultural heritage in Longyearbyen and Ny-Ålesund. In particular, the report provides results of condition survey of cableway trestles in Longyearbyen, assessment of natural hazard impacts on case study objects, recommendations for special case study objects, in addition to recommendations for monitoring and sources of data on climate projections.

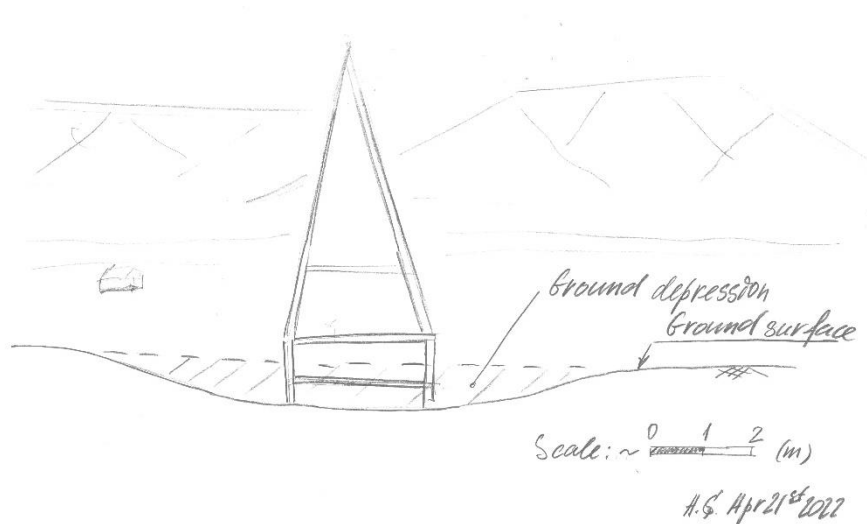
- Large settlements of structure into terrain (Figure 14), even if the structure looked intact (examples are presented on Figure 14–Figure 15, and interpretation of observations is presented on Figure 16) one may expect that cross-bracing elements would be broken in the result of settlement (examples are presented on Figure 17–Figure 18).

**Figure 16. Illustration of permafrost degradation at the cableway trestle Nr 21, Line 6 (side view).**

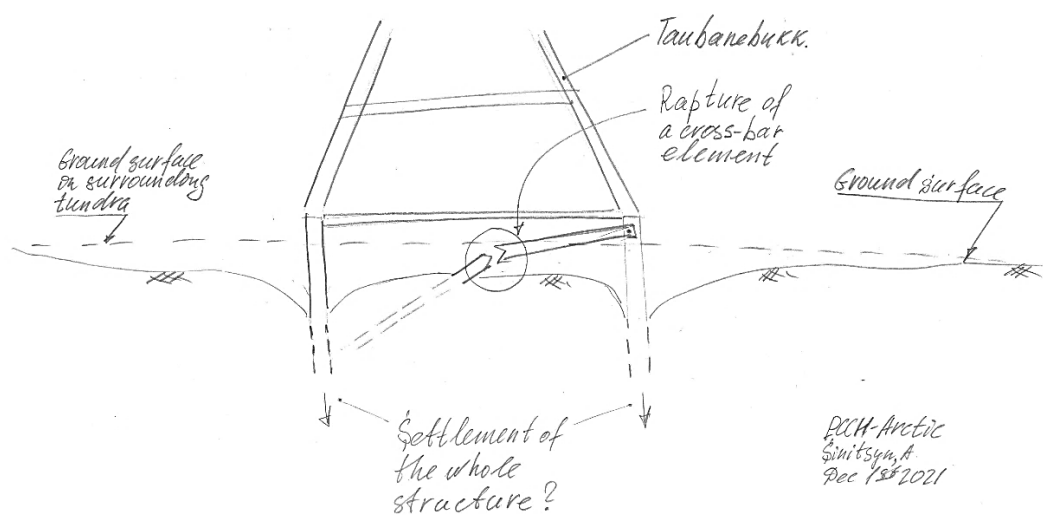
**Figure 18. Proposed mechanism of rupturing cross-bracing elements due settlements of objects into permafrost.**

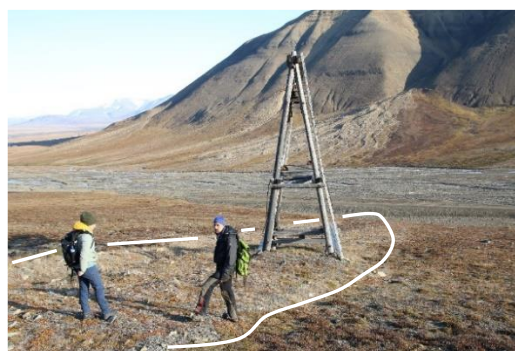
1. UC 0 and UC 1 correspond to safety classes S1 with corresponding nominal yearly probability of 1/100 (slope hazards) and F1 with corresponding nominal yearly probability of 1/20 (flood) with assumption that consequences are small and *not critical* for the object. For example, we saw cases when cableway trestles were able to withstand the impacts of small landslides and snow avalanches (see examples on Figure 19–Figure 22).

**Figure 20. Remains of old debris flow at cableway trestle Nr. 9, Line 5. White line presents outline of debris flow.**

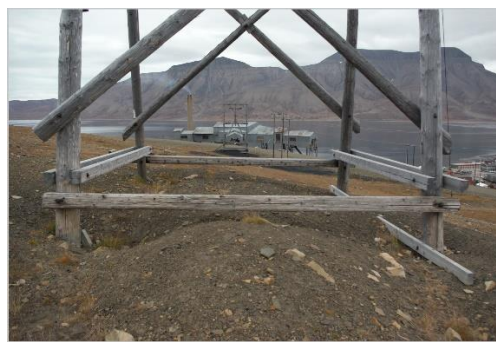
**Figure 24. Ground depressions under cableway trestle Nr. 23 on the Line 1b (2021). This trestle was restored in 2007. Picture: © Snaprud Christensen, C.**

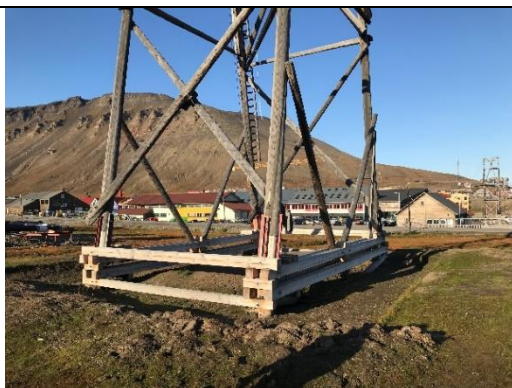
**Figure 25. Ununiform ground settlements below recently restored cableway trestle Nr. 6 at the Line 5-6. One shall acknowledge that some uneven terrain below the object is due to the excavation activities.**

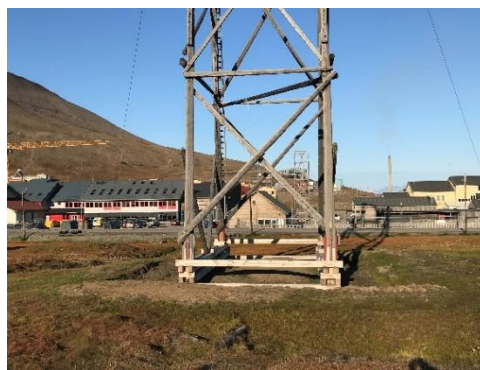
**Figure 26. Ununiform ground settlements below recently restored cableway trestle Nr. 6 at the Line 5-6. One shall acknowledge that some uneven terrain below the object is due to the excavation activities.**

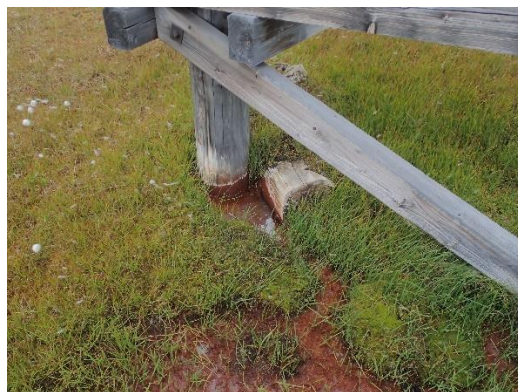
**Figure 30. More lush vegetation under cableway trestle Nr. 27 at the Line 6.**

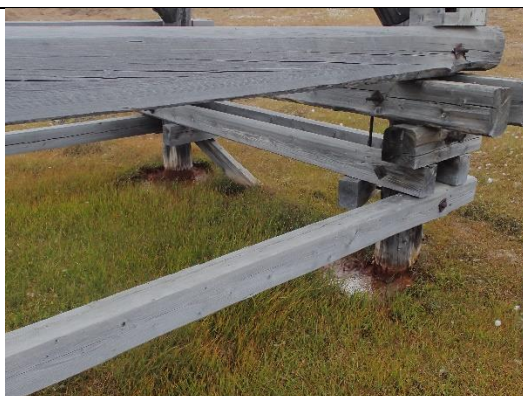
**Figure 31. More lush vegetation under cableway trestle Nr. 27 at the Line 6.**

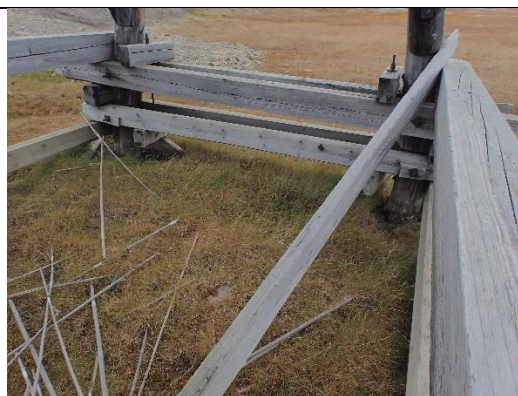
**Figure 32. More lush vegetation under cableway trestle Nr. 6 at the Line 6.**

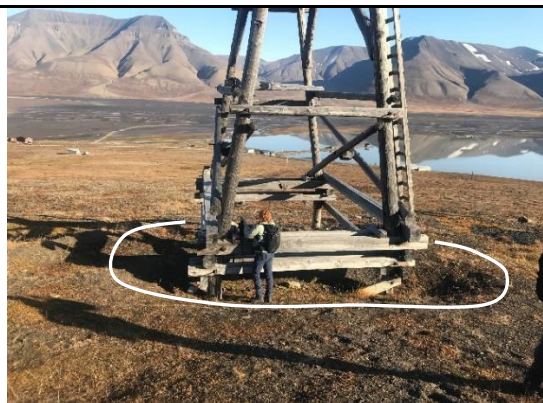
Figure 33. "Slide-like" settlements of the ground around structures on a sloping terrain – Cableway post Nr. 19, Line 5-6 (general view). White line depicts "scar" of the "slide".

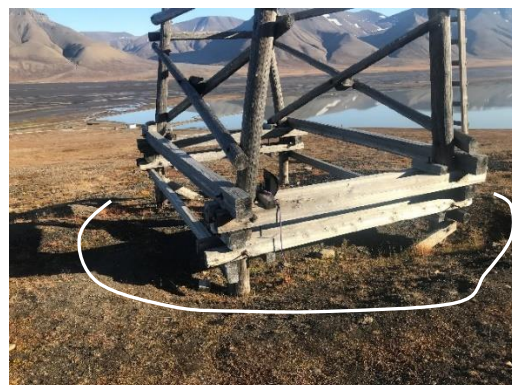
Figure 34. "Slide-like" settlements of the ground around structures on sloping terrain – Cableway post Nr. 19, Line 5-6 (close look-up). White line depicts "scar" of the "slide".

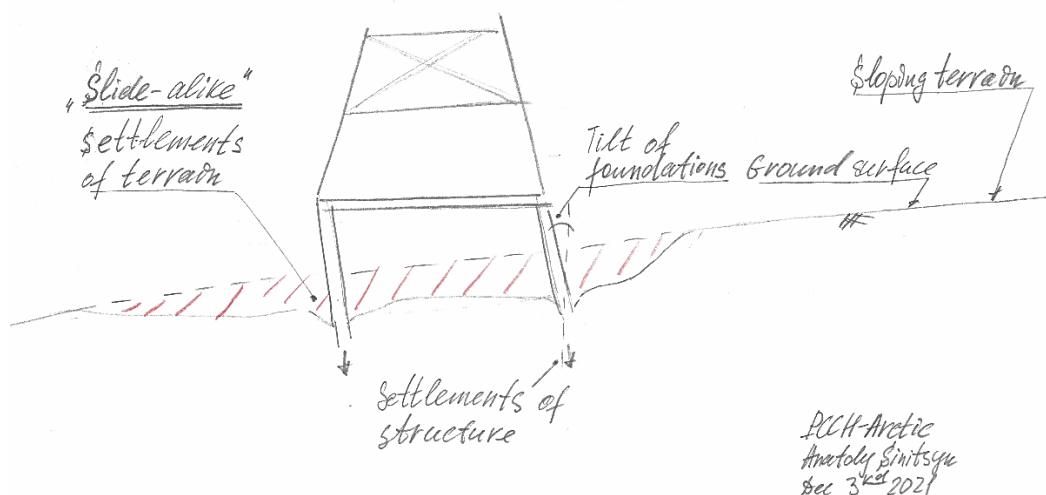
Figure 35. Sketch of proposed outline of the "slide-like" settlements of the ground around the structures on a sloping terrain.

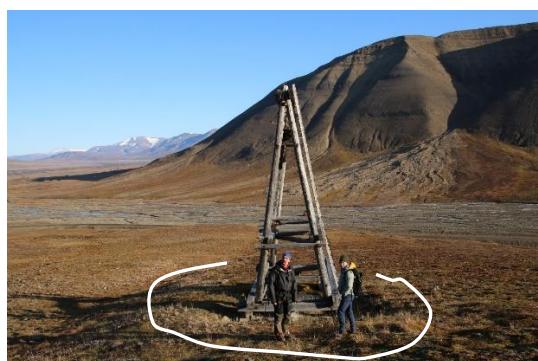
- Moderate cases of frost heave: elevated terrain around structure along with the structure settling into terrain. We suggest to consider such situation as an indicator of frost heave that occurs due to probably thinner snow thickness by the object, example of such situation is presented in Figure 38–Figure 39, and interpretation is presented on Figure 46. Such cases were mostly observed in the Endalen valley where local wind conditions and topography seems to be responsible for frost heave. It also seems that the object itself affects snow distribution around it.

Figure 38. Cableway trestle Nr. 10, Line 5: ground under the structure is elevated in relation to surrounding tundra, while the structure seems to be settled into the terrain. White line presents outline of the elevated terrain.

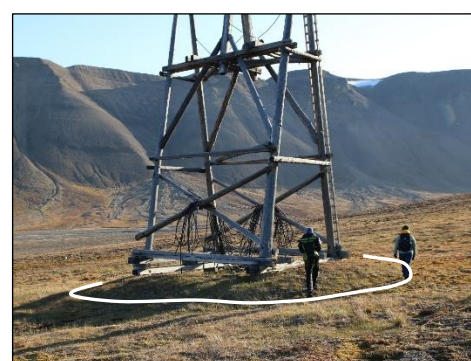
Figure 39. Cableway trestle Nr. 16, Line 5: ground is elevated in relation to surrounding tundra. White line presents outline of the elevated terrain.

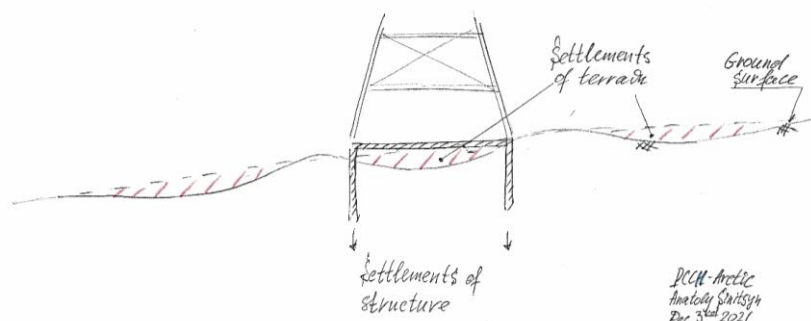
Figure 40. Sketch of proposed outline of the situation with elevated terrain and settled object.

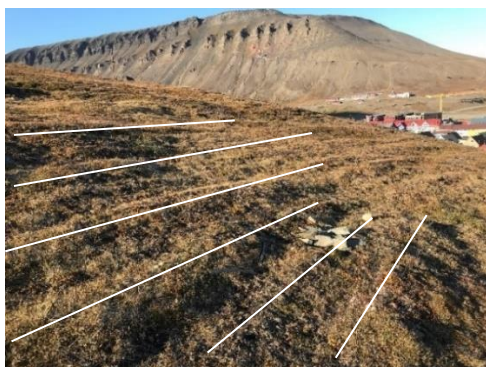
- Moderate cases of solifluction. Characteristic micro topography (with moderately “wavy” terrain) and tilted foundations of cableway trestles may serve as indicators of solifluction (examples are presented on Figure 41–Figure 44).

**Figure 41. Solifluction above the cableway trestle Nr. 8 at the Line 5-6. White lines depict crests of “wavy” surface of the terrain that is typical for solifluction.**

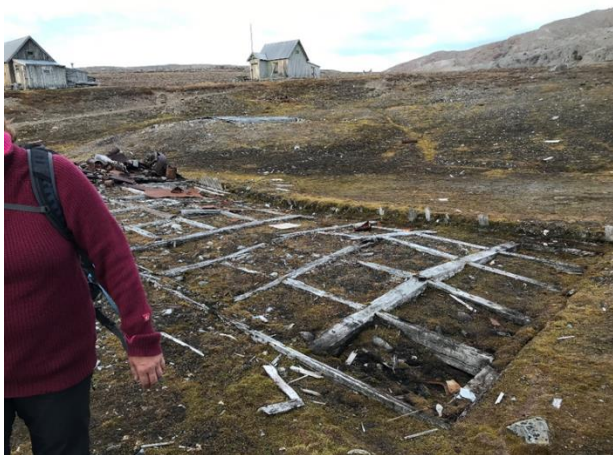
**Figure 67. Foundation remains in Ny-London (2021), similar foundation type is believed to be used at Green Harbour House.**

Shallow rock lying at approximately 3 m depth was discovered at Green Harbour House during PCCH-Arctic field work in Ny-Ålesund in spring 2024 ([27]). This suggests considering using pile foundations when restoring Green Harbour House. At the same time, as the load from the house is small and the object itself is quite compact, it may be advised to keep the authentic foundation solution with introduction of minor modifications such as slightly deeper planks of the foundation "grill" (see Figure 67). The grill plate may also be made sufficiently rigid to allow its levelling by inserting new timber elements/stones underneath when deemed.

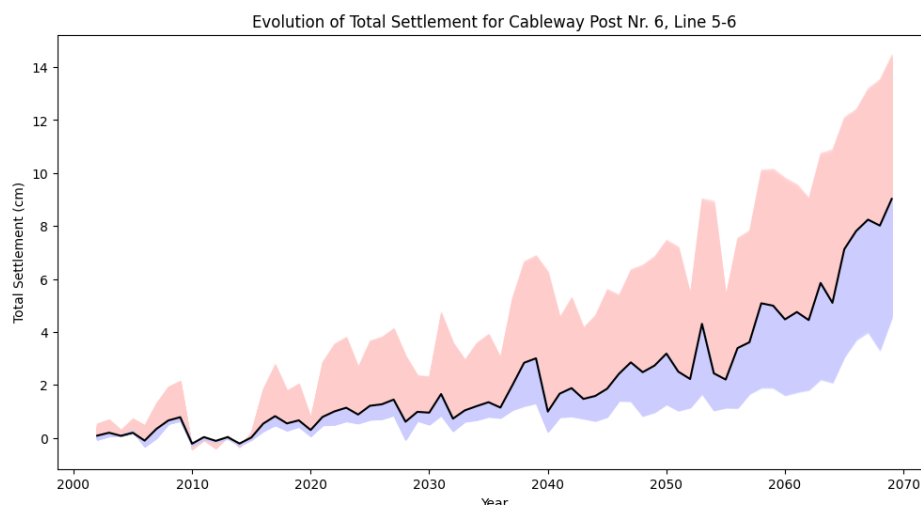
*For the long-term performance of Cableway trestle Nr. 6 (Line 5–6), total settlements of authentic shallow foundation reach significant class (approximately 10 cm) by 2070 (Figure 73). For restoration, one may assume to introduce new piles embedded 10 m into permafrost in 2026. The effective pile length gradually diminishes over time as the active layer thickness increases (Figure 74). Creep settlement of pile foundations remain relatively small for these new piles, reflecting the improved load transfer to deeper, colder layers. Consequently, total predicted settlement through 2070 remains noticeably lower than that of the shallow foundation, making pile retrofitting an attractive mitigation strategy if field investigations confirm suitable conditions for pile foundations.*

**Figure 73. Evolution of total settlement (creep and thaw) for Cableway trestle Nr. 6, Line 5-6 from 2000 to 2070. Figure: [22]. Pink and blue areas present upper and lower bound variations in total settlements.**

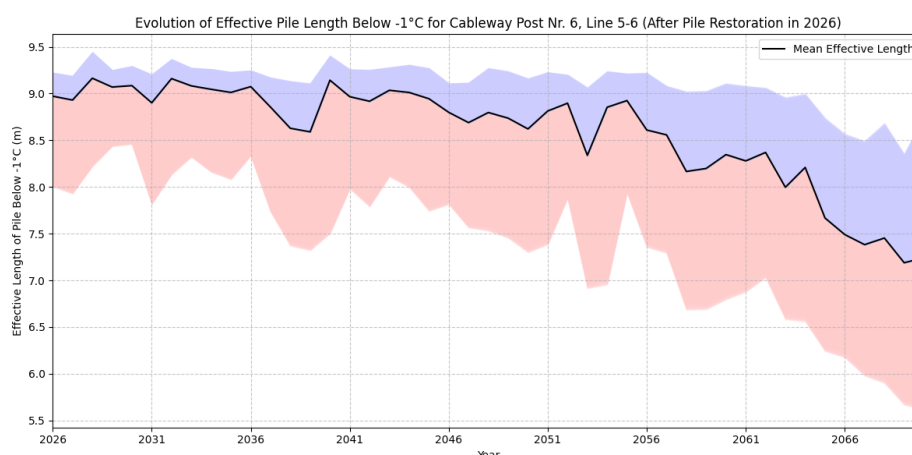
**Figure 74. Evolution of effective pile length for Cableway trestle Nr. 6, Line 5-6 after assumed pile restoration in 2026. Figure: [22]. Pink and blue areas present upper and lower bound variations in effective length of piles.**

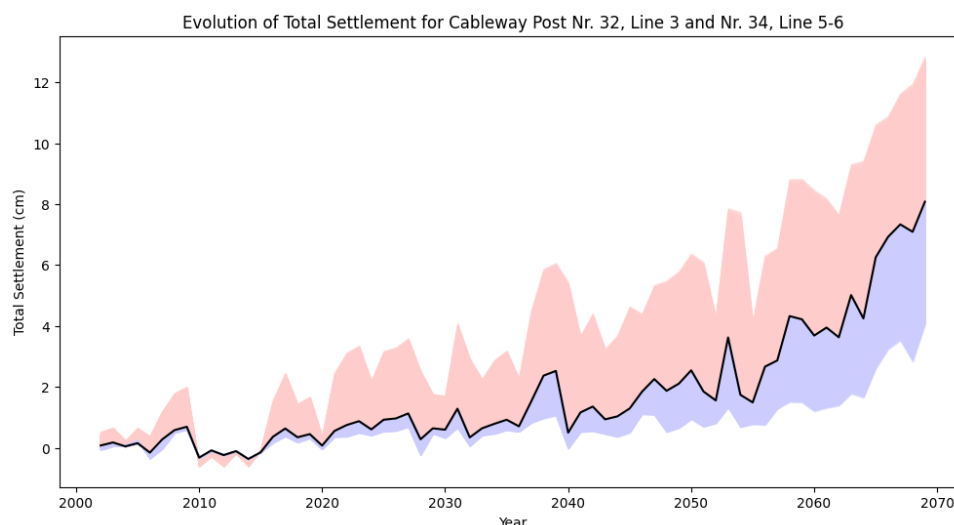
Similar analyses were conducted for **Cableway trestles Nr. 32 (Line 3) and Nr. 34 (Line 5–6)**. The summation of creep and thaw deformation is shown in Figure 75, suggesting that total settlement by 2070 could surpass practical serviceability limits for sensitive heritage structures. If these cableway trestles are restored using pile foundations in 2026 – mirroring the approach for Cableway trestle Nr. 6 (Line 5-6) – predicted settlements remain considerably lower (Figure 76). In these scenarios, deeper permafrost layers sustain the foundation loads more reliably, resulting in moderate creep rates and improved long-term stability.

Figure 75. Evolution of total settlement (creep and thaw) for Cableway trestle Nr. 32, Line 3 and Nr. 34, Line 5-6. Figure: [22]. Blue and pink areas present upper and lower bound variations in total settlements.

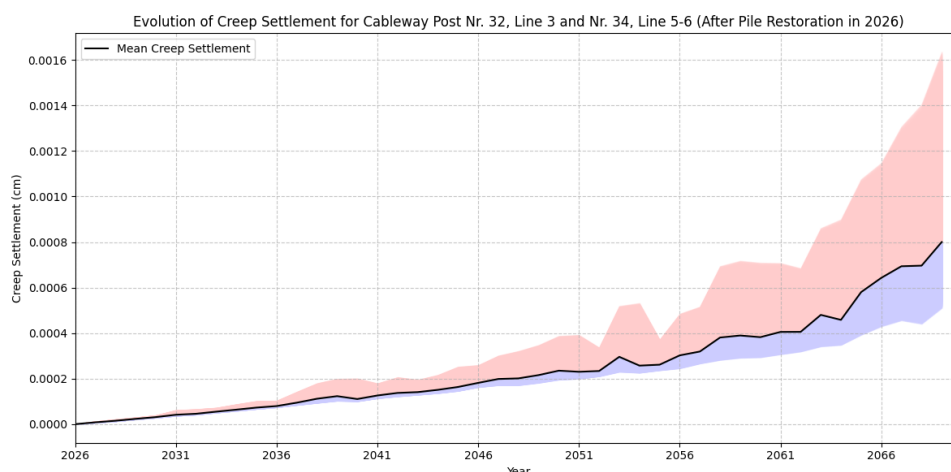
Figure 76. Evolution of creep settlements for Cableway trestle Nr. 32, Line 3 and Nr. 34, Line 5-6 after assumed pile restoration in 2026. Figure: [22]. Pink and blue areas present upper and lower bound variations in creep settlements.

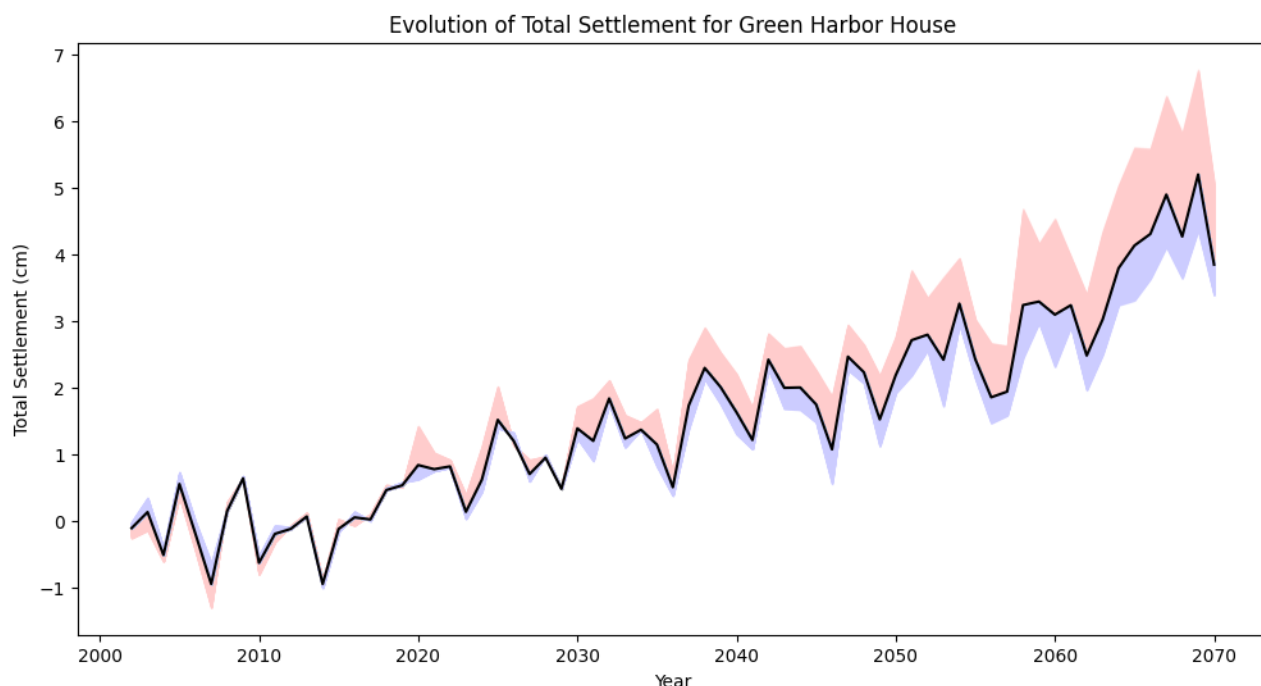
***Green Harbour House** rests on a series of surface foundations (logs supporting a simple frame). By 2070, total settlement (Figure 78) begins to approach levels that, especially if uneven, might compromise the structure's alignment or functionality. Although these absolute class remain moderate, heritage structures in permafrost often have little tolerance for differential movement. Therefore, even a few centimeters of settlement can become problematic over time.*

**Figure 78: Evolution of total settlement for Green Harbour House. Figure: [22]. Pink and blue areas present upper and lower bound variations in total settlements.**

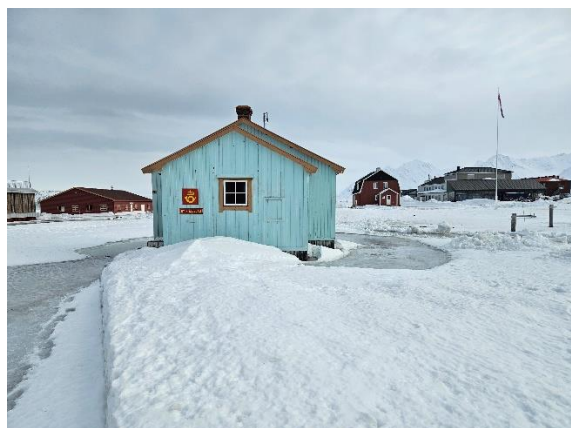
It is important to establish proper drainage conditions to avoid increased permafrost degradation around the objects of cultural heritage. This is especially relevant to the buildings in Ny-Ålesund (Figure 80–Figure 82) and for the Titan crane (Figure 83), in both cases ponding of surface water was observed.

**Figure 81. Flooding by Post office in Ny-Ålesund (April 2024), picture: ©Aga, J.**

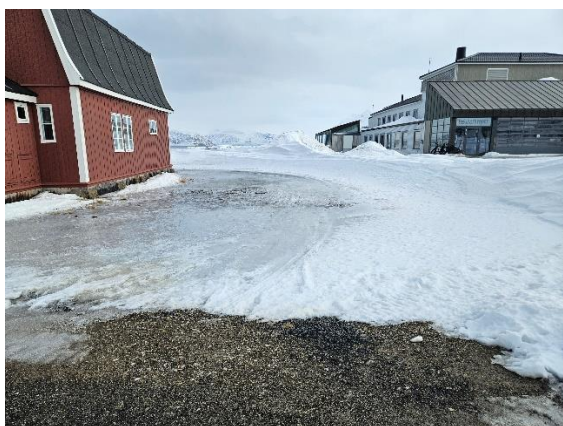
**Figure 82. Flooding by Amundsen villa in Ny-Ålesund (April 2024), picture: ©Aga, J.**

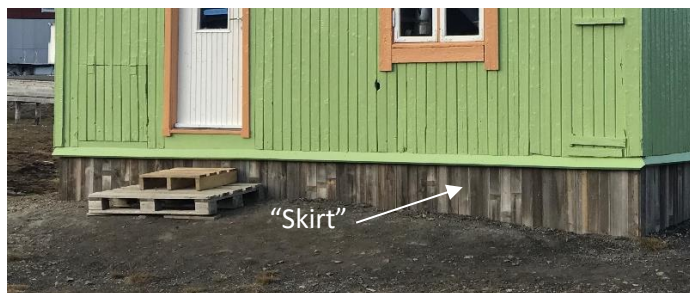
Simulations of permafrost response to snow conditions [28] point out on the need of avoiding snow storage (after ploughing) by the buildings in Ny-Ålesund. Another recommendation is related to the structure of timber “skirts” around historical buildings in Ny-Ålesund. One can see example of buildings with such skirts on Figure 84–Figure 85. We recommend that such “skirts” should be permeable for air flow. This will facilitate removal of heat from the ground during winter, hence contributing to preservation of permafrost. Such advice may be less relevant when buildings are resting on piles embedded in bedrock. Still, recommendations are relevant should unlithified permafrost be present above the bedrock surface. Degradation of unlithified permafrost may lead to ground depressions (magnitude of depressions will depend on ground ice content) beneath the buildings. Surface water may accumulate in such depressions, which in turn may further intensify degradation of permafrost.

**Figure 84. “Skirt” by Museum (*Museum*) cabin in Ny-Ålesund (2021), picture: © SINTEF/Sinitsyn, A.O.**

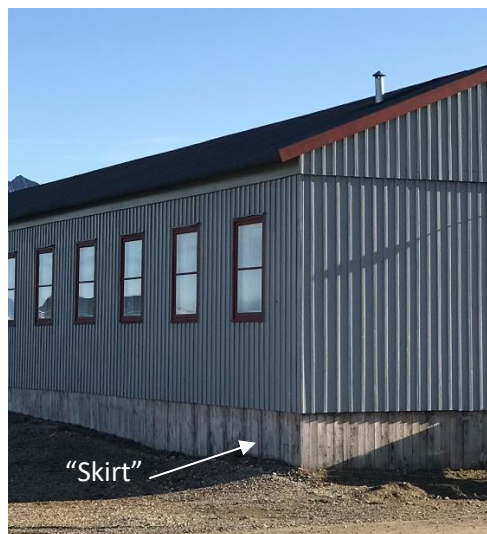
**Figure 85. “Skirt” by Hospital (*Sykehuset/Skutergarasjen*) in Ny-Ålesund (2021), picture: © SINTEF/Sinitsyn, A.O.**

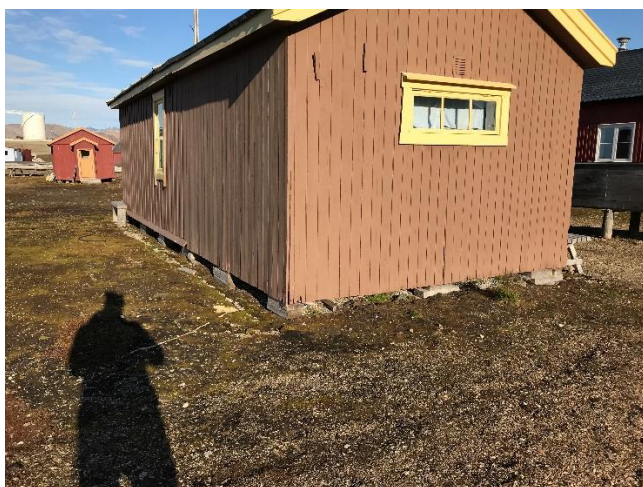
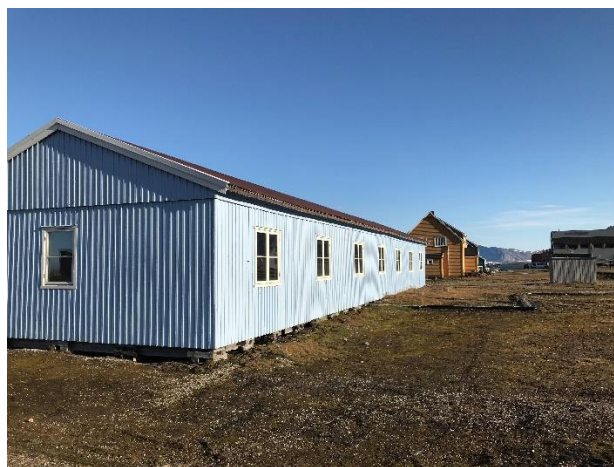
Figure 86. Sysselbu house in Ny-Ålesund.

Figure 87. Mexico barack in Ny-Ålesund.

In some cases (such as presented in Figure 86–Figure 87) when there is the gap between “skirt” and the ground surface installation a systems with mechanical circulation of cold air can be considered. Also, such systems may require additional openings in the “skirt”. Such systems may also be considered for situations when openings already exist in the construction of a “skirt” (see examples on Figure 88–Figure 89). Such system also especially relevant to the buildings that are in use, i.e. where heat loss from the building into permafrost underneath occur.

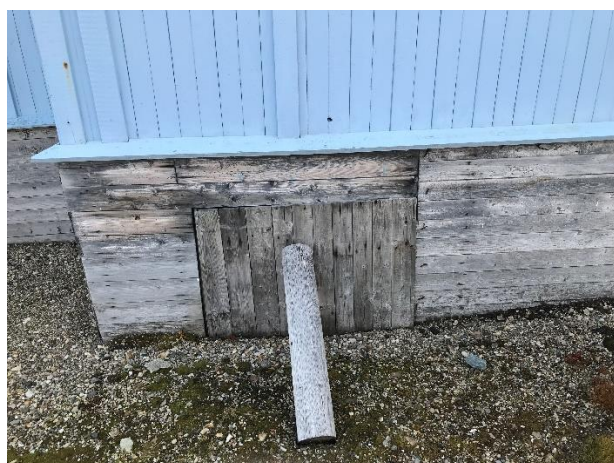
Figure 89. Opening is the "skirt" of Telegrafan, Ny-Ålesund. Such opening should be kept open during winter and closed during summer.

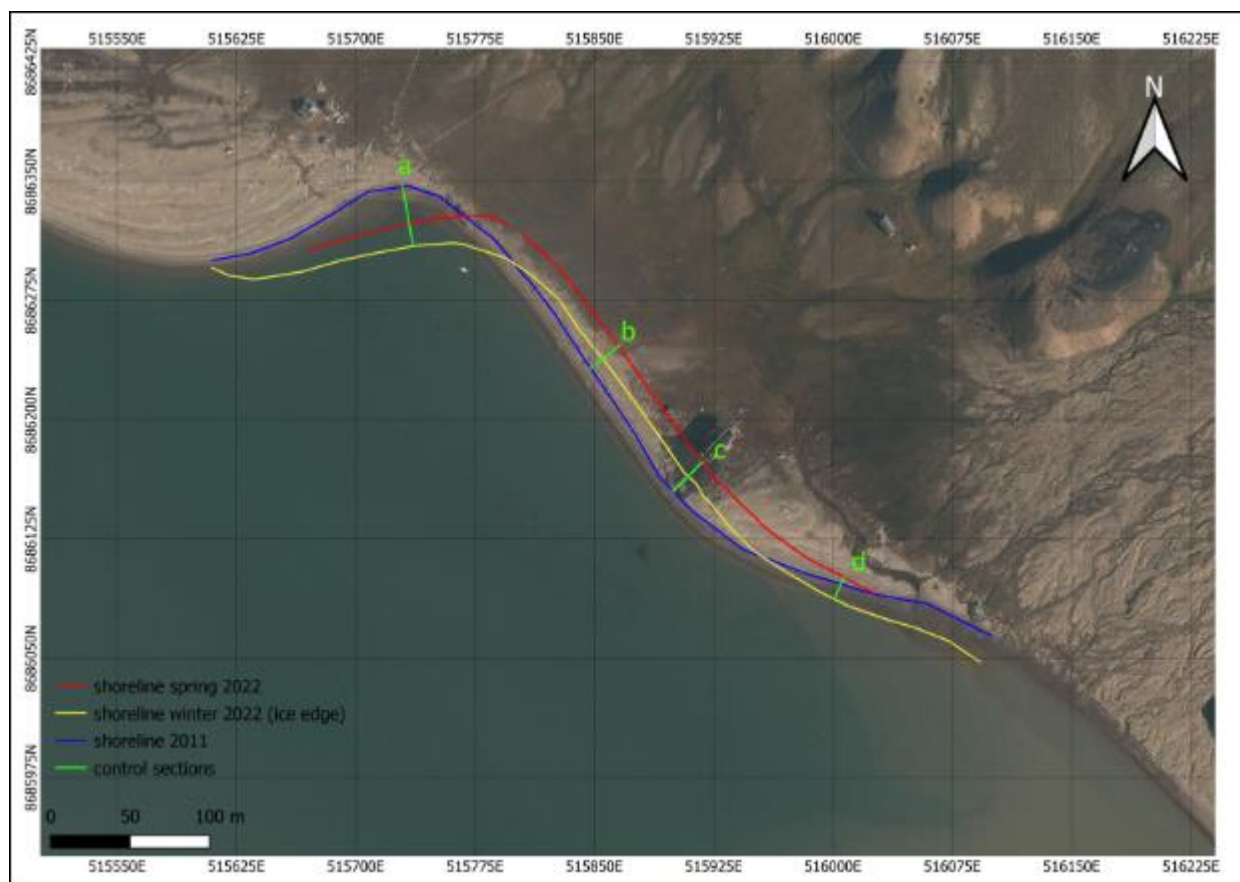
The natural hazard of coastal erosion is normally characterized by the rates of coastal erosion, expressed in m/yr, where negative class indicate erosion. Nicu, Stalsberg *et al.* [30] investigated the position of 1.3 km of the Hiorthhamn shoreline and reported average erosion rates of -0.21 m/yr for the 92-year period and pointed out the needs in continued monitoring and sustainable management of cultural heritage at the site. The authors classify these rates as "very high". It is important to note that only two shoreline positions were analysed by the study, i.e. from 1927 and 2019. The latter leaves room to hypothesize that erosion rates in the last decades may be even higher than the reported long-term class. Such a situation may be possible due to longer periods of wave activity and possibly stronger wave climate in the last decades, yet such assumptions shall be clarified by a hydro-meteorological analysis. Indeed, the measurements performed in 2022, revealed even higher erosion rates in the period from 2011 to 2022 – -2.15 m/yr [31] (Figure 91). Also, accretion (accumulation) area was found in approximately 300 m towards north-west from the station (Figure 91). Distance from the cable to the crest of coastal bluff was 2 m as for 2020, [29].

Figure 91. Shoreline evolution from 2011 to 2022. Aerial picture: © TopoSvalbard, Figure: [31].

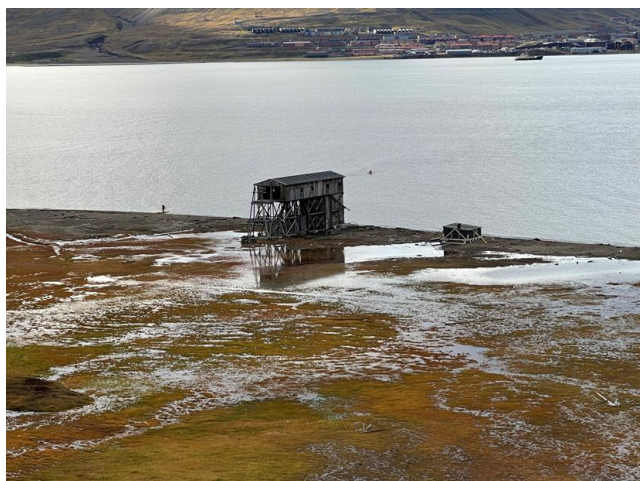
Another solution that at some point was under consideration is relocation of the Old cableway station on some several tens of meters inland. This solution has several challenges, from the historical perspective – function of the stion, i.e. connection to the sea will be lost. Also, area behind the station seems to be a boggy area that is sometime affected by surface flooding after rain events (Figure 97), these conditions may pose some technical challenges.

**Figure 96. Terrestrial flooding after severe rain event, early September 2023.**

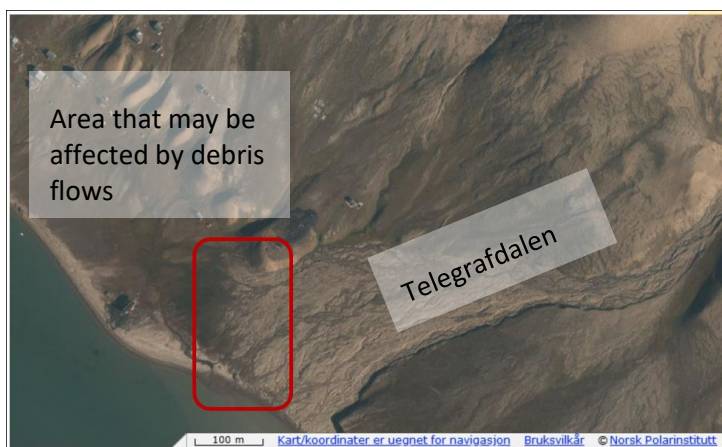
**Figure 97. Debris flow that may hypothetically come from Telegrafdalen. Photo: © TopoSvalbard.**

In addition, one may foresee establishment of protection from debris flow that may hypothetically come from Telegrafdalen (Figure 97).
