# Data Insights from an Offshore Wind Turbine Gearbox Replacement

Alexios Koltsidopoulos Papatzimos<sup>1,2</sup>  
Tariq Dawood<sup>2</sup>  
Philipp R. Thies<sup>3</sup>

<sup>2</sup>*EDF Energy R&D UK Centre, London, CR0 2AJ*

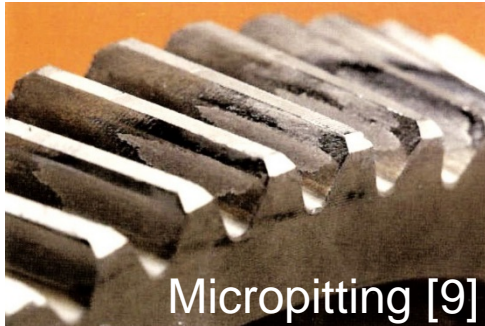
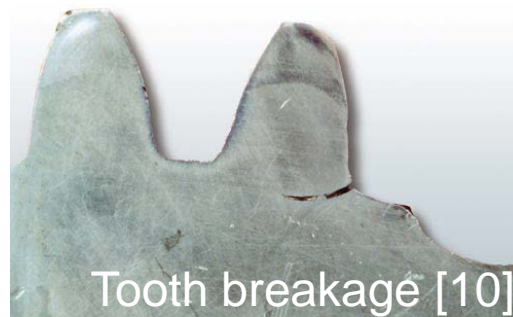
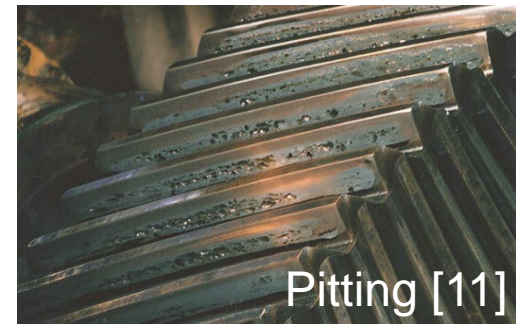
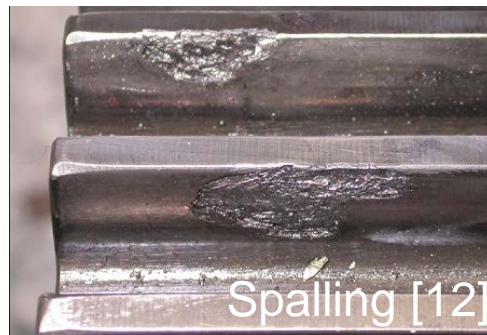
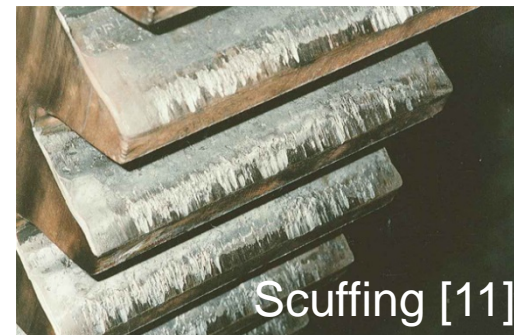
Most common failure modes:

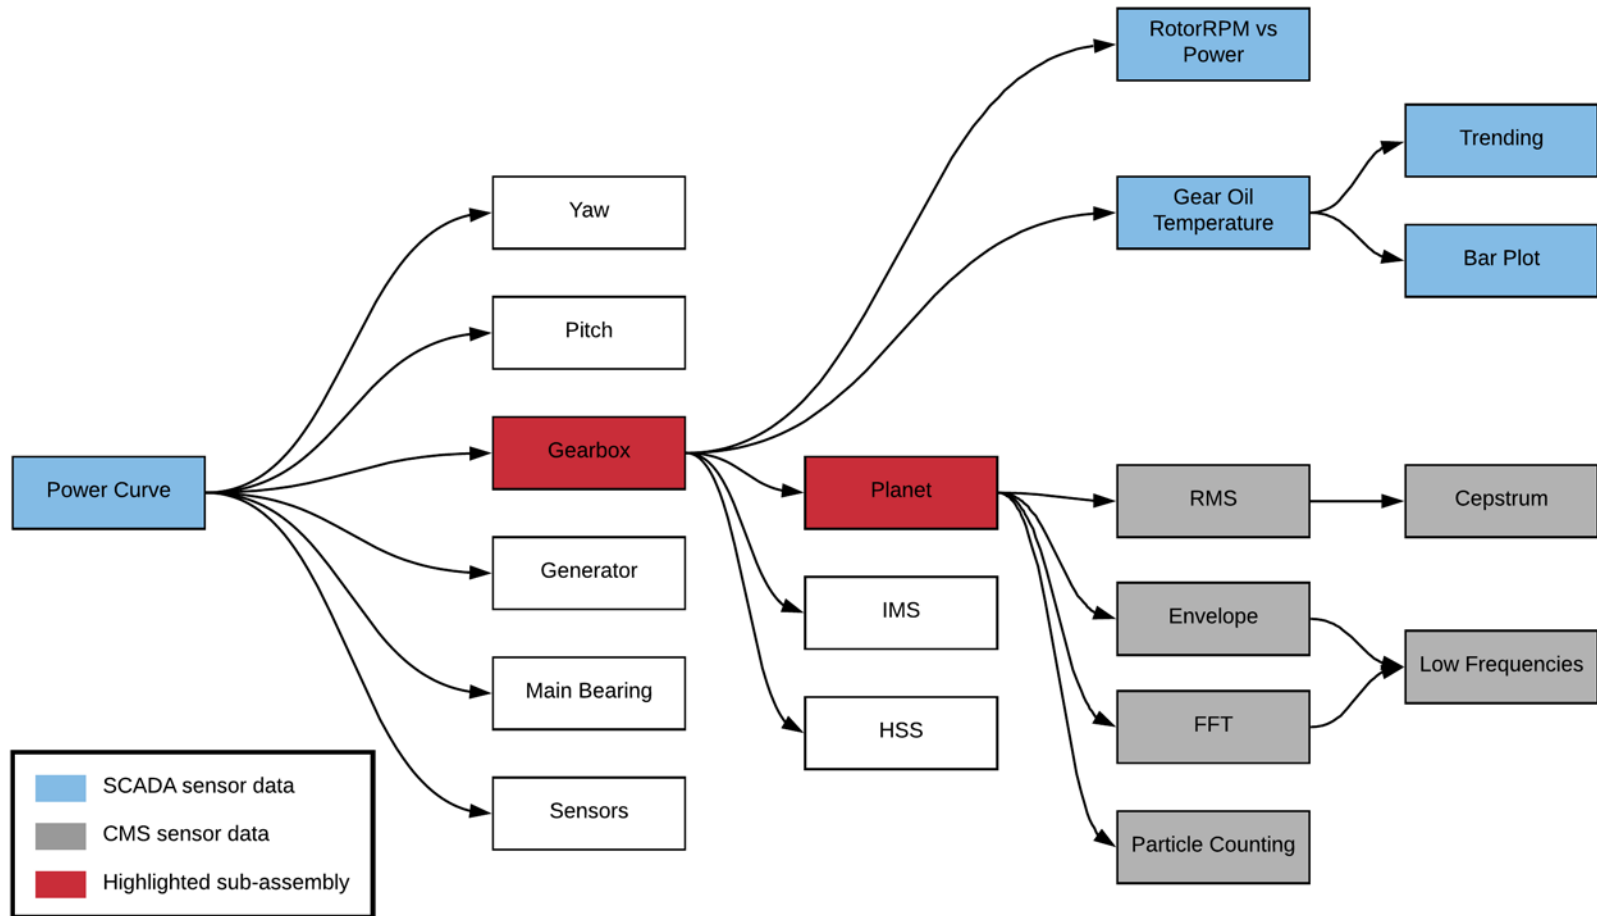
- Planet stage bearing spalling on a 3-stage 2.3MW turbine gearbox
- Similar studies investigated catastrophic gearbox failures
- Identify and diagnose the failure by using SCADA and CMS data
  - Temperature readings
  - RMS vibration
- Data driven models to predict future failures
