Husby terrasse

Renovated terrace houses in Norway

SINTEF Building and Infrastructure

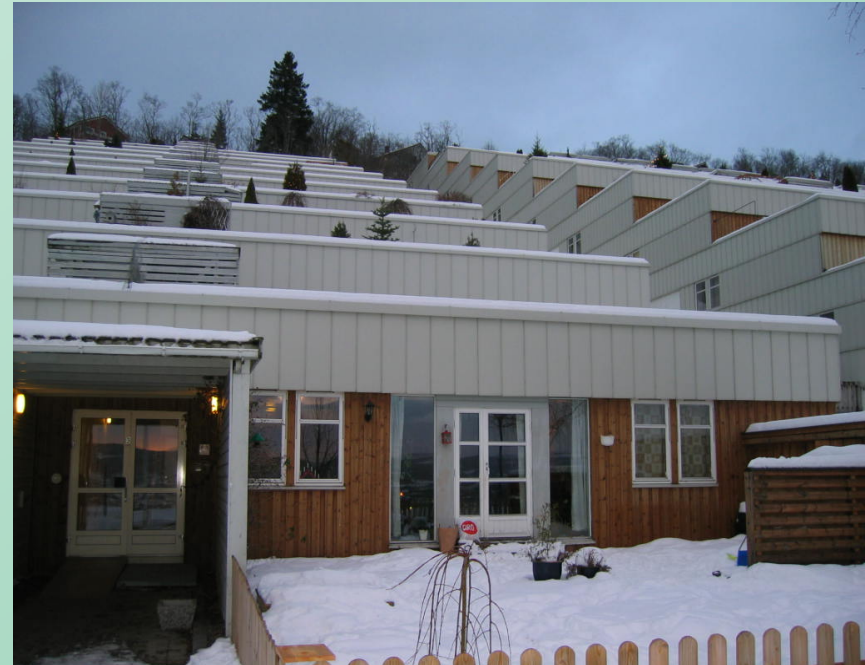
High energy consumption caused by...

- ▶ Exhaust ventilation with no heat-recovery (but outlet via culvert under the floors gives reduced heat transmission)
- ▶ Windows with high U-value
- ▶ External walls with high U-value
- ▶ Thermal bridges
- ▶ Air leakages
- ▶ Defective (lack of setback) in temperature control

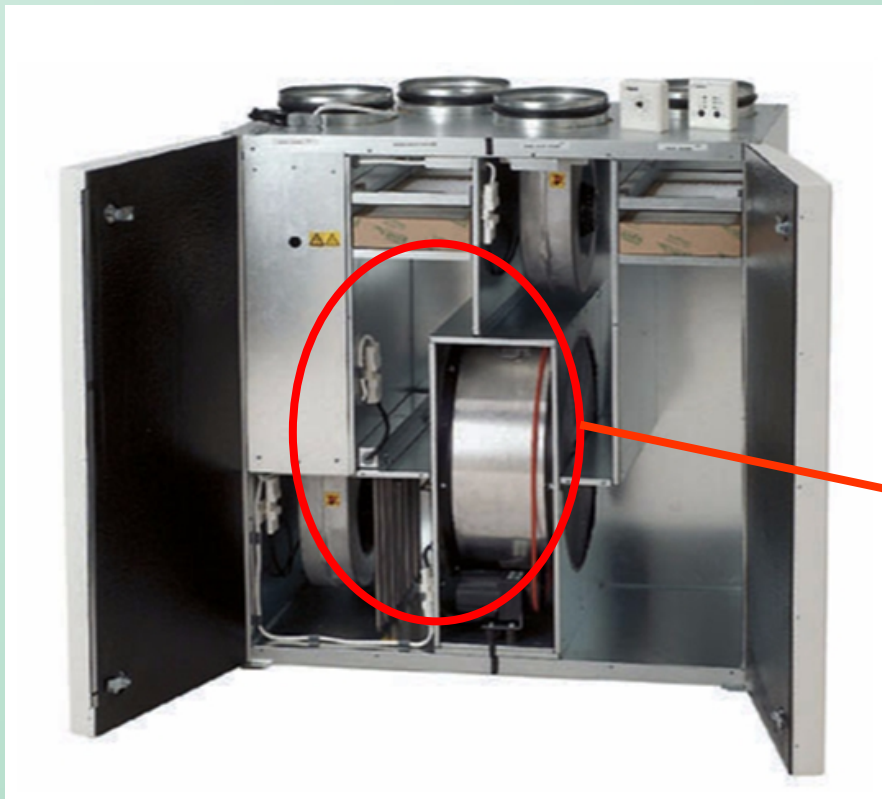
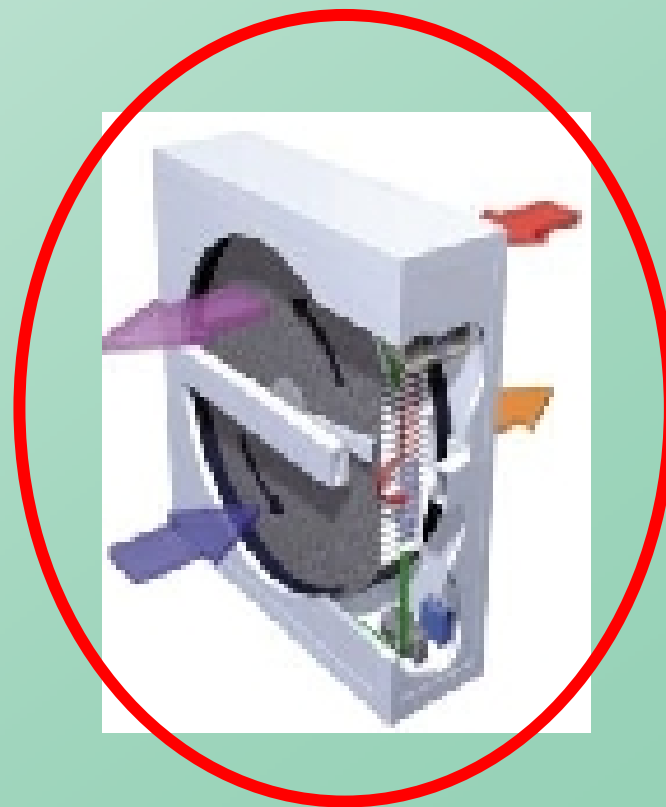
Balanced ventilation system with heat recovery
