Passivhus Norden 2009

## Renovation of the Brogården area to Passive Houses

*Ulla Janson, Tekn. lic,  
Energy and Building Design, Lund University;  
ulla.janson@ebd.lth.se <http://www.ebd.lth.se>*

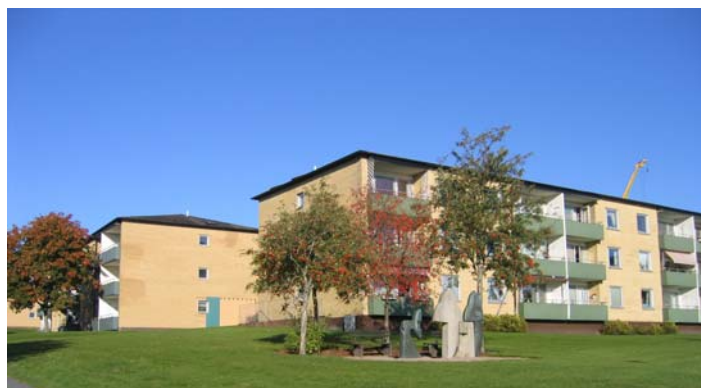
Figur 1 The Brogården area

There has been continuously maintenance during the buildings lifetime, but now the buildings are in need of a major renovation. Also, the tenants in the area complain about draught and uneven indoor temperatures and the apartments need to be more suitable for disabled persons. Otherwise, the apartments are popular and there are no vacancies in the area.
