Accident  
Investigation Board  
Norway

SL 2018/04

## REPORT ON THE AIR ACCIDENT NEAR TURØY, ØYGARDEN MUNICIPALITY, HORDALAND COUNTY, NORWAY 29 APRIL 2016 WITH AIRBUS HELICOPTERS EC 225 LP, LN-OJF, OPERATED BY CHC HELIKOPTER SERVICE AS

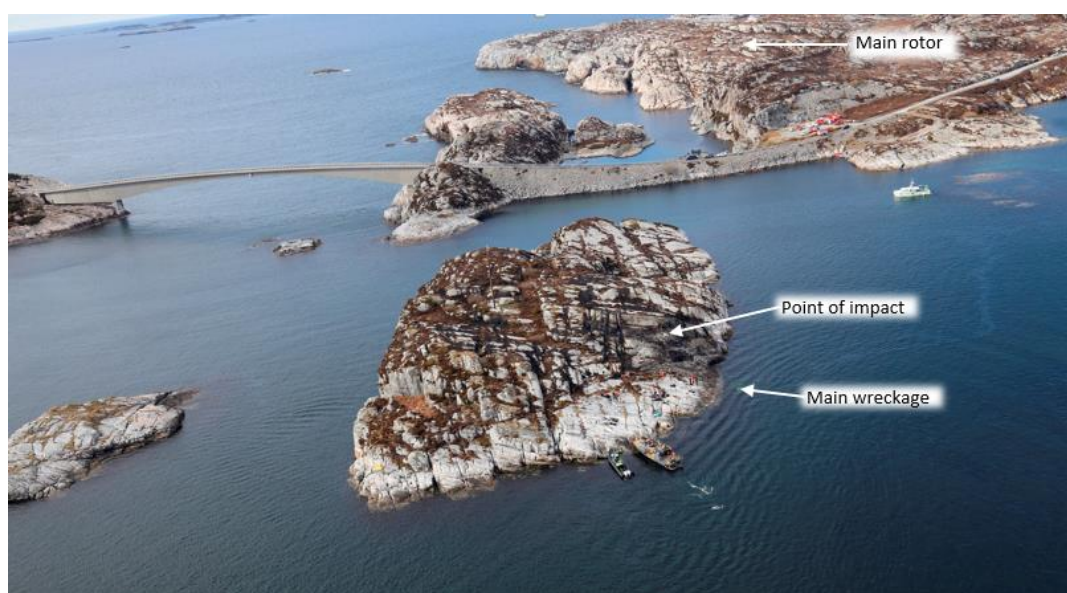
- 1.1.1.7 The main rotor detached above the western end of the Turøy Bridge and continued to fly on its own in a wide erratic descending left hand turn towards the north and fell down on the island Storskora (See Figure 2 and Figure 21).

Figure 2: Photo of the accident area taken at 1500 hours 29 April 2016. The helicopter flew over the Turøy Bridge seen to the left. View from south. Photo: Kripes

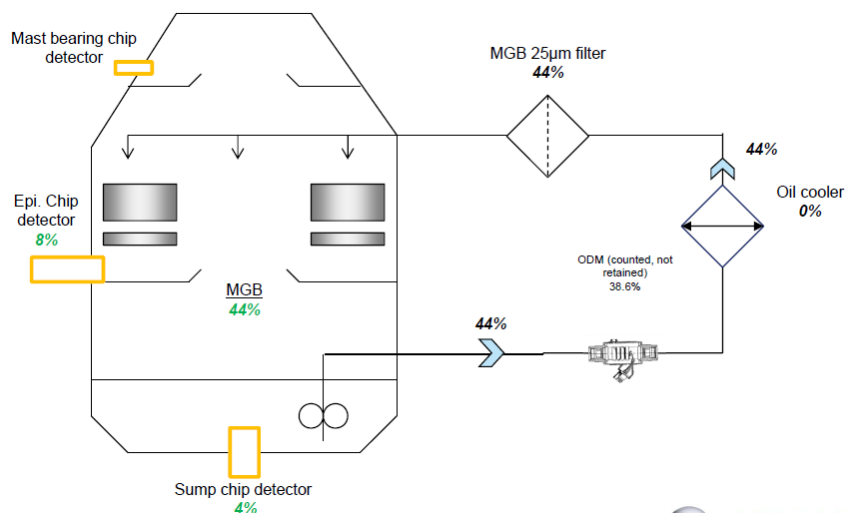
Following the LN-OJF accident, Airbus Helicopters provided an updated justification of the status of available MGB monitoring means. Based on the G-REDL test (see section 1.18.3.3) it was initially found that 12 % of the debris had been detected by the chip detectors while 44 % of the debris had been captured by the MGB oil filter (see Figure 12).

The configuration of the G-REDL test bench was different from the helicopter as it was not fitted with a standard oil cooler. Later, during the investigation of the LN-OJF accident, it was discovered that the standard oil cooler acted as a particle trap thus preventing the largest debris from reaching the filter. 44 % of the debris would not have reached the MGB oil filter as shown in Figure 12, but would have been partly retained in the oil cooler. This led to a thorough inspection of the LN-OJF oil cooler, in which several particles were recovered (see section 1.16.10.3).

Figure 12: The configuration of the G-REDL test and the detection rate of chip detectors (%: Particle quantity). Source: Airbus Helicopters

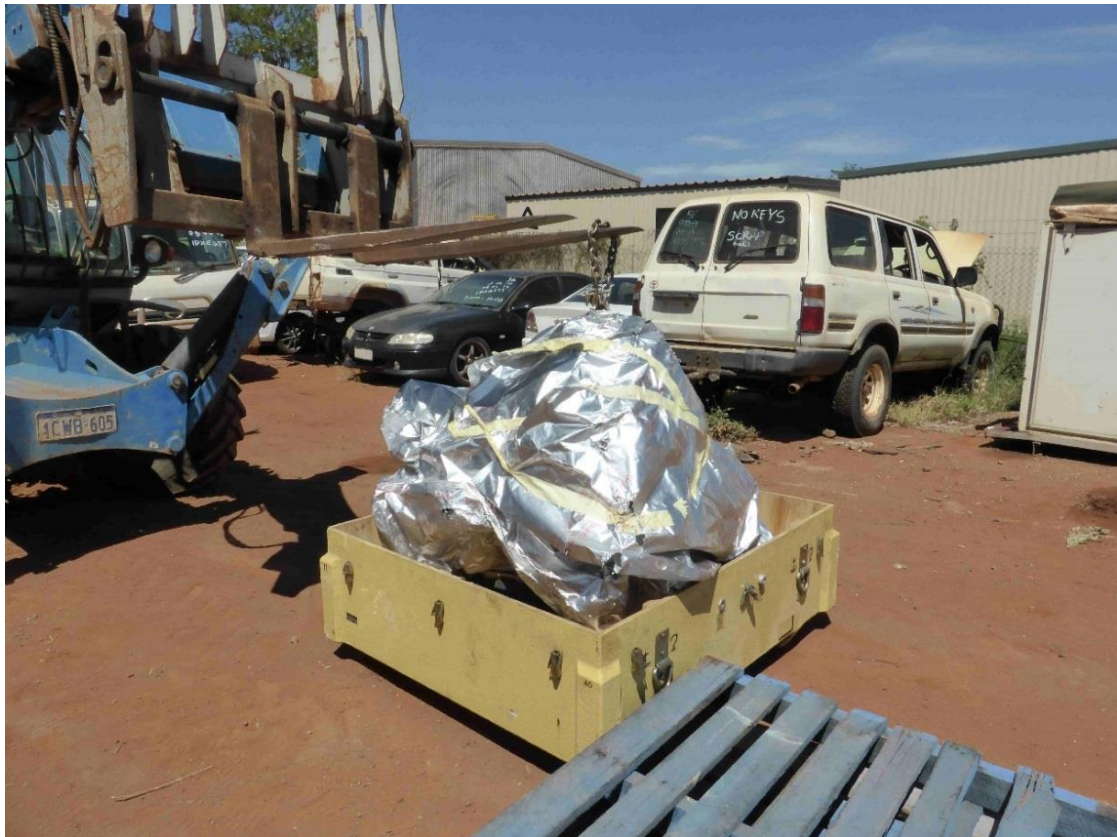
The gearbox was returned to Airbus Helicopters in Marignane, France for inspection and repair. Following inspection and repair, the MGB was supplied with an EASA Form 1 dated 5 January 2016 (see section 1.17.6.5). The document stated that the part was repaired with reference to overhaul instruction MRV EC 225 LP chapter 63 and log cards. According to Airbus Helicopters no anomalies on internal components were detected during this work, and all bearings and gears were re-installed.

The AIBN has asked for supplementary documentation of the inspection and repair and also of the workshare between the Part 21 and the Part 145 organisation at Airbus Helicopters (see section 1.17.4.2). This documentation does not fully describe the work performed. According to Airbus Helicopters there are deviations regarding formalization and documentation, but this has not affected their conclusions of the inspection.

Figure 14: The MGB in the transport container without the damaged top after the ground transport accident 13 March 2015. Photo: Airbus Helicopters

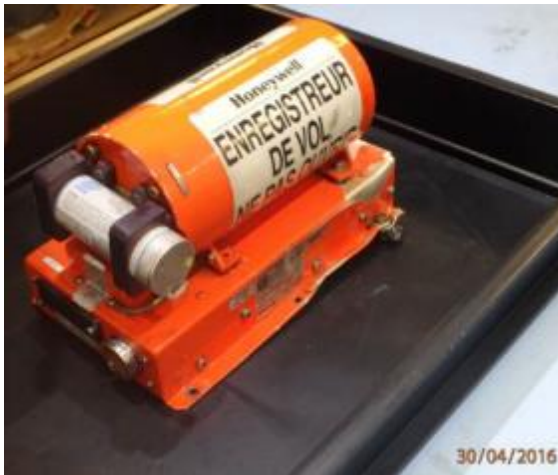
The CVFDR was removed from the tail boom that had been picked up from the seabed in the late evening of the 29 April 2016 and transported in fresh water by the AIBN to the AAIB at Farnborough, UK. Initially, it was not possible to download data because the wiring between the base unit and the CSMU was damaged. Following repair and use of a dummy fixture a successful download of all the data was performed.

Figure 15: CVFDR from LN-OJF as received at the AAIB. Photo: AIBN

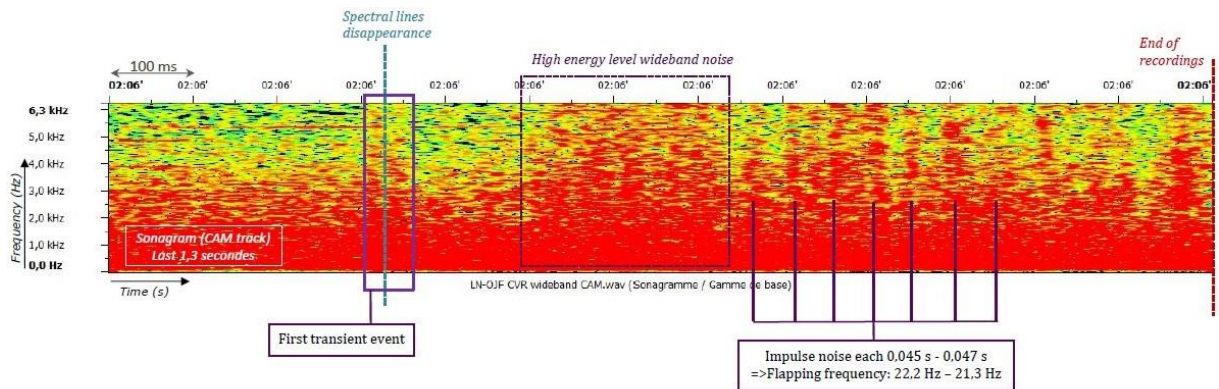
Following the readout at the AAIB, all four audio files were transferred to the BEA in France for further analysis. Spectrum analysis from the CAM recording is shown in Figure 17. The CAM spectrogram shows that the CVR recording ended 1 second after the first transient event.

Figure 17: Spectrum analysis from the CAM audio file showing 1.3 seconds believed to be the beginning of the MGB break-up. Source: BEA

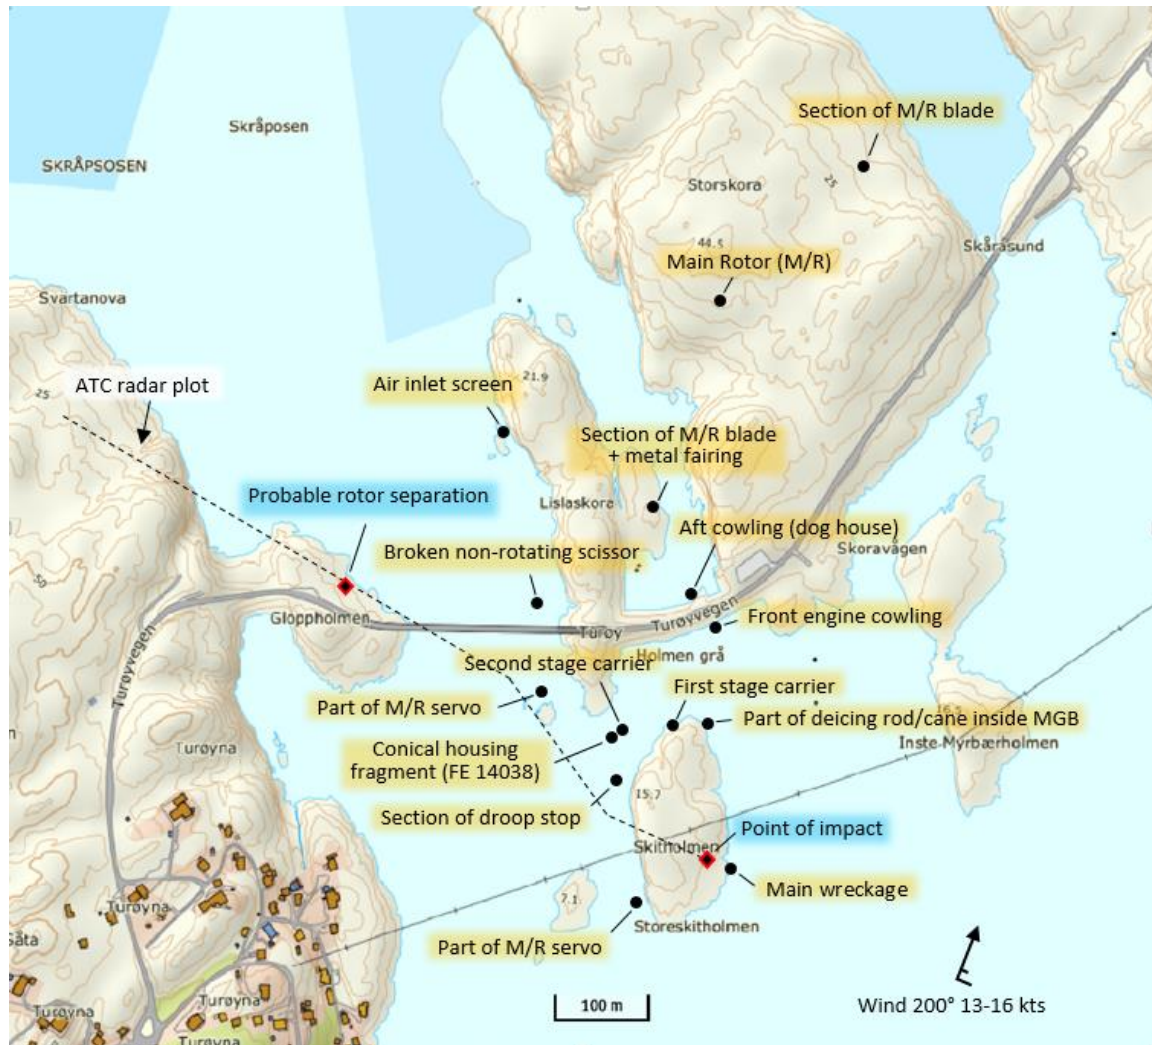
As mentioned in section 1.12.1.1, a number of parts from the helicopter were found dispersed over an area of about 180,000 m<sup>2</sup>. However, most of the helicopter wreckage came to rest on the seabed just outside Storeskitholmen island. The largest part found separate from the accident site itself, was the main rotor, which was at the Storskora island. The map in Figure 21 shows where a number of parts were discovered.

Figure 21: Accident site overview with wreckage parts of interest. Source: The Norwegian Mapping Authority adapted by the AIBN

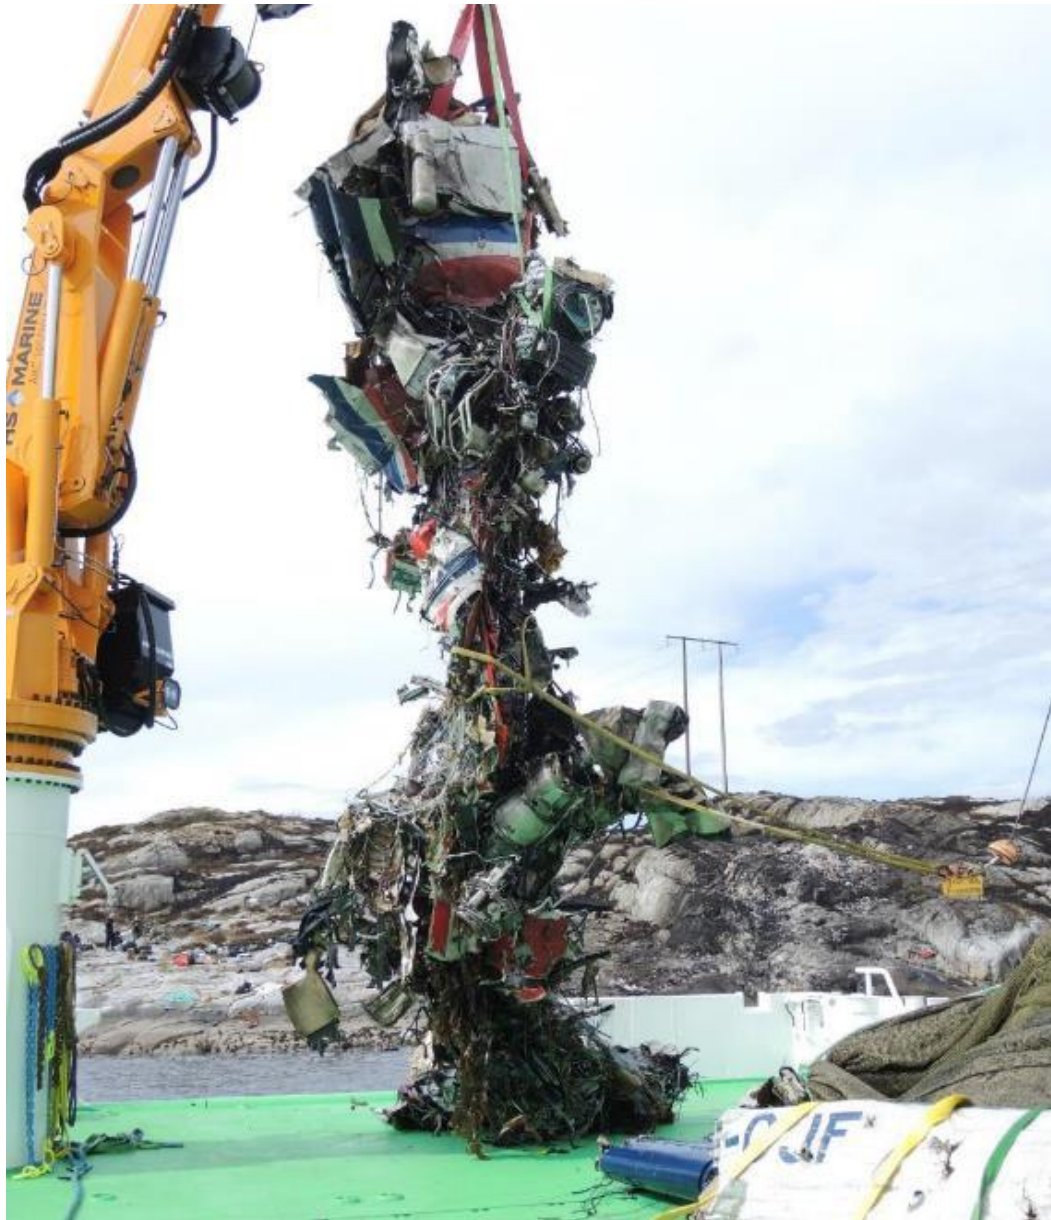
The main parts of the helicopter cabin, including the cockpit, were recovered as one piece, held together by bars, wires, tubes and pipes, but otherwise structurally destroyed. They were damaged to such extent that it was almost impossible to conduct any meaningful investigations of the wreckage components (see Figure 22).

Figure 22: The main wreckage during recovery. The tail boom seen at the lower right had already been recovered. Photo: AIBN

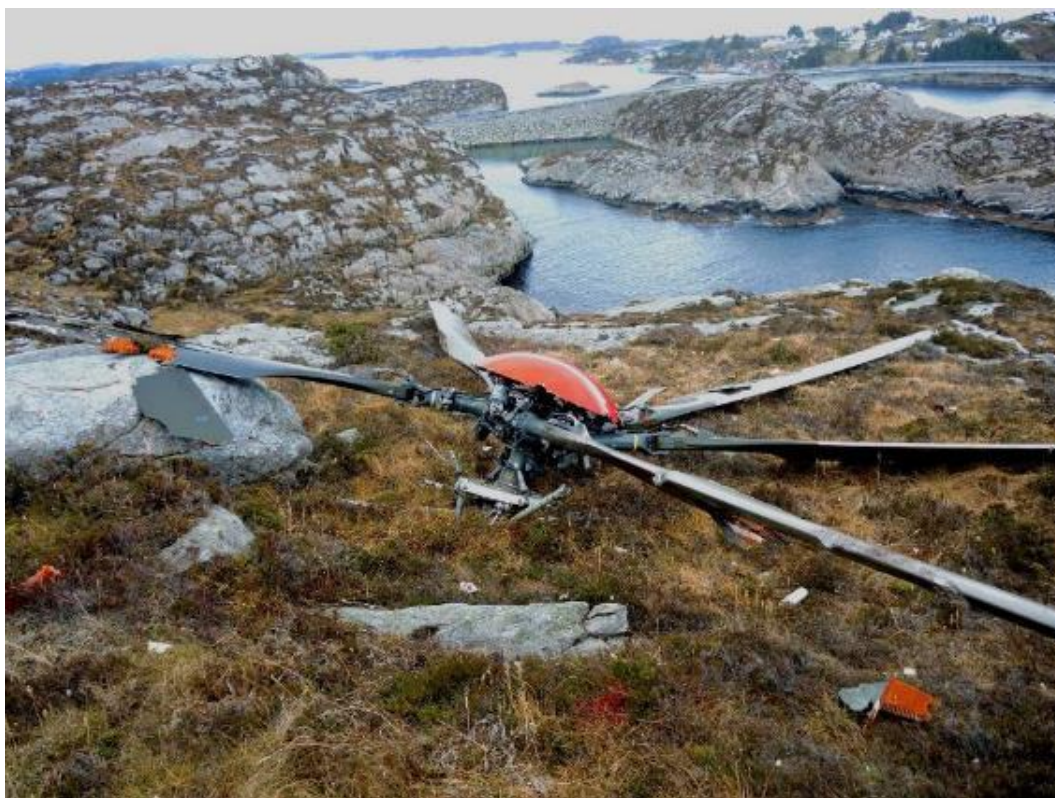
The main rotor including the main rotor mast, parts of the conical housing including the lift bearing and two suspension bars were discovered on the island Storskora (see Figure 2 and Figure 24).

The main rotor blades were dismantled from the rotor head and examined by the AIBN. In general, the innermost sections of the main rotor blades were structurally intact, but the outer parts of the black, white, red and blue blades were significantly damaged. Several blades had lost large sections of the honeycomb structure behind the main spar. There was a clear imprint on the yellow blade, after contact with one of the engine's air inlet screens, 1.9 metres from the blade bolts.

The rotor head and the mast were sent to Airbus Helicopters and further examined under the supervision of the AIBN and the BEA. Detailed examinations of the Main Rotor Mast coupling splines and the Main Rotor Mast bearing did not reveal any pre-impact anomalies and they were found to be in normal and standard operational conditions.

Figure 24: The main rotor and rear suspension bars as found on the island Storskora.  
Photo: AIBN

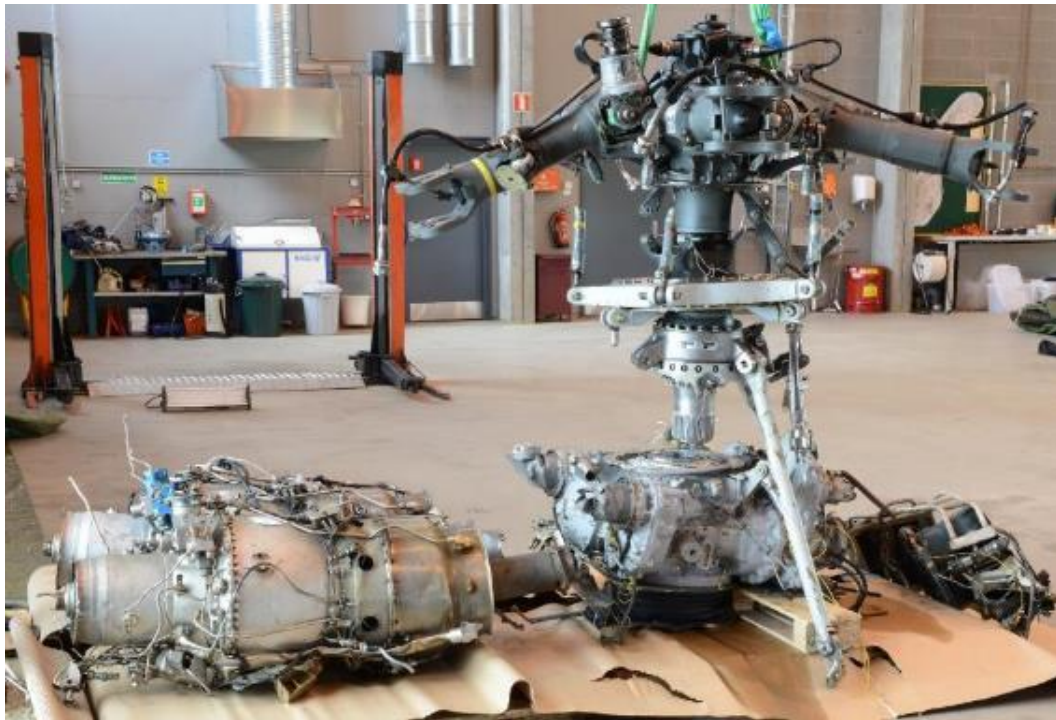
The main module was relatively complete and with limited damage. Both engine high speed input shafts had been twisted off near the main gearbox in a manner which indicates high torque, possibly combined with bending. The linking tubes (liaison tubes) were bent upwards (see Figure 25). The oil sump in the main module contained large quantities of metal fragments and shavings. All findings during examinations of the main module are consistent with the helicopter hitting the ground with great force and then ending up in the sea. Seawater had caused heavy corrosion, particularly to magnesium alloy parts.

*Figure 25: Engines, substantial parts of the MGB, two suspension bars and main rotor head assembled at the AIBN premises. Photo: AIBN*

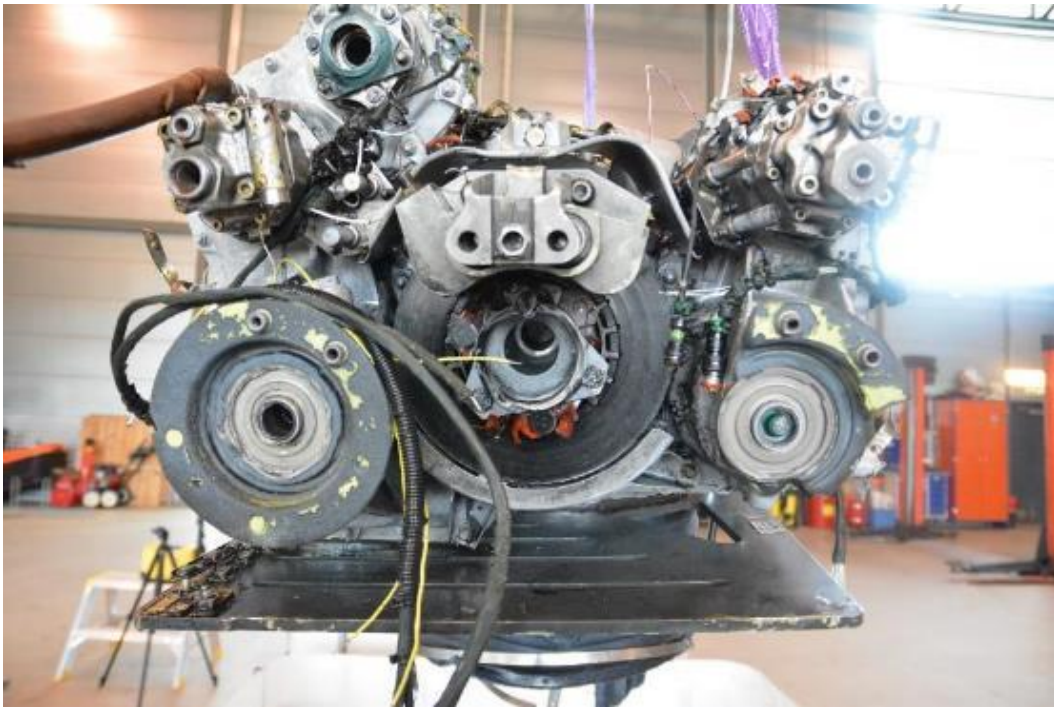
The right and left accessory modules were relatively complete and with only minor damage (see Figure 26). Both generators had come loose from the gear box. Both hydraulic pumps were still attached. The axles for the cooling fan and tail rotor had broken off very close to the connections.

Figure 26: L/H and R/H accessory modules seen from behind. The flexible mounting plate is seen attached to the MGB oil sump. Photo: AIBN

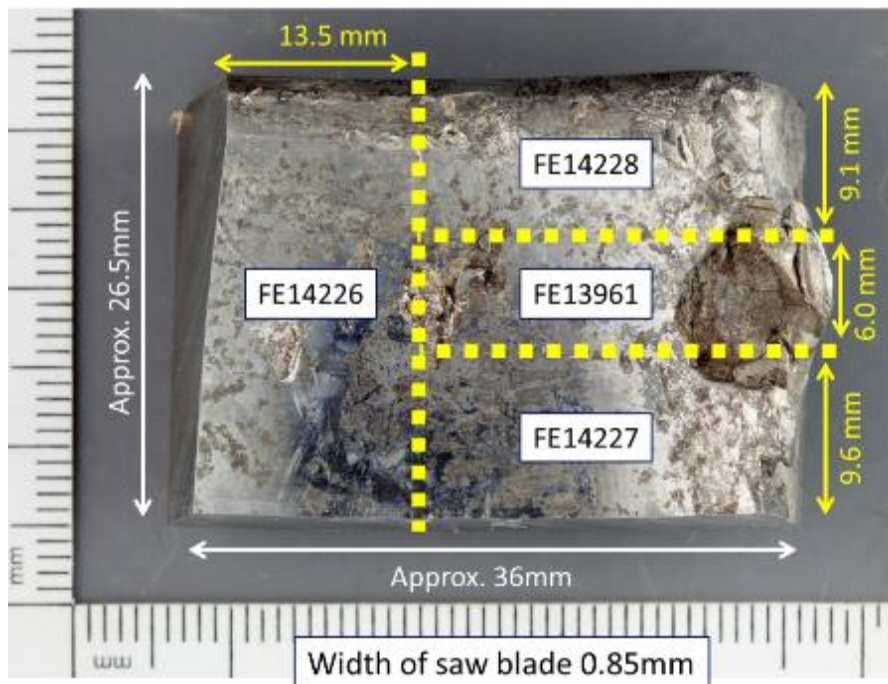
Following detailed examination, the outer race of section FE 13961 (see Figure 40) was separated from the gear bulk material at QinetiQ. The outer race (cap/calotte) was later sent to Airbus Helicopters for additional examinations.

Figure 40: Cutting lay out based on CT-scan results (see Figure 38). FE13961 contains spall three and four, FE14226 contains spall one and two. Photo: AIBN/QinetiQ

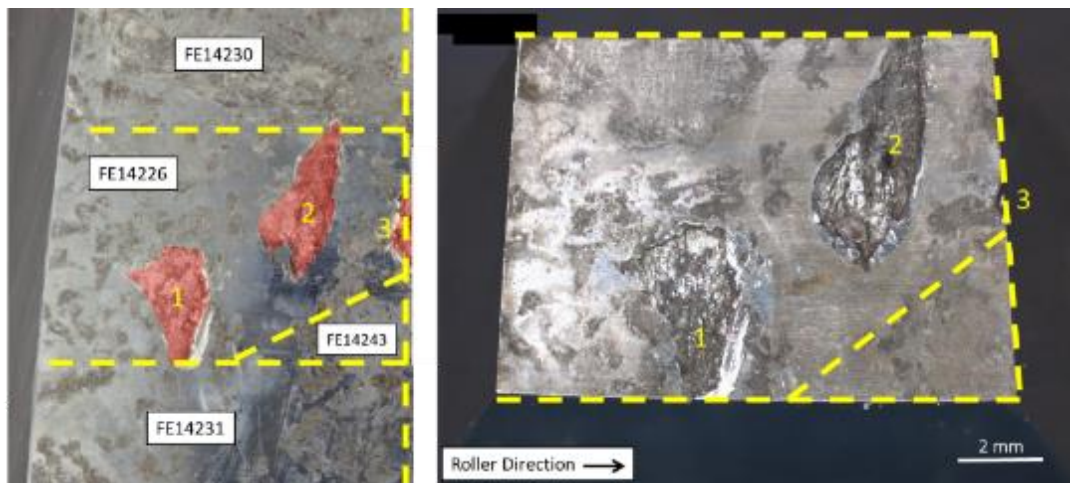
The sample (section FE 14226) was cut again in order to examine spalls 1 and 2 and the cracks between spalls 1, 2 and 3 (see Figure 40 and Figure 46).

Figure 46: Figure showing cutting for examining spalls 1 and 2 and the cracks between spalls 1, 2 and 3. Photo: AIBN/QinetiQ

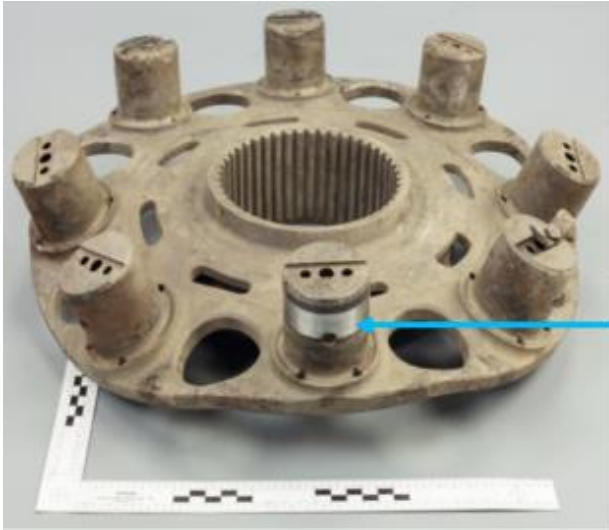
- 1.16.4.1 During a diving exercise in February 2017, about 10 months after the accident, the second stage planet carrier was found (see Figure 52). On the planet carrier the inner race of the fractured planet gear was still on the carrier, but rotated 35° and pulled off 20.4 mm. The lower rotor mast bearing was still attached to the carrier.

Figure 52: The second stage planet carrier found in February 2017 shown after cleaning. The inner race of the fractured second stage planet gear has been removed from stub shaft number 3 in front. Photo: AIBN/QinetiQ

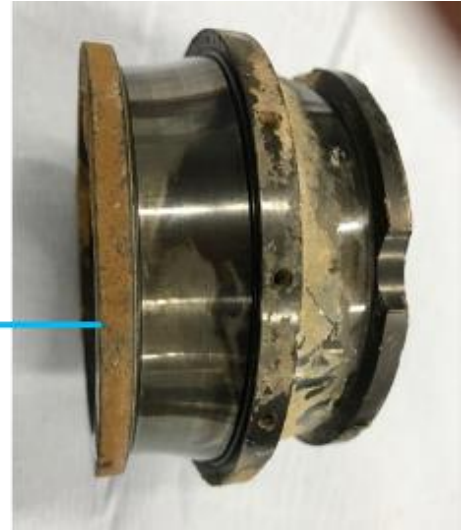
- 1.16.4.2 After cleaning, the inner race surface (see Figure 53) was in good condition for further examination at QinetiQ together with the carrier and the mast bearing. The rotor mast splines have been visually inspected and no geometrical deviations or mechanical damage, other than corrosion, were observed. Examination of the lower rotor mast bearing showed no mechanical damage, see Figure 54, as might arise from misalignment or jamming. The carrier had symmetrical deformations around the stub shaft where the fractured planet gear had been mounted (see Figure 55).

Figure 53: The inner race of the fractured planet gear after cleaning of the upper race (left in photo). Position on the carrier is given by the arrow. Photo: AIBN/QinetiQ

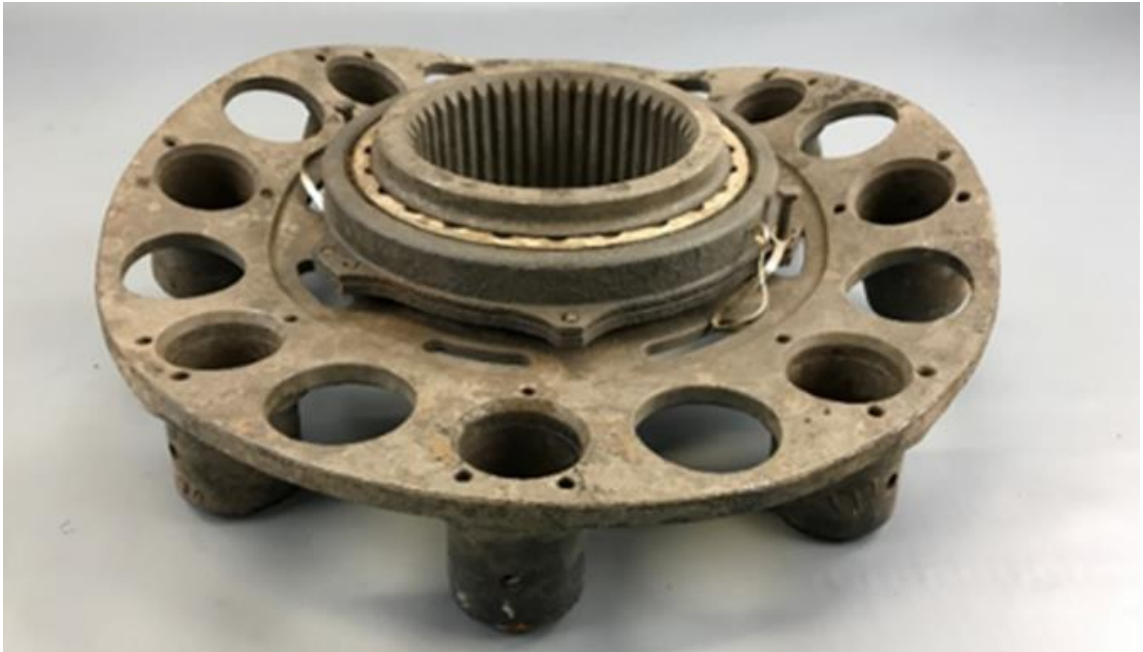
Figure 54: The second stage planet carrier found in February 2017 shown after cleaning. The lower mast bearing is shown on top of the carrier. Photo: AIBN/QinetiQ

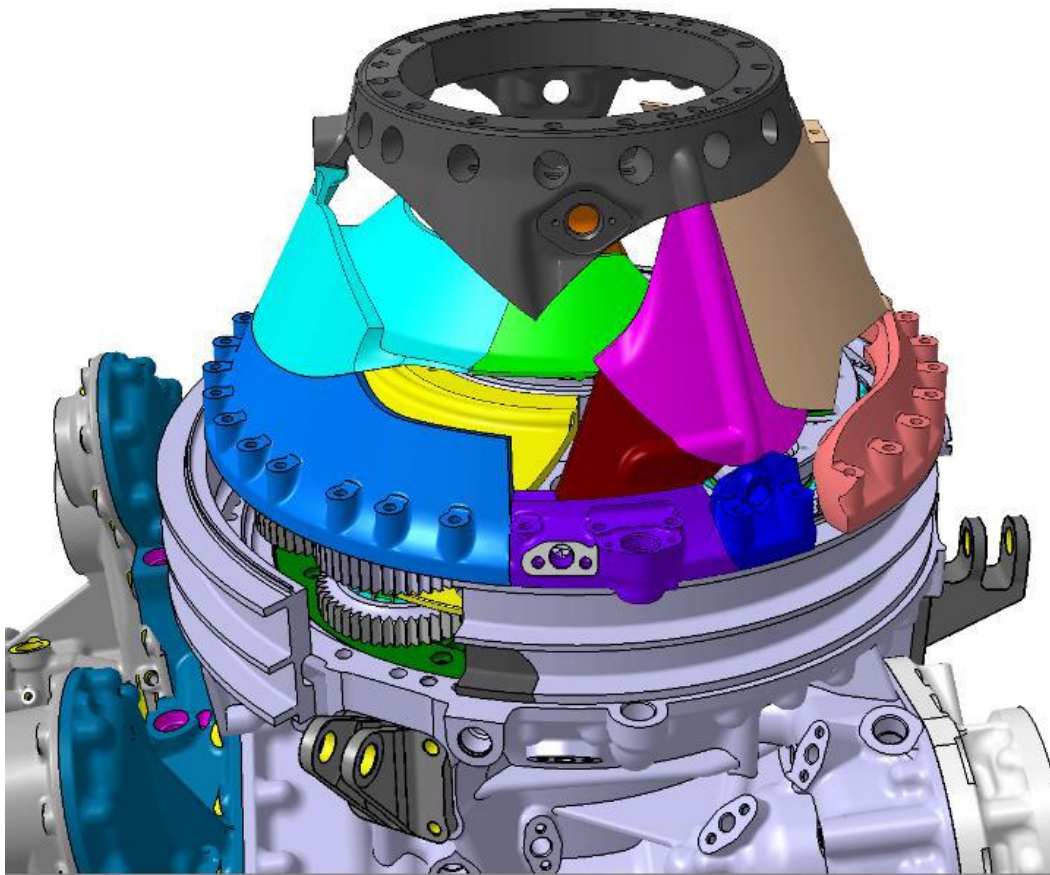
*Figure 58: Illustration of how the retrieved fragments of the conical housing are pieced together in order to look for break-up sequence/mechanism. Illustration: Airbus Helicopters*

- 1.16.7.1 The conical housing is made from an aluminium alloy. The conical housing was shattered and found in many smaller segments. As these segments were gradually salvaged piece by piece, they were examined, scanned and documented. A complete conical housing was used as template at QinetiQ. Airbus Helicopters used their design and manufacturing data model in order to fit the different parts in the correct position (see Figure 58).

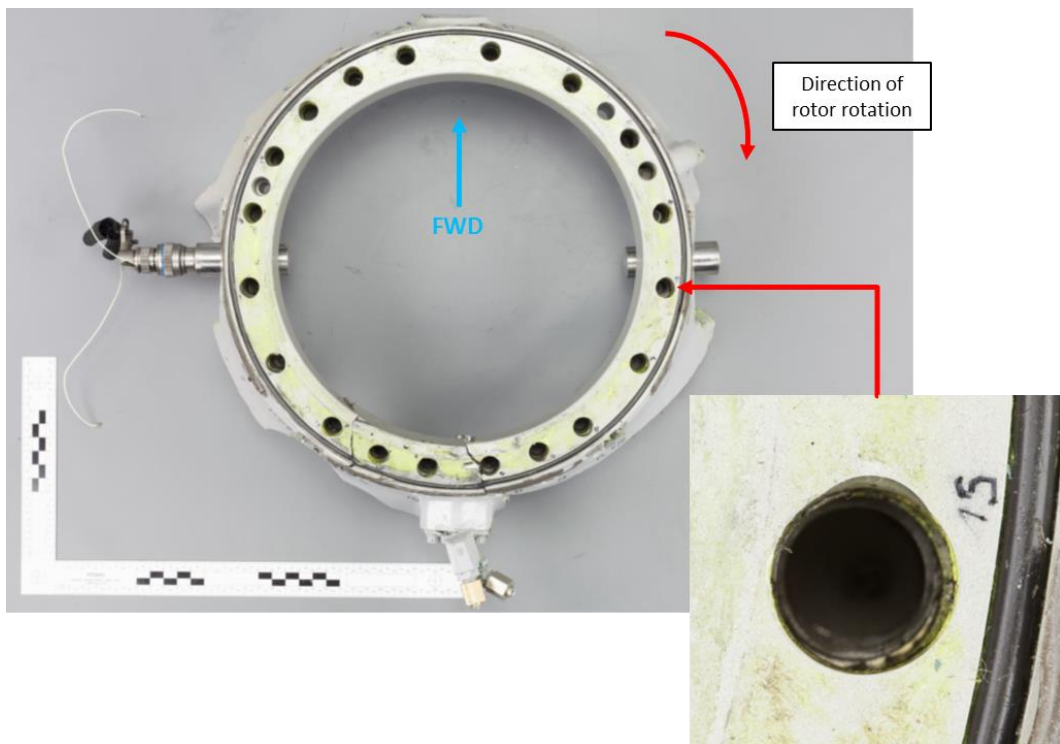
Figure 60: Top of conical housing. This segment of the conical housing was still attached to the rotor mast following the accident. Photo: AIBN/QinetiQ

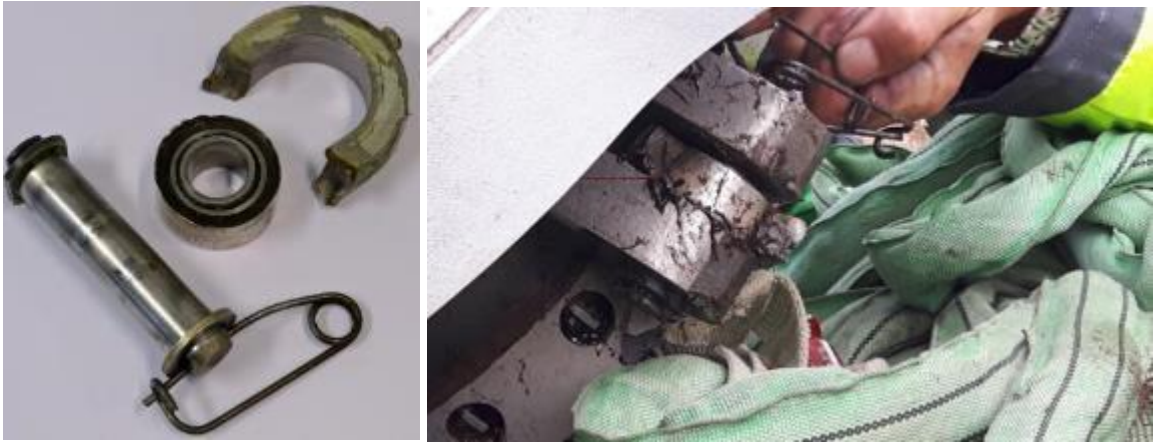
The only parts from the forward suspension bar that were recovered were the upper fractured mounting lug with its clevis, and two safety pins that were attached to the lift housing. These parts were brought to the QinetiQ laboratories for metallurgical examination, see Figure 63 (two safety pins shown on right photo).

Both top and bottom fractures were examined in a scanning electron microscope (SEM) and found to be overload. There was no evidence of progressive crack growth such as fatigue. Both top and bottom fractures exhibited necking and deformation consistent with tensile overload failure. The deformation was consistent with the lift strut bending in a port direction. More deformation (twisting) was observed on the bottom fracture, which suggests that the top of the lug failed first, allowing the strut to twist about the remaining bottom part of the lug before final failure. Bottom fracture face appeared to be twisted approximately 10° anticlockwise, see Figure 64.

Figure 63: Upper forward suspension bar, part of the mounting lug, the bearing, the clevis pin (with only one of the two safety pins) and the safety pins. Here shown both as found at the rotor mast (right photo) and dismantled (left photo). Photo: AIBN

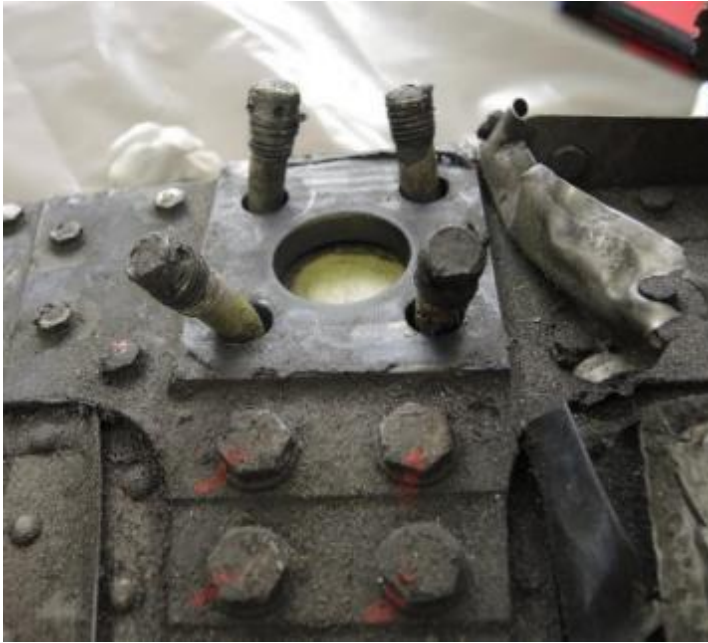
Inspection of available suspension bar airframe fittings, the mating airframe shim and plate, showed no major fretting, see Figure 65.

No evidence of fatigue failure was observed on the parts.

Figure 65: The four bolts from the lower forward fuselage fitting protruding from the support plate. Photo: AIBN

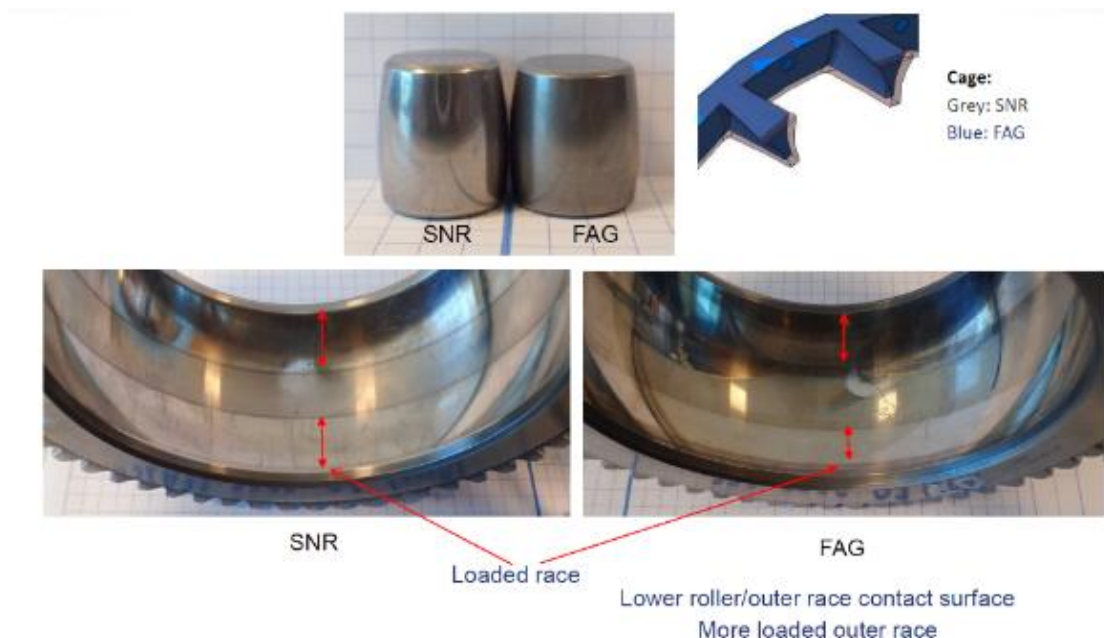
Figure 68 shows the geometry differences between a FAG and a NTN-SNR bearing and their contact pattern on outer race. The roller geometry and the cage dimensions differ.

Figure 68: Geometry differences between NTN-SNR and FAG bearings and contact pattern on outer race. The two cages, one grey and one blue, superimposed to show the difference in design. Source: Airbus Helicopters

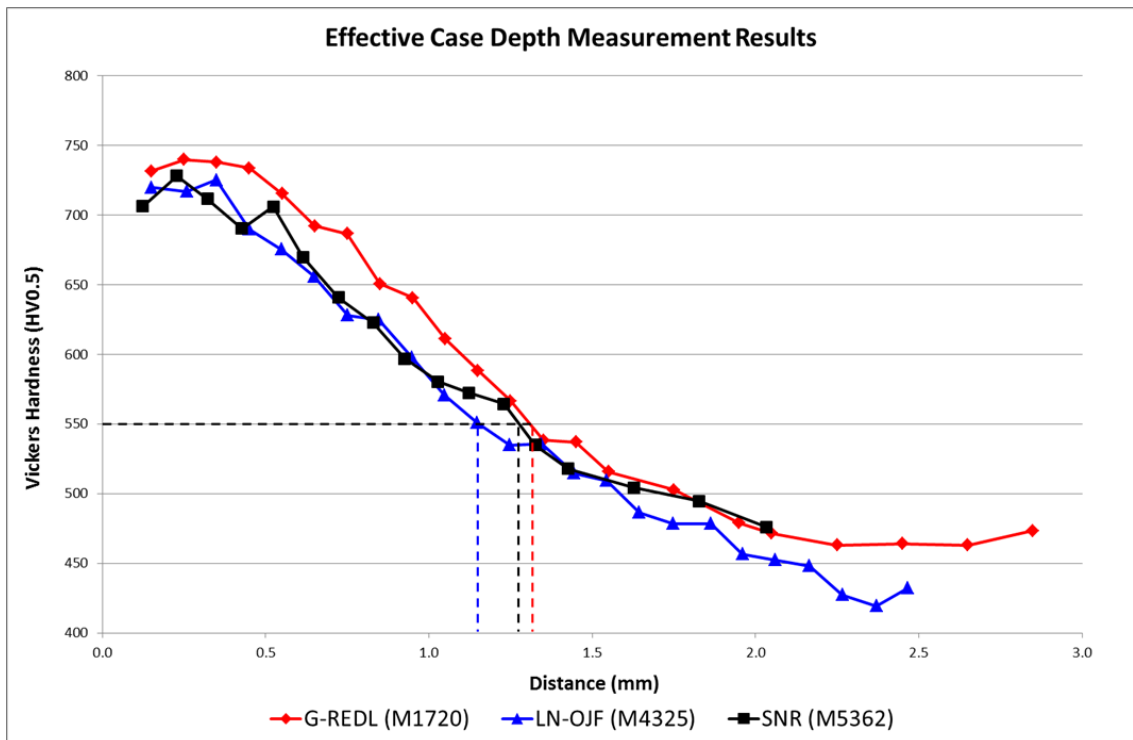
All of the planet gears are case hardened (carburised) by Airbus Helicopters before final grinding of the bearing surfaces. No significant differences in effective case depth have been noted between any of the gears examined, see Figure 69. Surface hardness measurements by both AIBN/QinetiQ and Airbus Helicopters at a range of different loads showed that the FAG gears tend to have a higher surface hardness, see Figure 70. This is consistent with the typically higher surface compressive residual stress in FAG gears, and is believed to be related to the final stage of the manufacturing process.

Figure 69: Outer race hardness values, comparison between a NTN-SNR gear, LN-OJF and G-REDL Figure: AIBN/QinetiQ

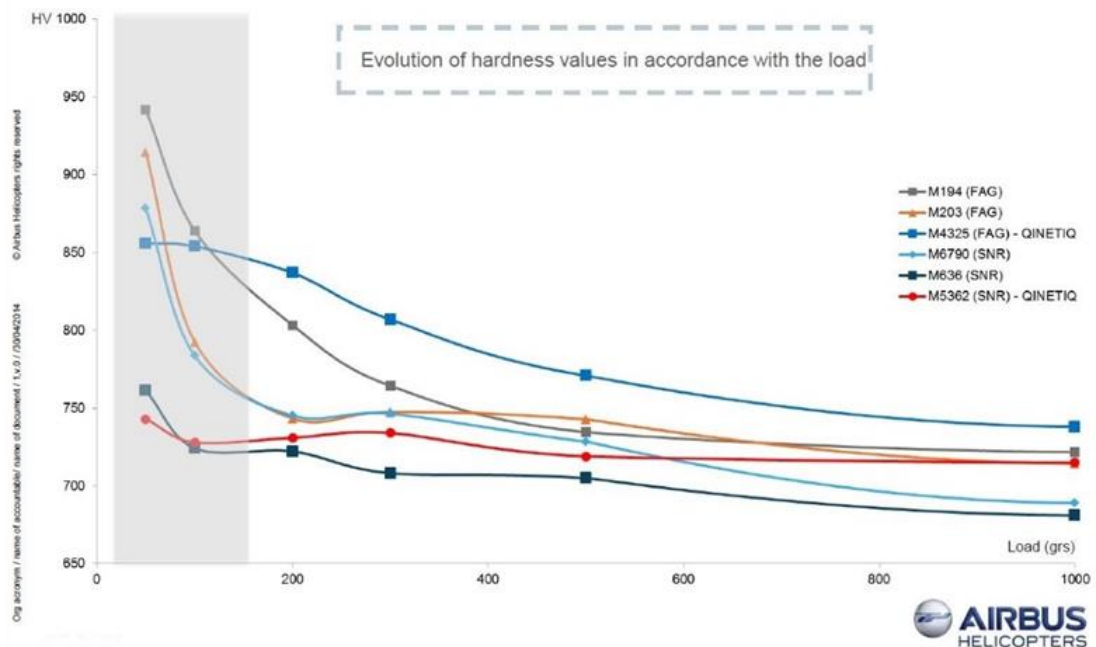
Figure 70: Hardness values vs. indentation load. From upper at the left hand side in the figure: FAG, FAG, FAG (QinetiQ), NTN-SNR, NTN-SNR, NTN-SNR (QinetiQ). Figure: Airbus Helicopters

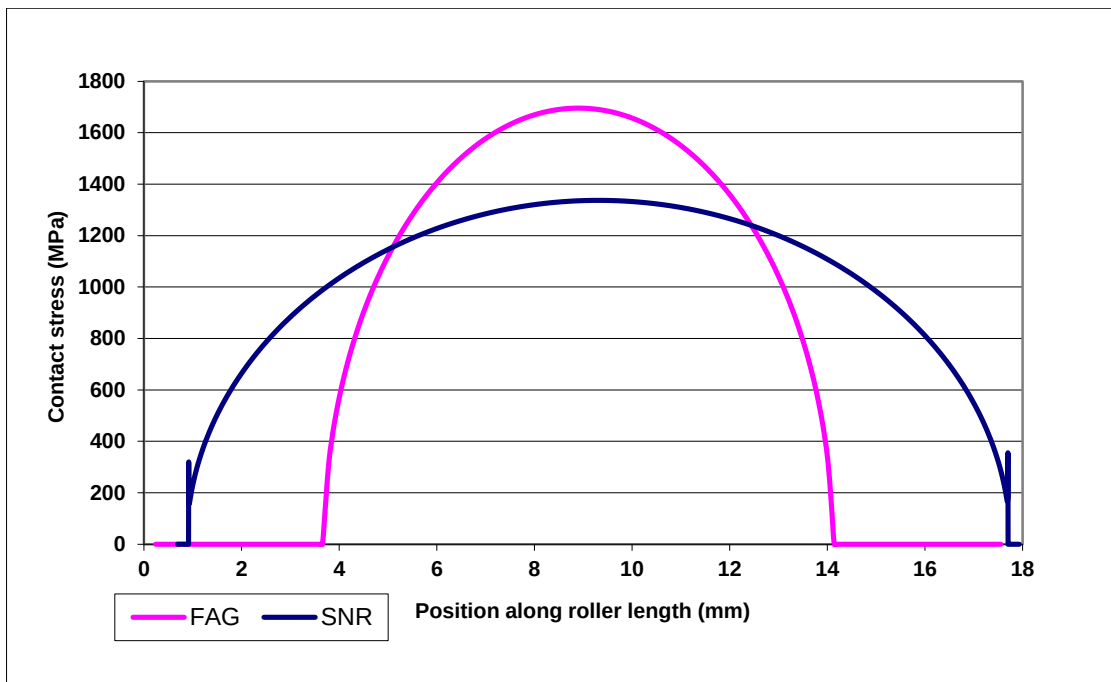
Both inner and outer raceways of the FAG bearing experience higher central contact stress than the SNR bearing. The stresses for the outer raceway are the most relevant to the failure mode in this investigation, and the graph below compares the two types (see Figure 71). As can be seen, the contact pattern for the FAG bearing is more concentrated towards the centre of the roller length. These results are consistent with Airbus Helicopters calculations performed after the accident.

Figure 71: Comparison of outer race contact stresses for peak roller load. EC 225 LP mean cubic power condition. Source: Romax/AIBN

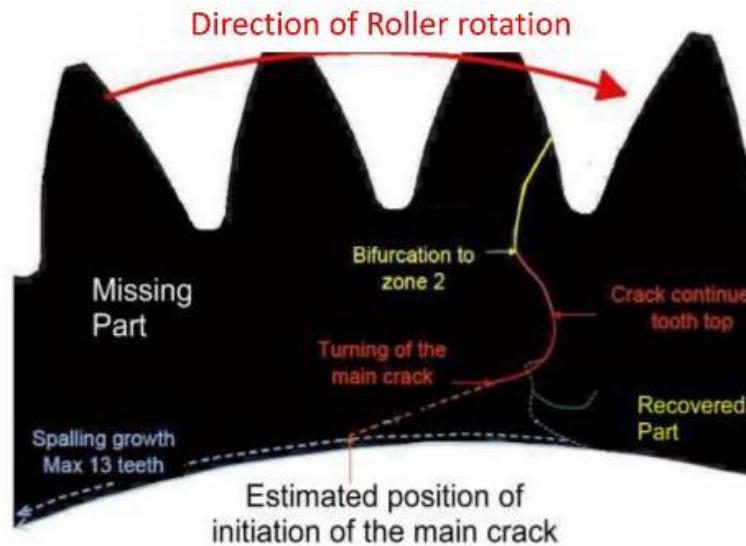
Figure 74: Stress model estimation of crack growth. Source: Airbus Helicopters

- 1.18.2.4 The origin of the crack was found to be in a section of the failed gear which was not recovered. Figure 74 shows a stress model prediction of crack growth as displayed in the G-REDL report. The Findings section in the report contained amongst the following:

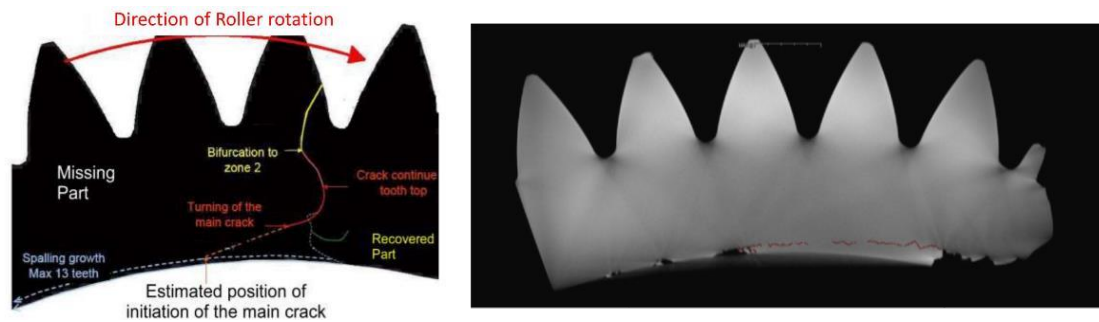
- 2.8.2.6 The G-REDL report displayed a stress model prediction of crack growth in the section of the planet gear which was not recovered (see section 1.18.2). The crack propagation underneath the depth of the carburized layer in the retrieved second stage planet gear from the LN-OJF accident appears to be very similar to the G-REDL stress model prediction of crack growth (see Figure 77). The LN-OJF gear segment closely resembles the estimated missing gear part from G-REDL.

Figure 77: Stress model estimation of crack growth from the G-REDL accident to the left (Source: Airbus Helicopters) compared with the CT scan from the LN-OJF gear with the crack in red (Photo: CT-scan from AIBN/Southampton University).
