# The first apartment house renovation with Passive House components in Norway

Dipl.-Ing. Architekt Michael Klinski, Dr.-Ing. Tor Helge Dokka  
 SINTEF Building and Infrastructure, Postboks 124 Blindern, N-0314 Oslo  
 Tel. (+47) 22 96 55 53, Fax (+47) 22 69 9438, michael.klinski@sintef.no

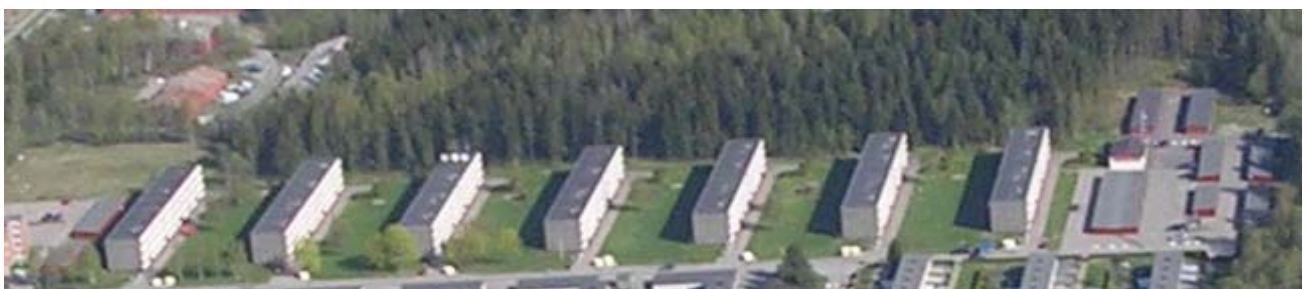
**Figure 1. Myhrerenga: seven similar blocks with west-facing and east-facing main façades.**

Myhrerenga housing cooperative is situated 15 km north-east of Oslo in Skedsmokorset and consists of 7 similar blocks, erected in 1968-1970, three storeys high with 24 apartments in each block. There are only two types of apartments, six one-bedroom flats with 54 m<sup>2</sup> living space and 18 two-bedroom flats with 68 m<sup>2</sup> floor area per block, in total 168 dwelling units. A façade in need for renovation, together with complaints about draft, cold floors and poor air quality initiated the renovation process in 2006. Since the buildings were in need of a major renovation anyway, the Norwegian State Housing Bank in cooperation with SINTEF suggested an ambitious “Passive House renovation”, which is assumed to reduce the overall demand of delivered energy from about 275 – 300 to 80 kWh/m<sup>2</sup> per year, and to cut the net space heating demand by 80 – 90 percent to about 25 kWh/m<sup>2</sup> per year.

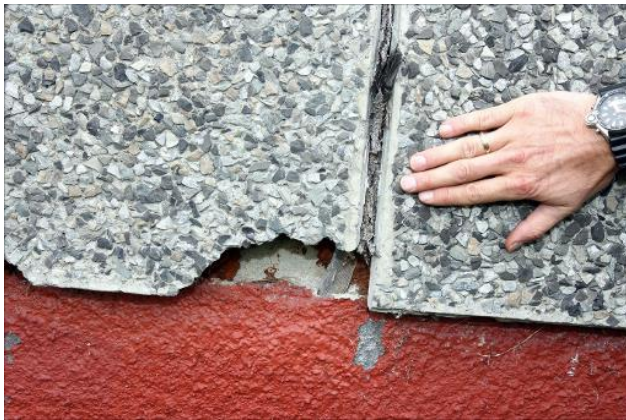
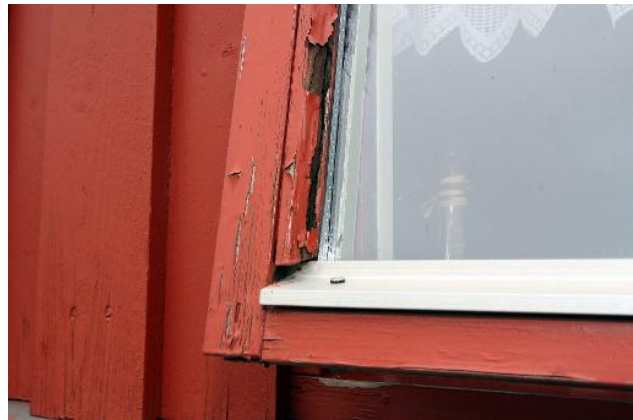
**Figure 2.** The façade is worn out, and the windows are in need for replacement.

The construction system consists of load-bearing concrete elements, with filled-in wooden construction in the long facades. The gable walls consist of poorly insulated concrete sandwich elements. The roof is a wooden insulated construction above the concrete slab. The walls and the roof are insulated with 10 cm mineral wool (gables only 8 cm or less), while the floor against the unheated basement is insulated with 5 cm EPS (Expanded Polystyrene). The two-pane wooden windows are from the eighties, but nevertheless in need of replacement.

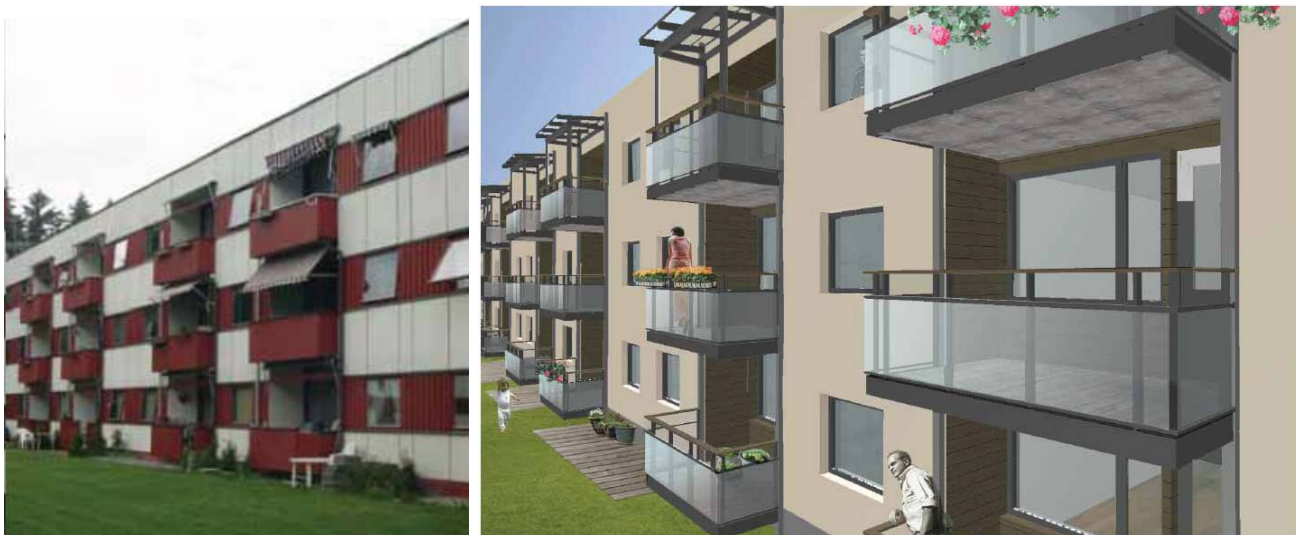
Figure 4. Myhrerenga before and after renovation. Illustration: Arkitektskap AS.
