SFH PIAF[®] in Sint Pancras NL

PROJECT SUMMARY

IEA – SHC Task 37 Advanced Housing Renovation with Solar & Conservation

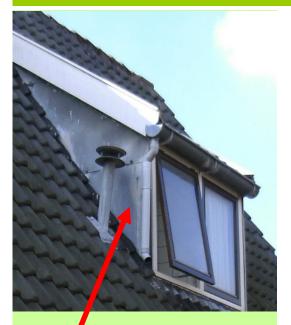
Health hazard: Exhaust vent for flue gas from kitchen gasburner directly beside dormer window.

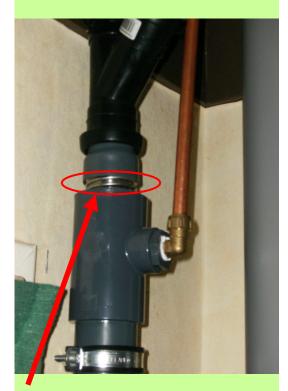
Picture showing the top part of the installed (Bries) heat recovery unit for domestic hot water (shower). The special design (ribbed 2.2 m long), ensures a high efficiency of over 70%.

Section showing part of the ribbed heat exchange area between the hot waste water running down and the cold supply water.
