Impact response of injection-moulded polypropylene parts for automotive exteriors

Summary: Injection moulded polypropylene plates were impact tested at -30 °C at low velocities (≤ 4.4 m/s) and low impact energies (≤ 34 J). Brittle fracture was observed above a certain velocity for plate thicknesses below a certain value. Weld lines, surface texture, paint and more concentrated load induced brittle fracture in more cases.

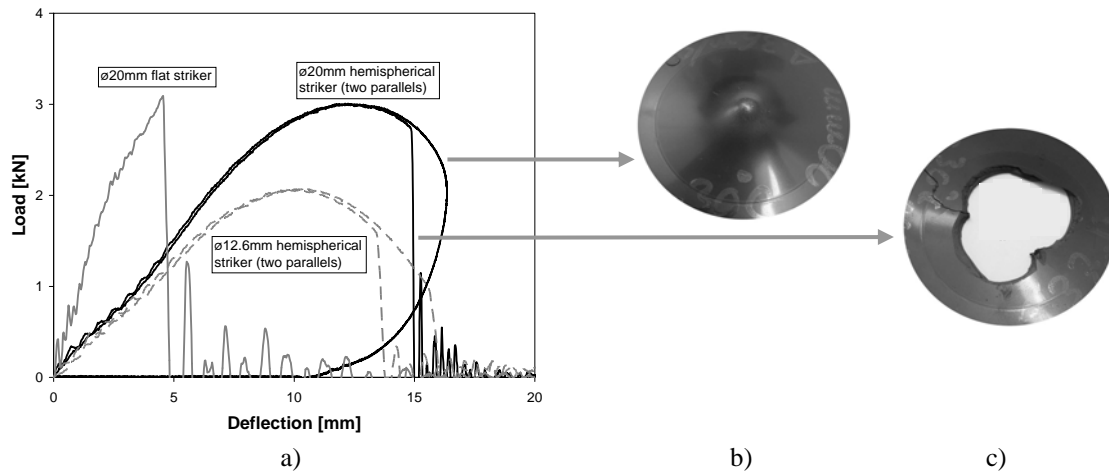
Figure 2: a) Load-deflection curves for 2.4 mm thick plates, with strikers as indicated. b) and c) Plates after testing with the $\varnothing 20\text{mm}$ hemispherical striker. Impact velocity 4.4 m/s and test temperature -30°C .

When using a smaller hemispherical striker (\varnothing 12.6 mm) at an impact velocity of 4.4 m/s, all plates except the thickest (3.9 mm) showed brittle fracture. The 3.3 mm thick plate was a borderline case, i.e. some, but not all, tests showed brittle fracture. A flat \varnothing 20 mm striker was also used in some tests of 2.9 and 2.4 mm thick plates. With this striker the plates fractured at quite low deflections, before the load reached a maximum, see Fig. 2a. The peak load was about the same as with the \varnothing 20 mm hemispherical striker.

By using an exchangeable mould insert, 2.4 mm thick plates were also made with one side having a surface texture (roughness) typical of a bumper cover. When striking this plate at the textured side (untextured side in tension under the striker), the load-deflection curve was the same as for the standard plates. However, when striking at the reverse side, the plates showed a brittle response with lowered impact energy, both at 3.0 and 4.4 m/s, see Fig. 3. Note that when striking the untextured side, the impact energy was lower at 4.4 m/s than at 3.0 m/s, which was opposite to the trend for the standard plates, even when they were brittle at 4.4 m/s (Fig. 2a).

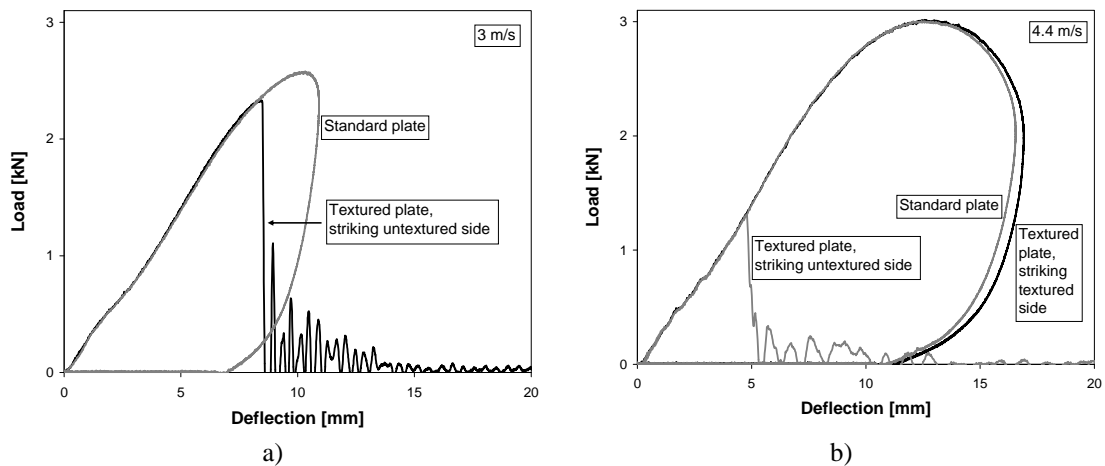
Figure 3: Load-deflection curves for 2.4 mm thick plates, with and without one textured side, tested at indicated impact velocities. Test temperature -30°C .

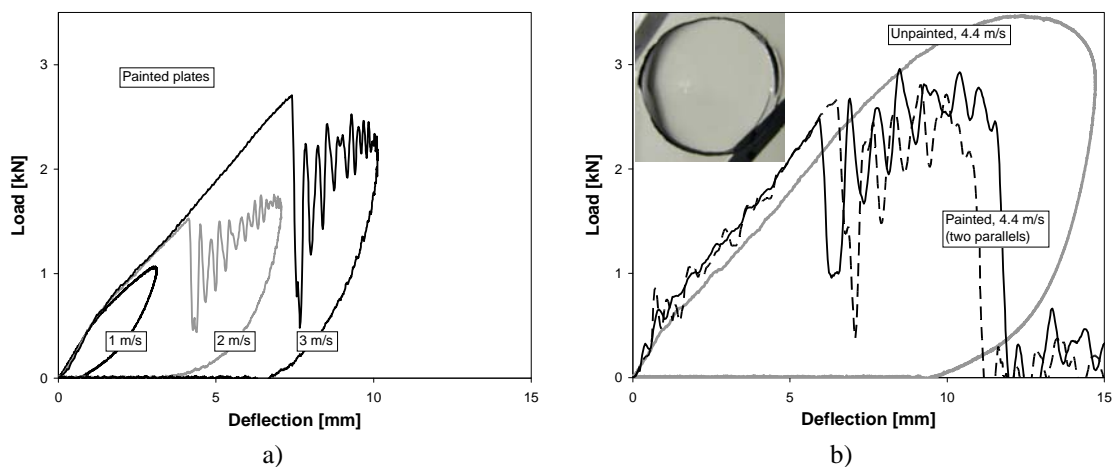
Figure 4: Load-deflection curves for 2.9 mm thick painted and unpainted plates, at indicated impact velocities. Test temperature -30°C . The photo shows the circular crack, running through the plate, for impact speed 4.4 m/s.

Some 2.9 mm thick plates were painted with a commercial paint system (primer, basecoat, clearcoat) and tested at different impact velocities, impacted at the painted side. No cracks were observed after testing at 1 m/s. At 2 and 3 m/s, a circular crack with diameter 40-45 mm (i.e. aligned with the clamping) formed on the impacted side only. At 4.4 m/s this crack ran through the plate. Some load-deflection curves, and a photo of the circular crack, are shown in Fig. 4. Note that this effect of painting was not observed at room temperature.
