Helicopter Safety Study 3b

A limited update of HSS-3 focusing on the period 2010–2015

SINTEF Technology and Society Safety Research 2017-05-31

CLIENT Norwegian oil and gas

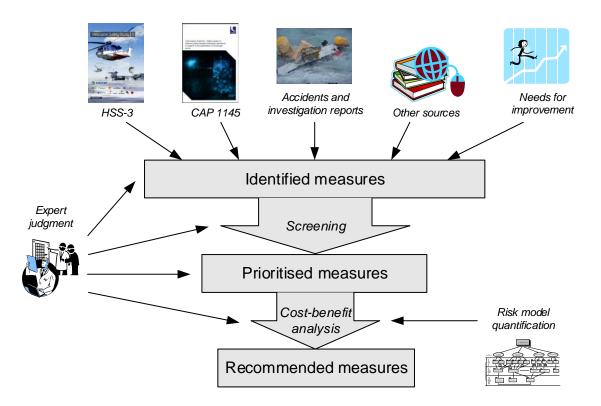
Figure 2.1: Procedure for the identification and recommendations of safety measures.

The procedures for identifying and prioritising the different recommendations are depicted in Figure 2.1.

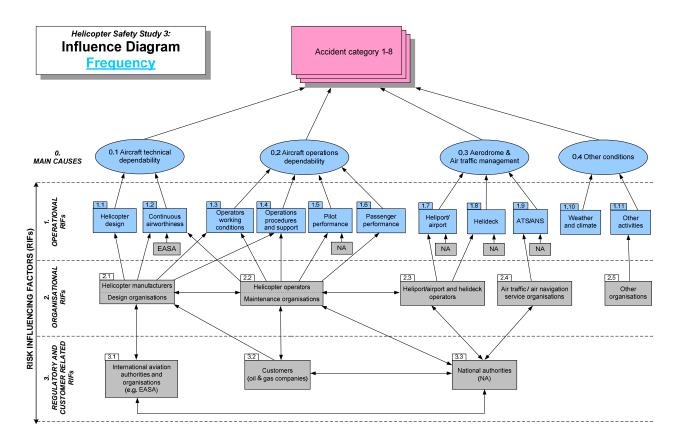
Figure 2.3: Influence diagram for the frequency dimension of accidents. A similar diagram exists for the consequence dimension (see appendix A).

Figure 2.3 depicts the RIF hierarchy including risk factors affecting the *frequency* of accidents. The RIFs are organised in 3 levels: 1) operational RIFs, 2) organisational RIFs, 3) authorities and customer related RIFs. There is a similar diagram for RIFs affecting the consequential part of risk. Both diagrams are presented in Appendix A (with higher resolution).

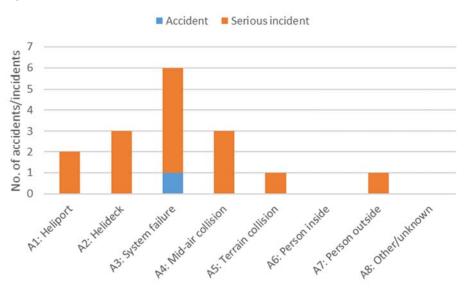
Figure 5.1: Distribution of accidents and serious incidents based on accident category; NCS 1999–2015.

The table above refers to the different accident categories described in section 2.4. A distribution of the accidents/incidents based on accident categories are presented in Figure 5.1. Note that those events (9 and 12) that are placed in two categories also count as double in the presentation below, thus the total is not accurate. This is subordinate since the purpose is to describe frequency/importance among the accident categories themselves.

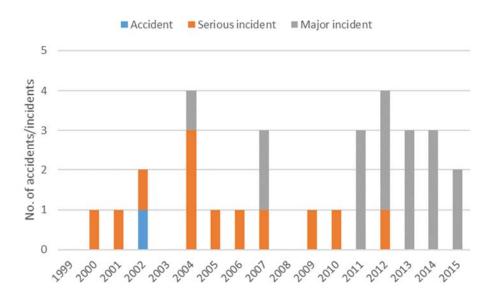
Figure 5.2: Accidents and serious/major incidents per year on the NCS for the period 1999–2015.¹

We observe a slight reduction of serious incidents over the last years. On the other hand, there has been an increase in the number of "major incidents", which have a lower degree of severity. This may to some extent be related to how reporting and classification have been adjusted during the period. All incidents categorized as "major" are in fact air traffic incidents where the helicopter has come too close to other traffic (i.e. accident category A4 Mid-air collision). A couple of the serious incidents are also of this type. Figure 5.2 presents how accidents and incidents (both serious and major) are distributed per year for the period.

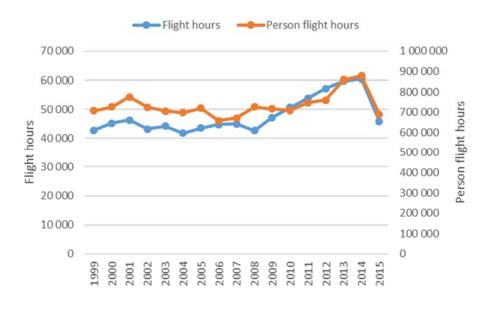
Figure 5.3: Traffic volume for the NCS 1999–2015.

Figure 5.3 depicts a relatively stable traffic level for the first part (1999–2009) of the period, after which it increases steadily and peaks in 2014. For 2015 there is a considerable drop in volume back to the same level as before the increase. This coincides with the business downturn in 2015.

Table 5.2 and Figure 5.3 presents the traffic volume for passenger transport on the NCS for the period 1999 - 2008, based on data from CAA-N. The data relate to regular passenger transport, hence training, testing, cargo flights, medevac and rescue operations are not included. Similar data for the British sector are presented for comparison. The data are also used for calculating the accident statistics in Table 5.4 below. Note that some data are missing; these data have been estimated and put in italics.

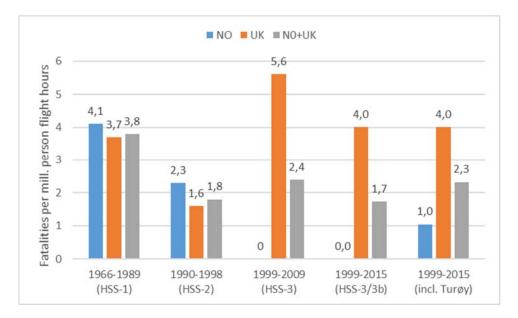
Figure 5.4: The number of fatalities per million person flight hours on the Norwegian and British sectors and combined. Results are shown for the different HSS periods: a) HSS-1 1966–1989; b) HSS-2 1990–1998; c) HSS-3 1999–2009; d) extended HSS-3/3b 1999–2015; e) extended HSS-3/3b 1999–2015 hypothetically including the Turøy accident.

Figure 5.4 illustrates the development in the number of fatalities per million person flight hours over the various HSS periods in the Norwegian and British sectors, as well as the North Sea combined. In the figure the column groups a)–c) are results from the three previous HSS studies, as reported in HSS-3, while column group d) expands HSS-3 to also include HSS-3b. Finally, column group e) depicts hypothetical results for the expanded HSS-3/3b period if the Turøy accident is included in that period.

If the Turøy accident had occurred in 2015 instead of 2016, the number of fatalities per million person flight hours would have increased from zero to **2.8** for the NCS in the period 2010–2015 (not depicted). For the extended period 1999–2015, the increase would be from zero to **1,0** for the NCS (Figure 5.4). This is still well below the average for the North Sea as a whole.

Furthermore, Figure 5.4 demonstrates the following relations:

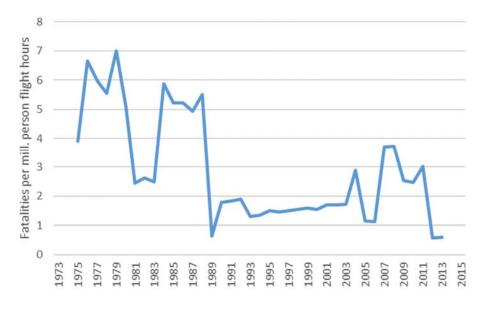
Figure 5.5: The number of fatalities per million person flight hours in the North Sea (NO and UK sectors) for the period 1975–2013; 5-year moving average.

Figure 5.5 depicts a 5-year moving average for the number of fatalities per million person flight hours for the North Sea (NO+UK) for the period 1975–2013. A large and stable improvement after around 1990 is indicated, with some variation from 2004 and onwards. The global trend from the 1970-ies is showing a notable reduction.

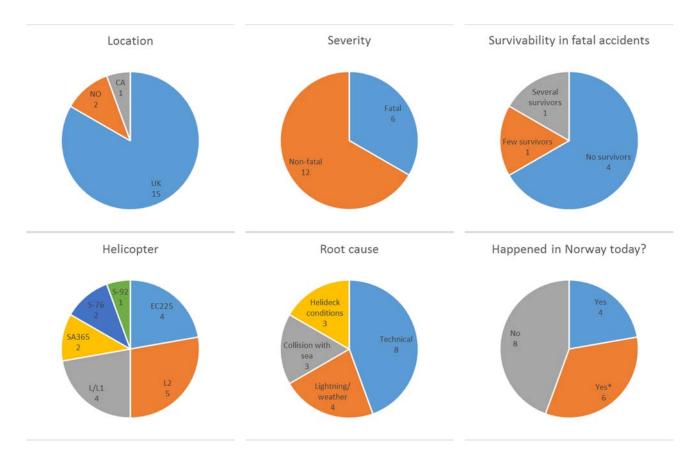
Figure 6.1: Visual summary of information about accidents in the North Sea (and Canada) for the period 1999–2015/16.

Figure 6.1 gives a visual summary of central information and assessments of the accidents.

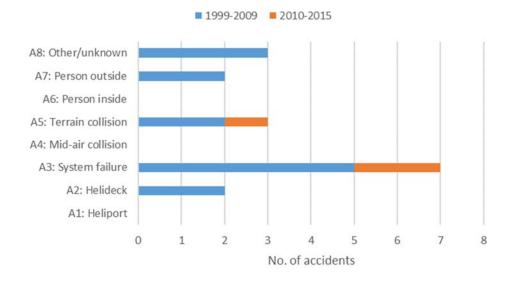
Figure 6.2: Accidents in the North Sea (and Canada) 1999–2015 by accident category.

Figure 6.2 depicts the distribution of accidents by categories. The distribution is for the British and Norwegian sectors (and Canada) for the period 1999–2015.

From Figure 6.2 we observe the category A3 Accident caused by critical failure in helicopter during flight are dominating with 7 accidents. However, the analysis shows that 5 of the 7 accidents could have been prevented today.

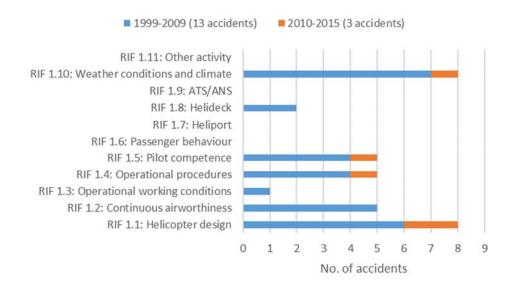
Figure 6.3: Accidents in the North Sea (and Canada) 1999–2015 by RIFs for frequency.

Figure 6.3 presents all the accidents distributed by the defined RIFs for the two periods. We observe that the RIFSs *Weather and climate* and *Helicopter design* hold the largest contribution to accidents since 1999. The accidents linked to *Helicopter design* are for a large part type *A3 System failure*, and the reduction of this type of accidents will also result in a decrease in this RIF's contribution.

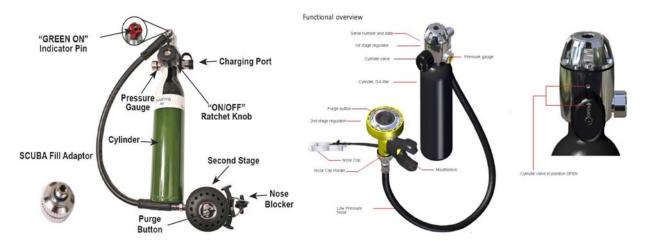
Figure 7.1: Example of two current breathing systems: Apeks PSTASS (left) and Hansen Protection SeaAir EBS (right). (Source: Falck Nutec)

Cat A breathing systems will be a requirement in HOFO. Should HOFO be introduced on the NCS, such systems will be compulsory, unless alternative solutions can be justified (AltMoC).

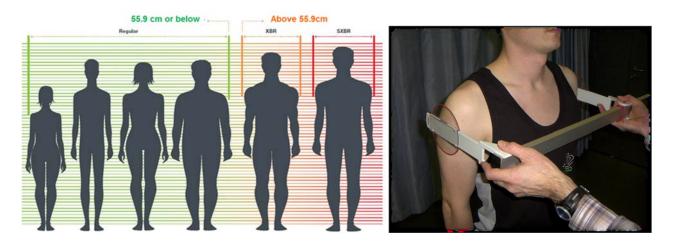
Figure 7.2: Shoulder width exceeding 22 inches (559 mm) are categorised as "extra broad" (XBR). Both the measuring procedure and tools are standardised. (Source: Step Change in Safety)

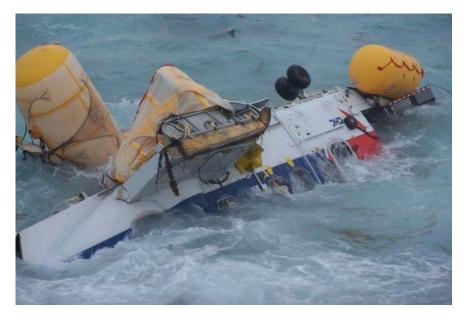
Figure 7.3: Floating devices preventing capsizing will reduce the need for reactive measures (consequence reduction). Picture from the Sumburgh accident in 2013. (Source: The Shetland Times).

Offshore helicopters are equipped with inflatable emergency floating devices with the purpose of keeping the helicopter afloat and stable given an emergency landing on water (this equipment is not designed for CFIT or uncontrolled landings). The helicopters are certified ("ditching performance") to stay afloat in certain sea conditions (e.g. 6 m significant wave height for the S-92 and the H225). The probability of capsizing increases with wave height, and in given circumstances the helicopter may capsize in wave heights below the certified limitation.⁵ The floating devices are attached to the lower part of the helicopter. To avoid capsizing the devices should rather be attached higher on the helicopter ("side floating device"). With a side floating device the helicopter will be less prone to capsizing and only partially submerged. This will create an air pocket inside the cabin for use during emergency evacuation.

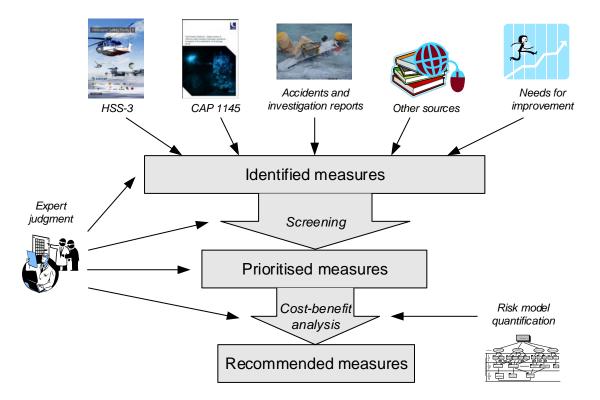
Figure 8.1: The process of identifying measures and recommendations.

The process of identifying measures and recommendations are illustrated in Figure 8.1.

For the three levels of measures (Figure 8.1) the following apply:

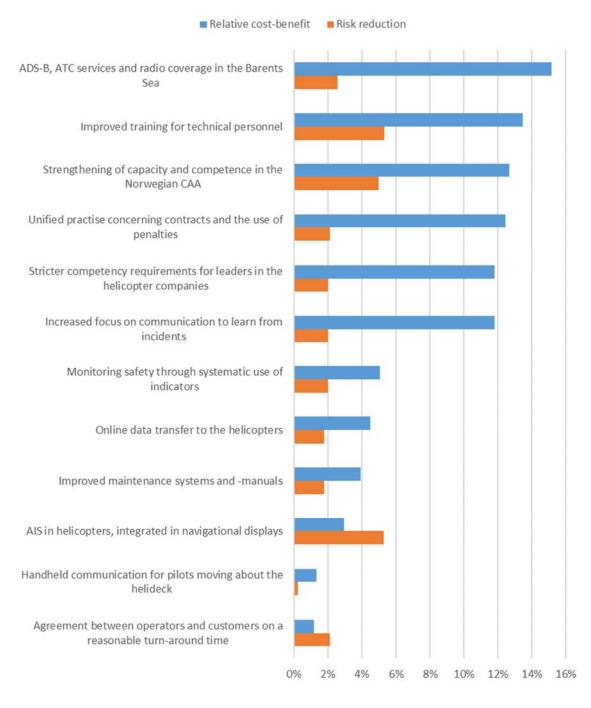
Figure 8.2: Overview of safety measures sorted by cost-effectiveness (relative cost-benefit yield for a measure compared to the other measures).

Figure 8.2 presents a summary of the measures that have been assessed with respect to cost-benefit, sorted by the relative cost-benefit contributions for the measures. In addition, the figure presents the expected risk reduction given a complete implementation of the measure. The results show that the following measures are the most efficient based on cost-benefit:
