COMPUTER AIDED REHABILITATION OF SEWER NETWORKS  
RESEARCH AND TECHNOLOGICAL DEVELOPMENT PROJECT OF EUROPEAN COMMUNITY  
Budapest University of Technology and Economics, Muegyetem rkp.3., Budapest, Hungary  
Phone: +36 1 4631530 Fax: +36 1 4633753

## **Report D3**

### **WP2 – Structural condition**

#### **Classification systems based on visual inspection**

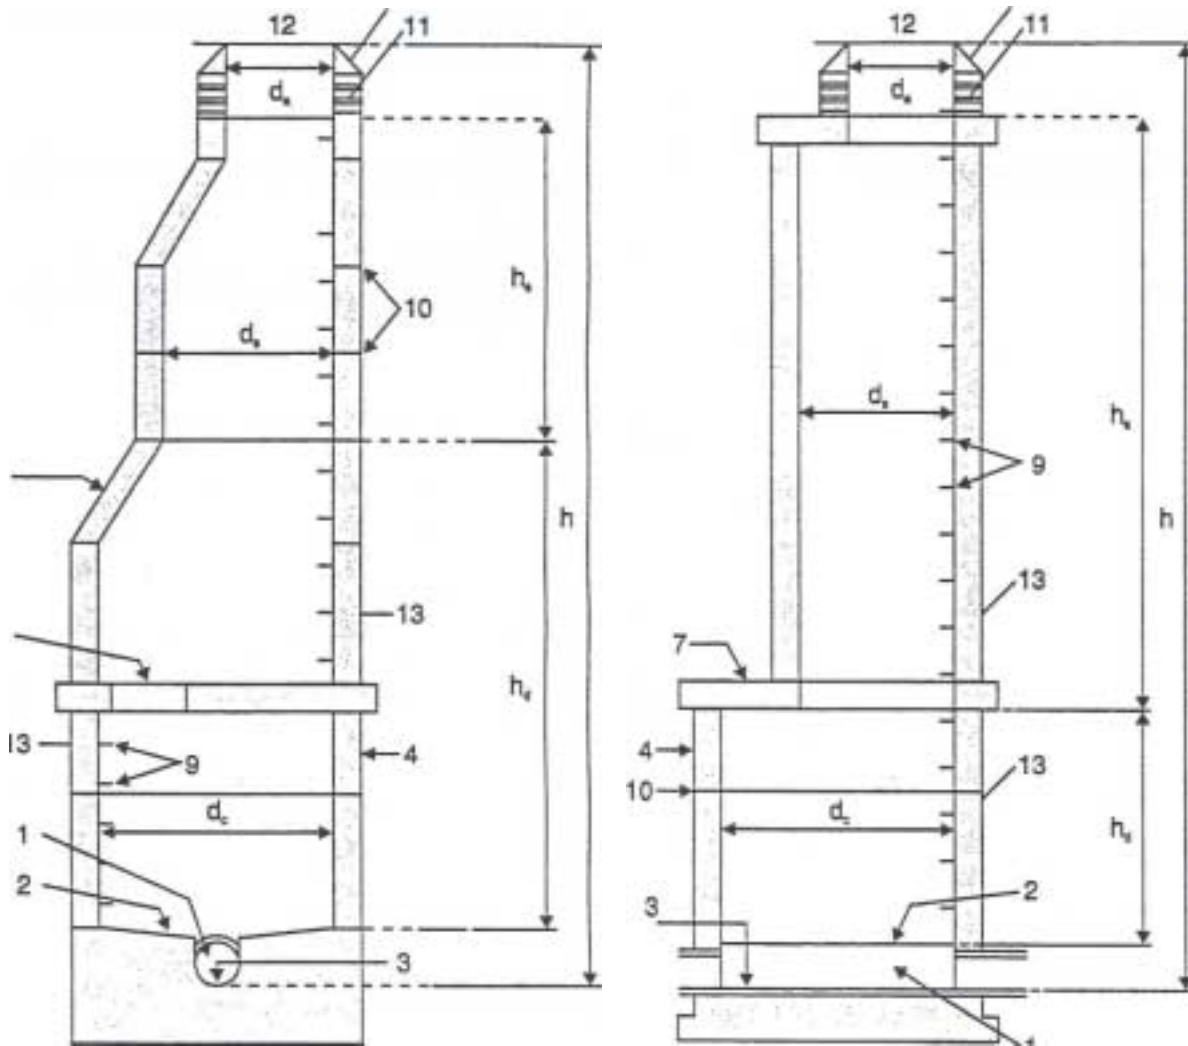
**Key**

1 Channel	8 Manhole top (cover and frame)	h Depth to invert
2 Benching	9 Step	$h_s$ Depth of shaft
3 Invert	10 Sealing material	$h_s$ Depth of shaft
4 Chamber unit	11 Adjusting construction	$d_a$ Access diameter/size
5 Taper	12 Cover level	$d_s$ Shaft diameter/size
6 Landing diameter/size	13 Manhole wall	$d_c$ Chamber
7 Reducing slab

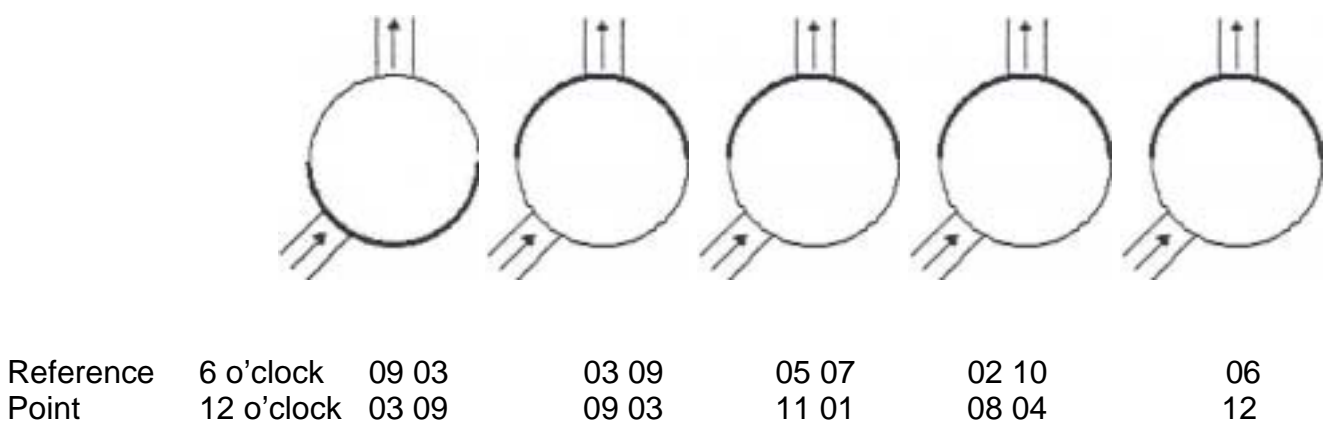
Figure 4 - Examples of clockface references in manholes and inspection chambers

By defining the circumferential reference point, the employing authority determines whether the lowest outgoing pipeline is described as being at 6 o'clock or 12 o'clock (see 10 (t)). The circumferential reference point used shall be as stated in the header information as described in 10.1. Other details of the clockface reference system are as described in 8.1.5.

Examples of clockface references are given in Figure 4
